RFP Number 15020  
Ketchikan Shipyard Engineering and Cost Estimating Services  
Addendum 3

## CO004/COR007 Diving Recovery Project- Final Report

Project Title: Ketchikan Cathodic Protection Project

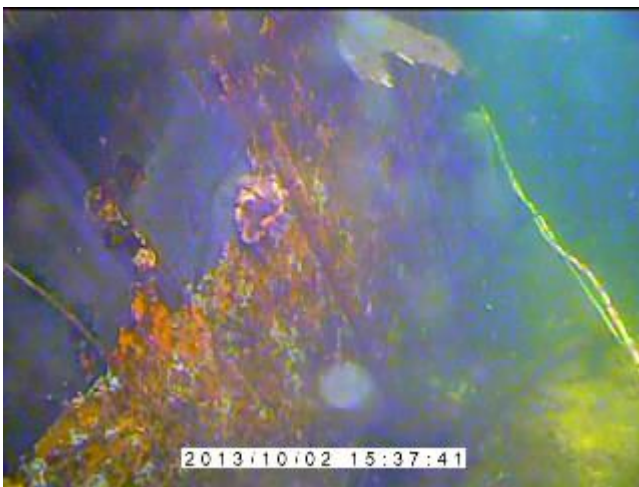
No major structural anomalies were found and the sea wall appeared to be in good condition. There were some areas of missing paint. See Fig.1 & Fig.5

Fig.1 Typical Sea wall missing paint

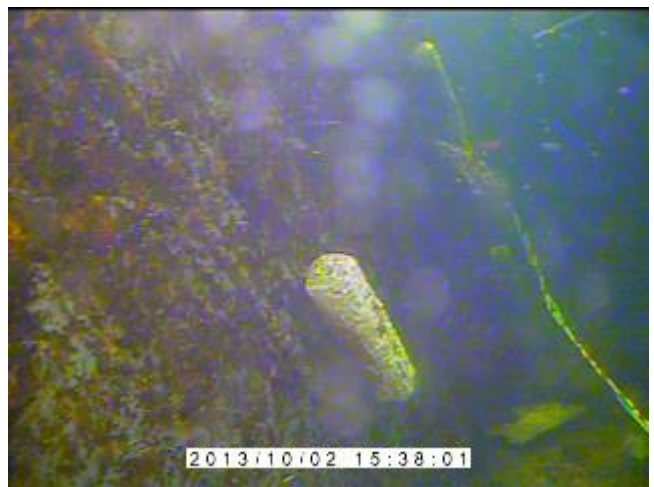
Anodes were in good condition and showed signs of depletion indicating they were doing their job.

Fig.2 Typical Anode

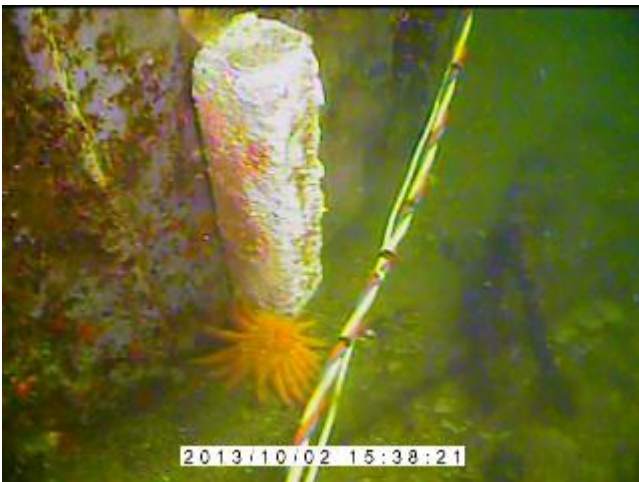
Fig.3 Typical Anode Depletion

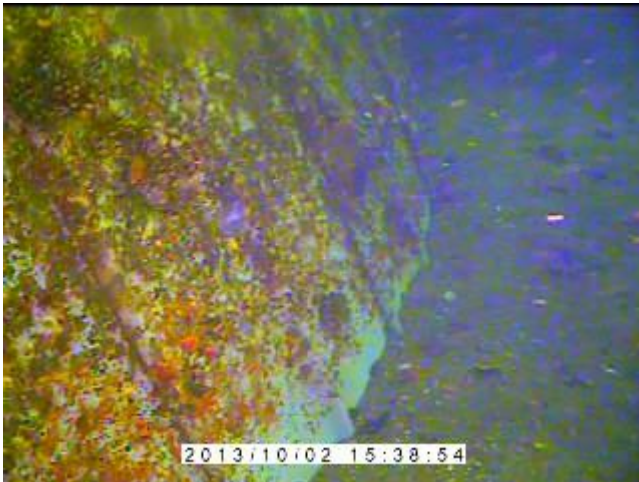
Fig.5 Typical Sea Wall To Sea Floor

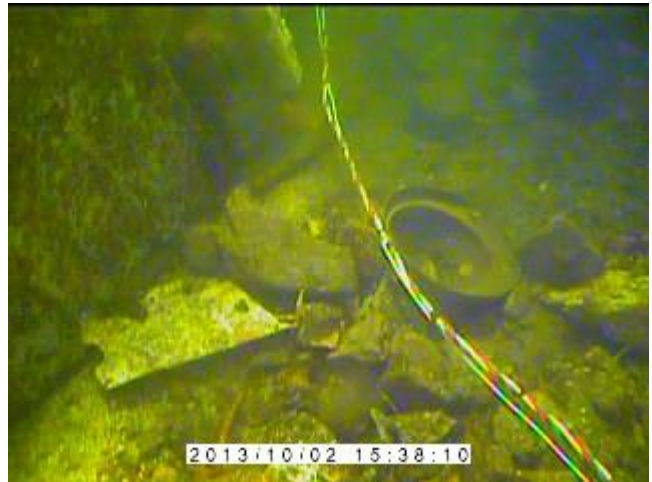
Fig.6 Typical Bottom Debris

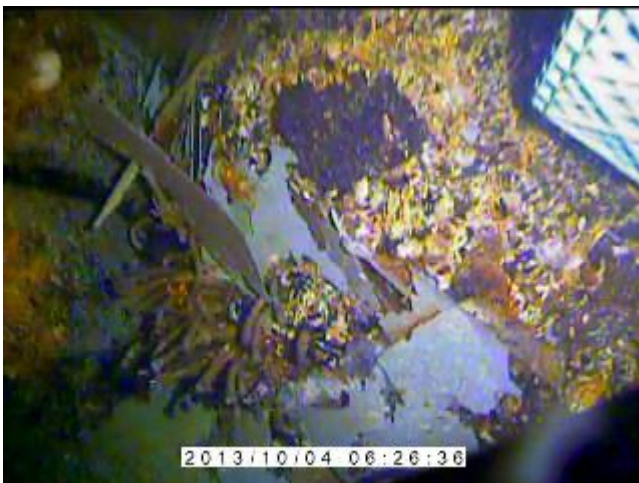
Fig.7 Paint Debris before Cleaning

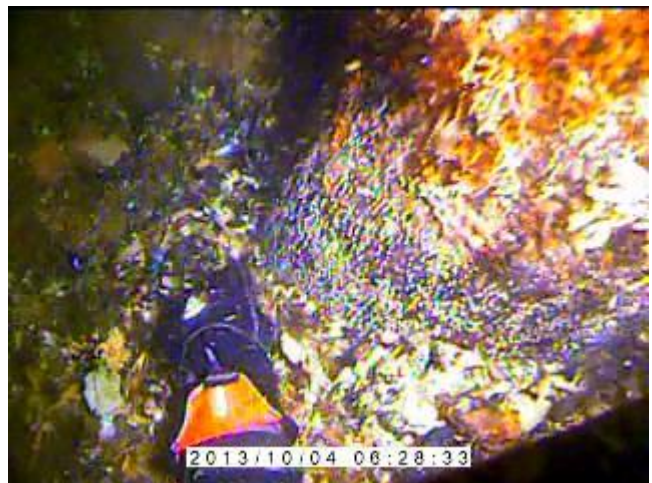
Fig.8 Same Area after Cleaning

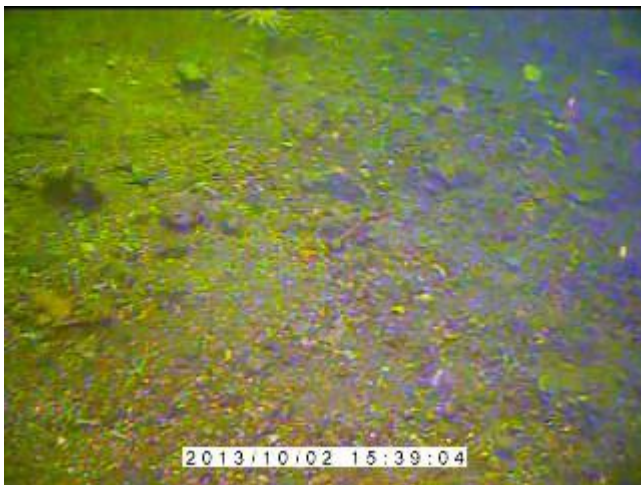
Fig.11 Typical bottom no paint chips

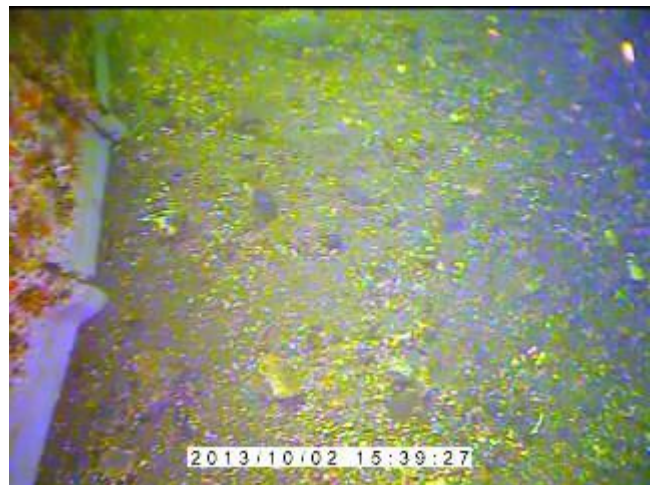
Fig.12 Typical bottom near Sea Wall
