**HAZARDOUS MATERIALS SURVEY
FINAL REPORT**

**AIDEA BUILDING
Anchorage, Alaska**

April, 2011

USKH WO# 1040301

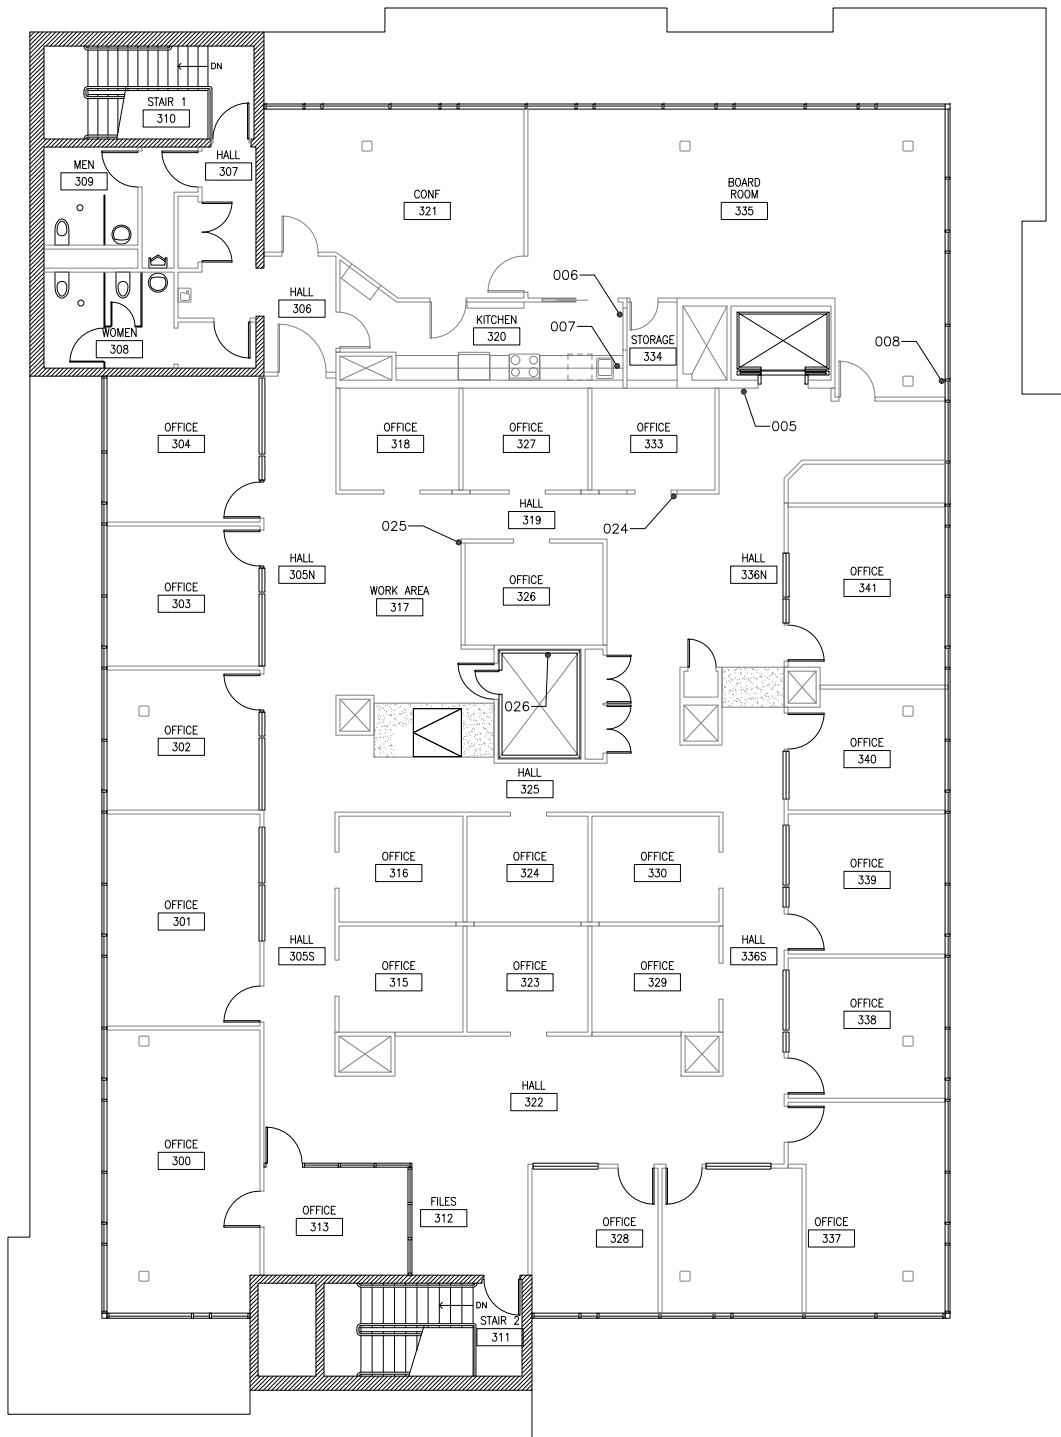
2 THIRD FLOOR ASBESTOS SURVEY PLAN
 AS-102 SCALE: 1/8"=1'-0"

ASBESTOS BULK SAMPLE LABORATORY RESULTS			
SAMPLE ID	MATERIAL	LOCATION	TEST RESULTS FOR ASBESTOS
1040301-ACM BULK -005	GWB	HALL 336N	NONE DETECTED
1040301-ACM BULK -006	JOINT COMPOUND	KITCHEN 320	3% CHRYSOTILE
1040301-ACM BULK -007	SINK MASTIC	KITCHEN 320	5% CHRYSOTILE
1040301-ACM BULK -008	CEILING TILE	BOARD ROOM 335	NONE DETECTED
1040301-ACM BULK -024	JOINT COMPOUND	OFFICE 333	NONE DETECTED
1040301-ACM BULK -025	JOINT COMPOUND	WORK AREA 317	NONE DETECTED
1040301-ACM BULK -026	JOINT COMPOUND	MECH CHASE 336	4% CHRYSOTILE

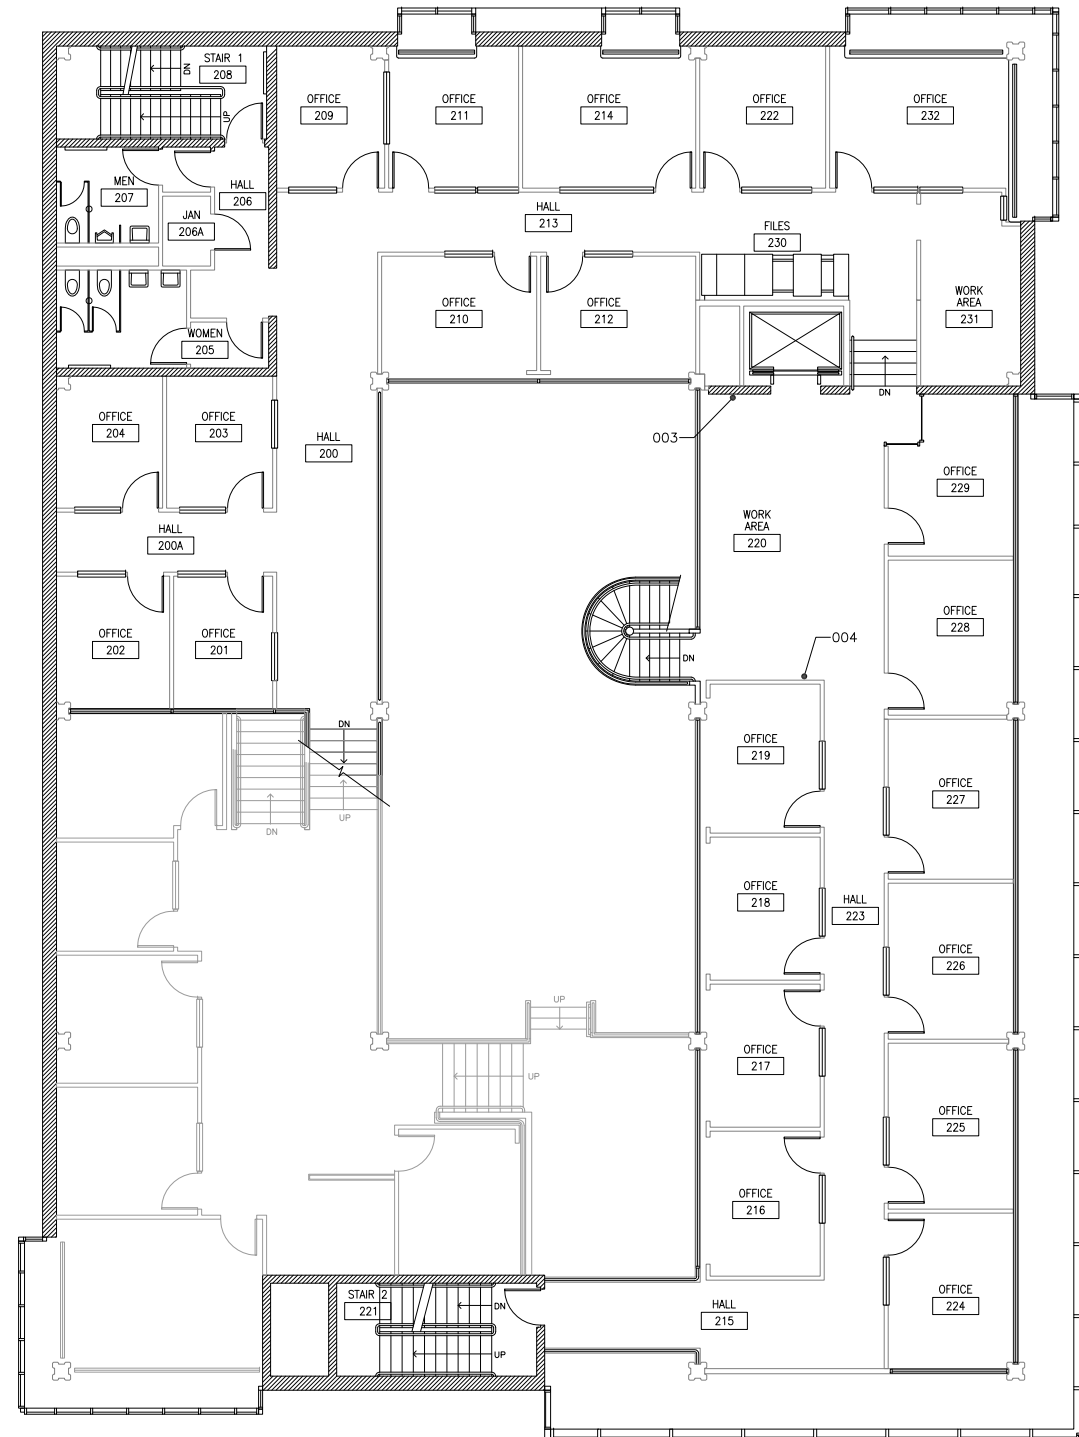
1 SECOND FLOOR ASBESTOS SURVEY PLAN
 AS-102 SCALE: 1/8"=1'-0"

ASBESTOS BULK SAMPLE LABORATORY RESULTS			
SAMPLE ID	MATERIAL	LOCATION	TEST RESULTS FOR ASBESTOS
1040301-ACM BULK -003	CEILING TILE	WORK AREA 220	NONE DETECTED
1040301-ACM BULK -004	JOINT COMPOUND	WORK AREA 220	NONE DETECTED
