# Letter of Transmittal

## REINSPECTION REPORT (ASBESTOS)

AIDEA FACILITY INSPECTED: 813 W. Northern Lights Blvd. DATE: April 5, 2005

AIDEA/AEA  
813 West Northern Lights Blvd.  
Anchorage, Alaska

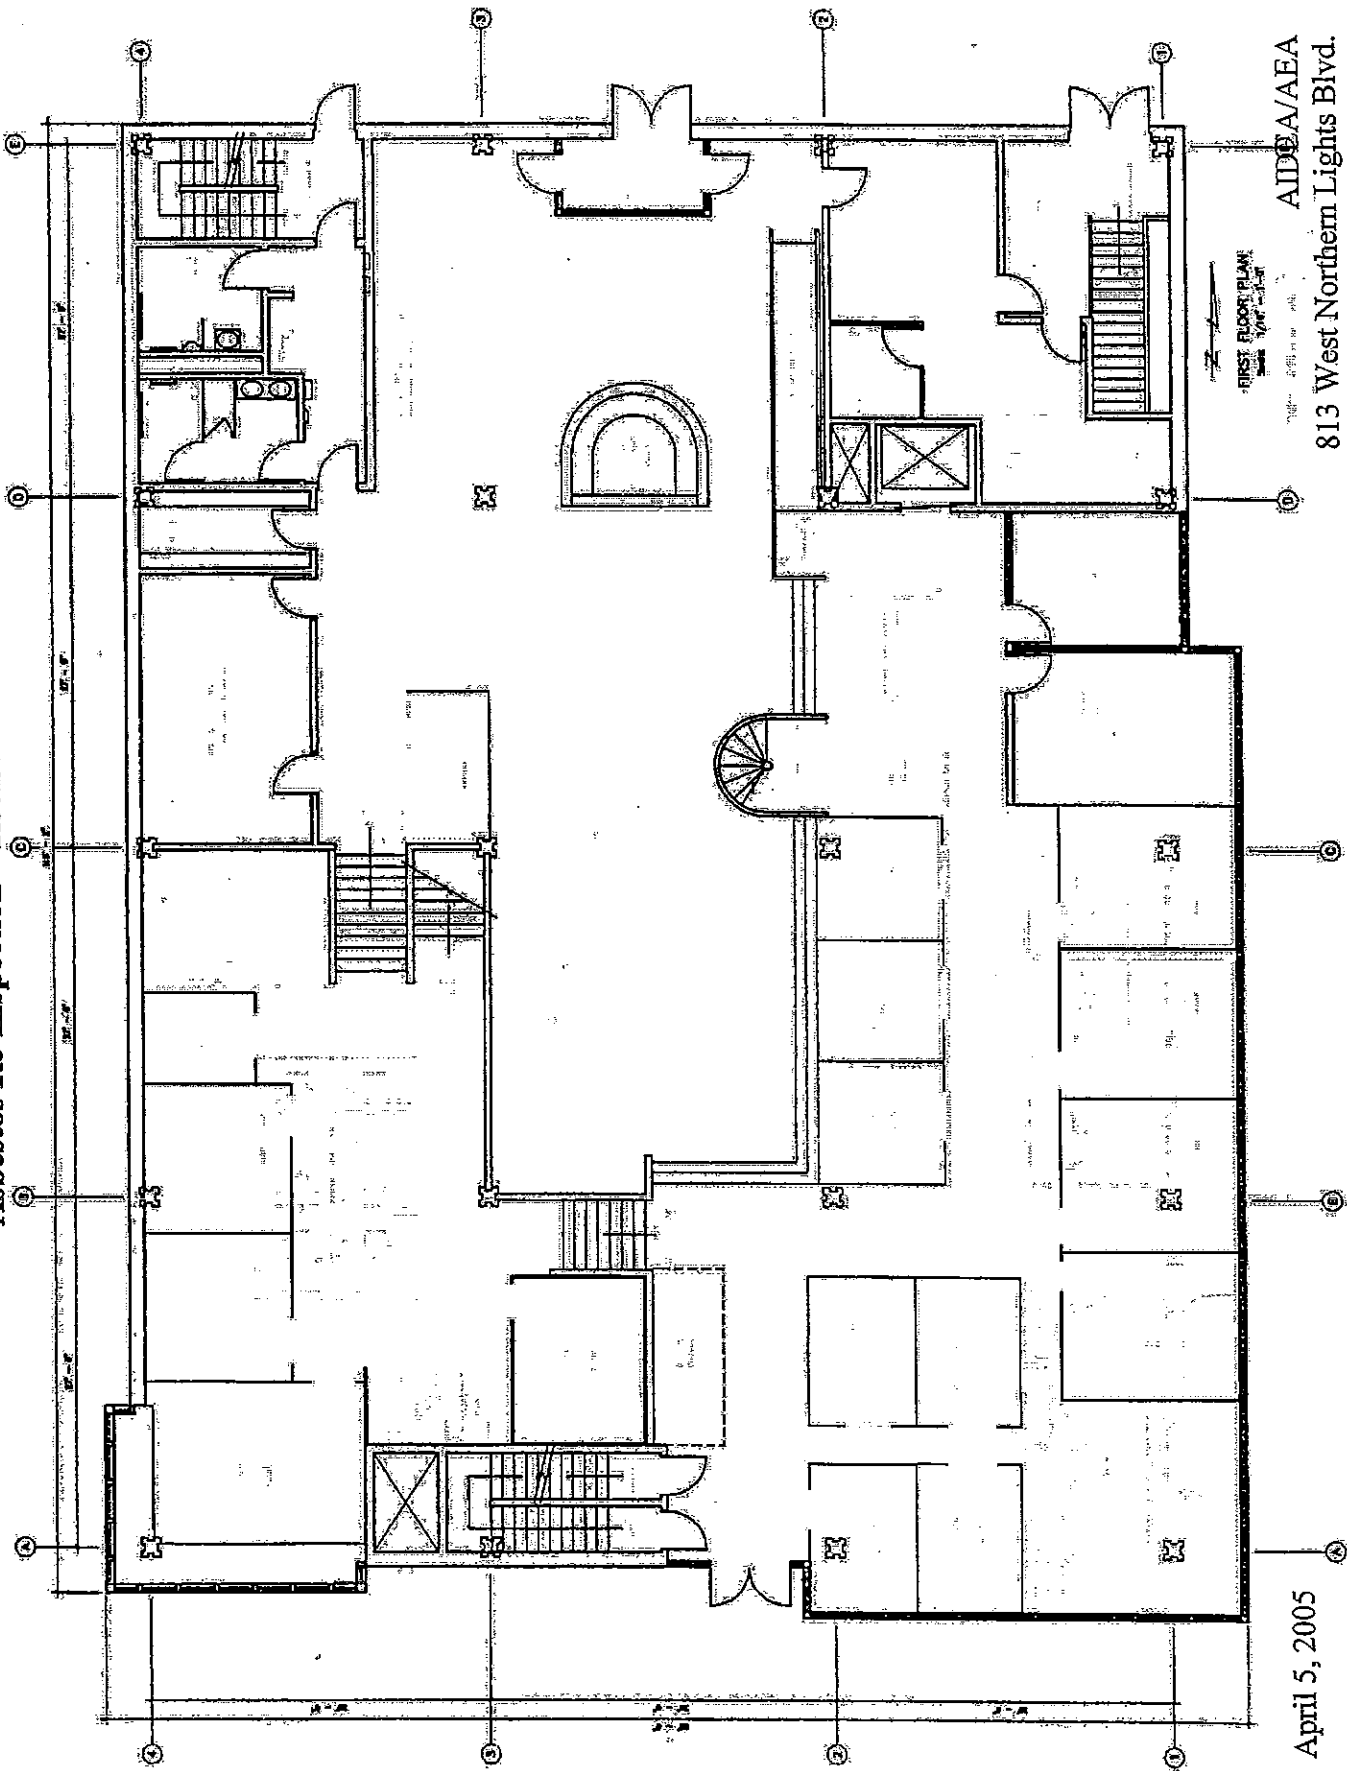
AIDEA/AEA  
FIRST FLOOR PLAN  
813 West Northern Lights Blvd.  
Anchorage, Alaska

| Asbestos-Containing Material | Location | Condition |
|---|--|---|
| Joint compound on gypsum wallboards | Throughout Building | Some gypsum board walls were removed during a remodel. All joint compound is in good condition. Joint compound on remodeled wall (highlighted in yellow on attached floor plans) should be tested for asbestos prior to the next renovation. It is doubtful that the joint compound on these newer walls contains asbestos. |
