**ALASKA INDUSTRIAL DEVELOPMENT AND EXPORT AUTHORITY**  
**SKAGWAY ORE TERMINAL**  
**SHIP LOADER STRUCTURAL INSPECTION**  
**November 11, 12 and 13, 2013**

**R&M Consultants, Inc.**

December 17, 2013

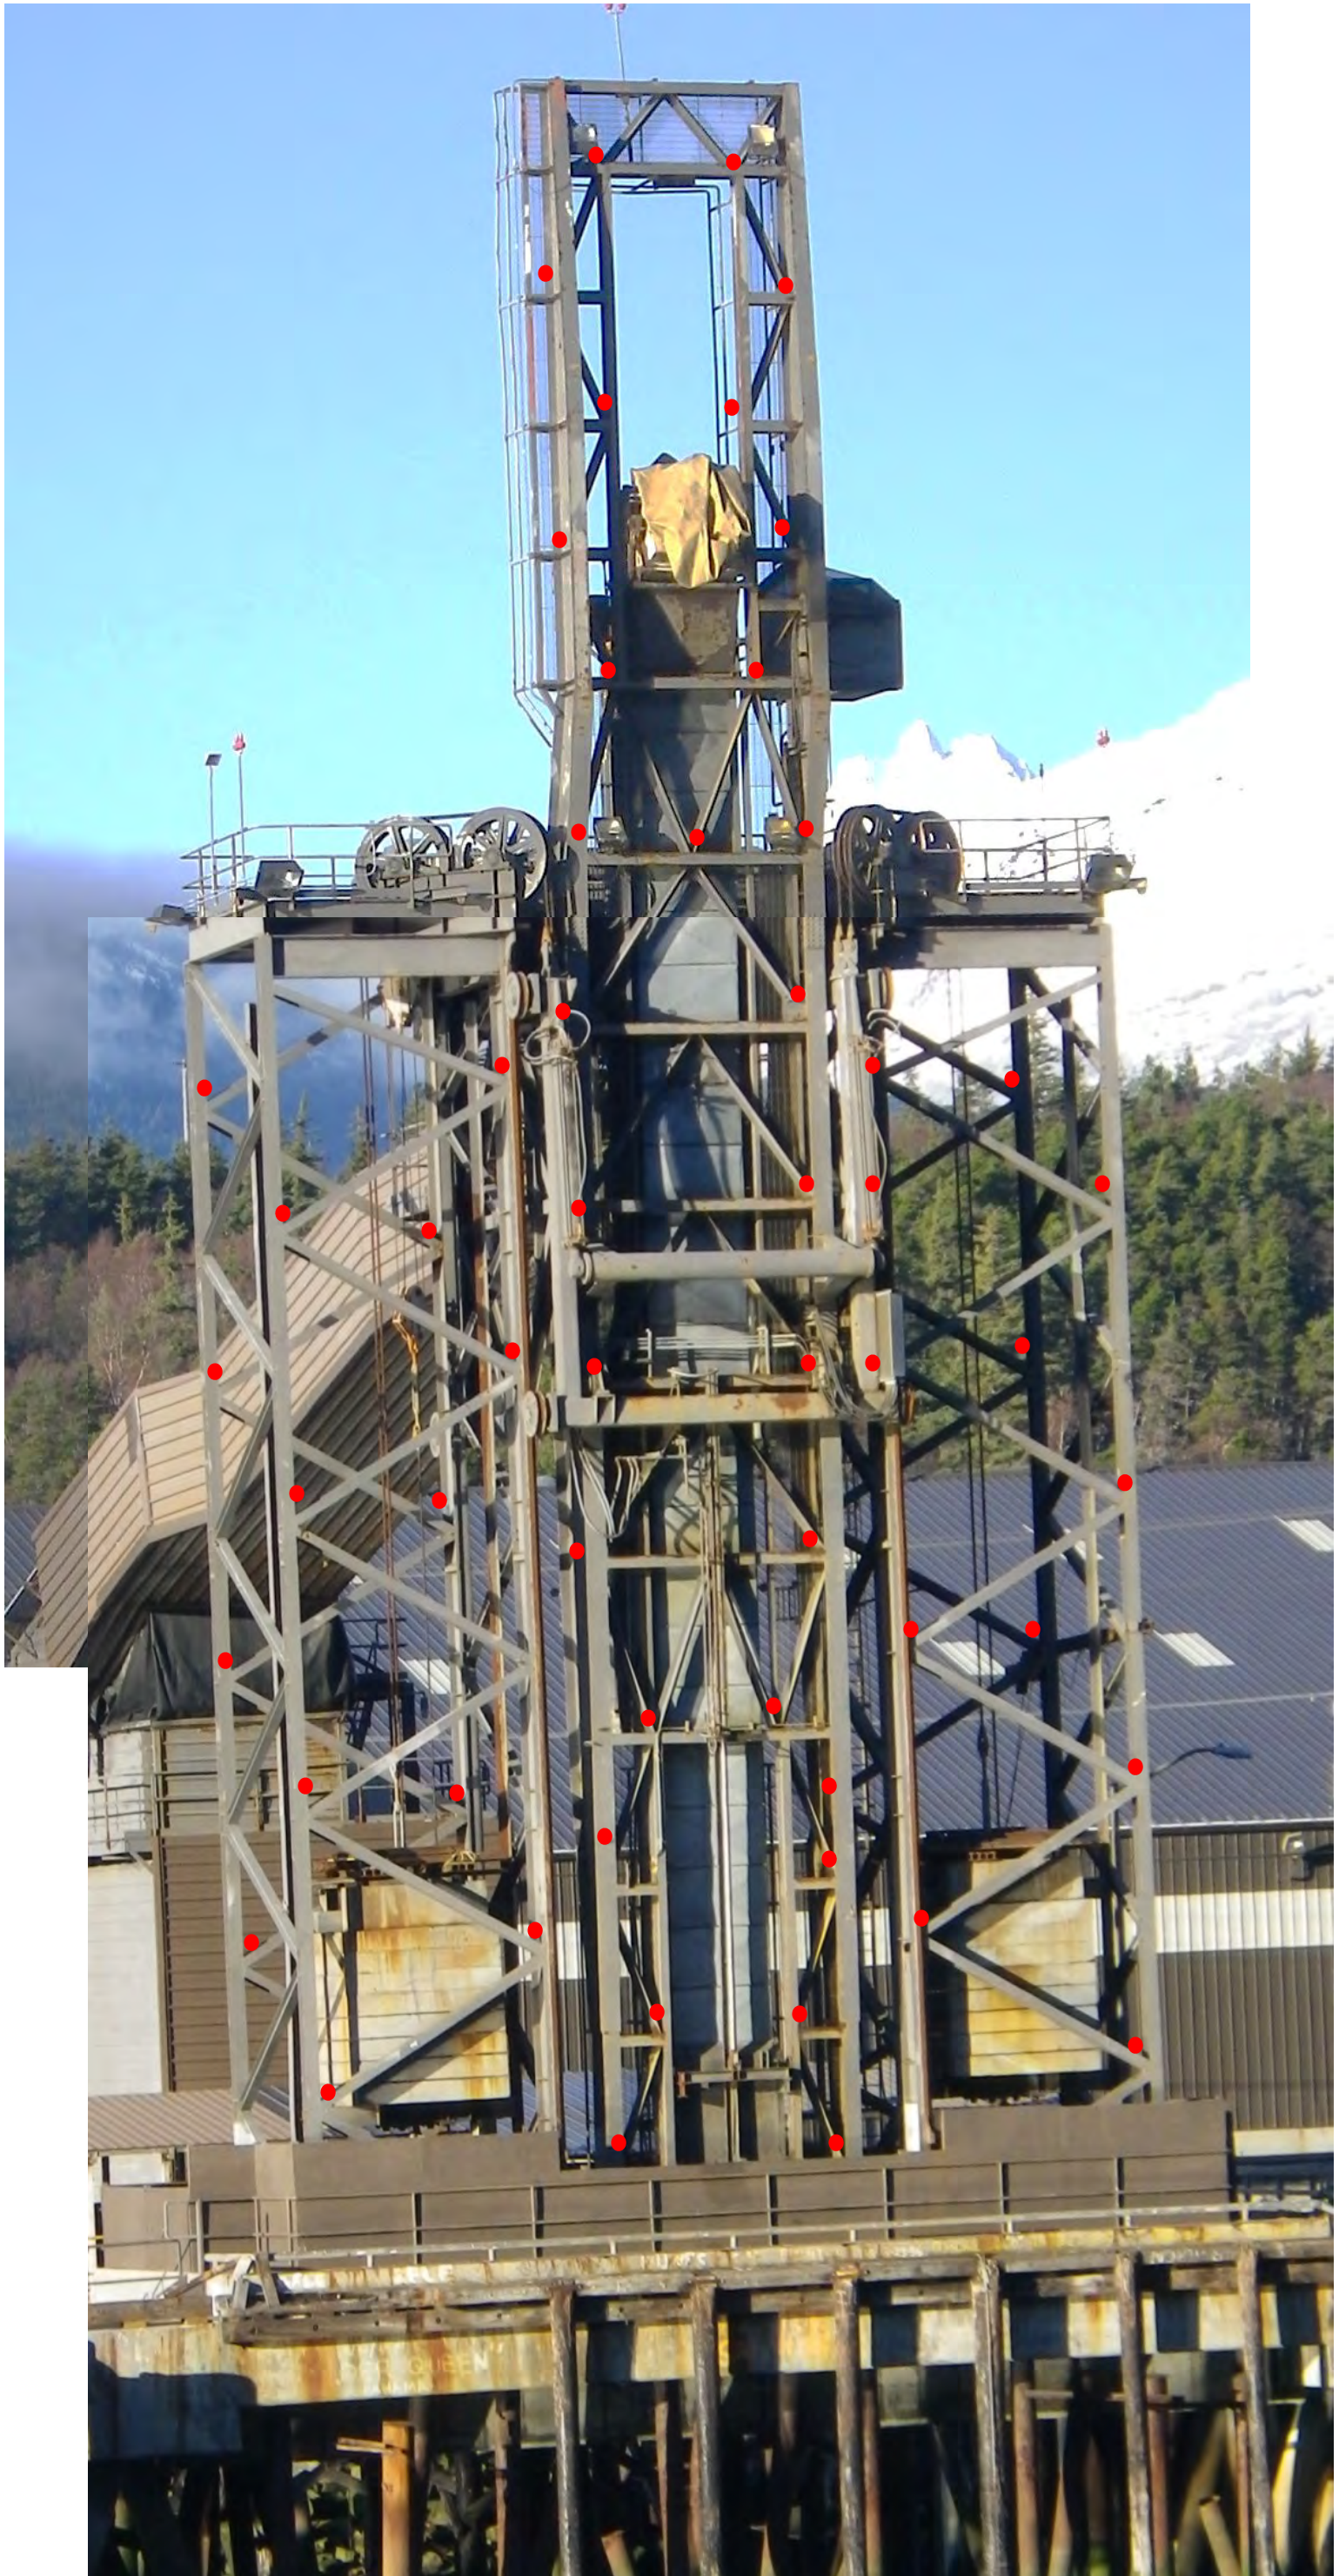
EAST FACE OF SHIP LOADER WITH BOOM IN PARKED POSITION – RED DOTS INDICATE SOME OF THE JOINTS REQUIRING URGENT REPAIR;  
NOTE THAT NOT ALL POINTS REQUIRING REPAIR ARE VISIBLE IN THIS PHOTOGRAPH

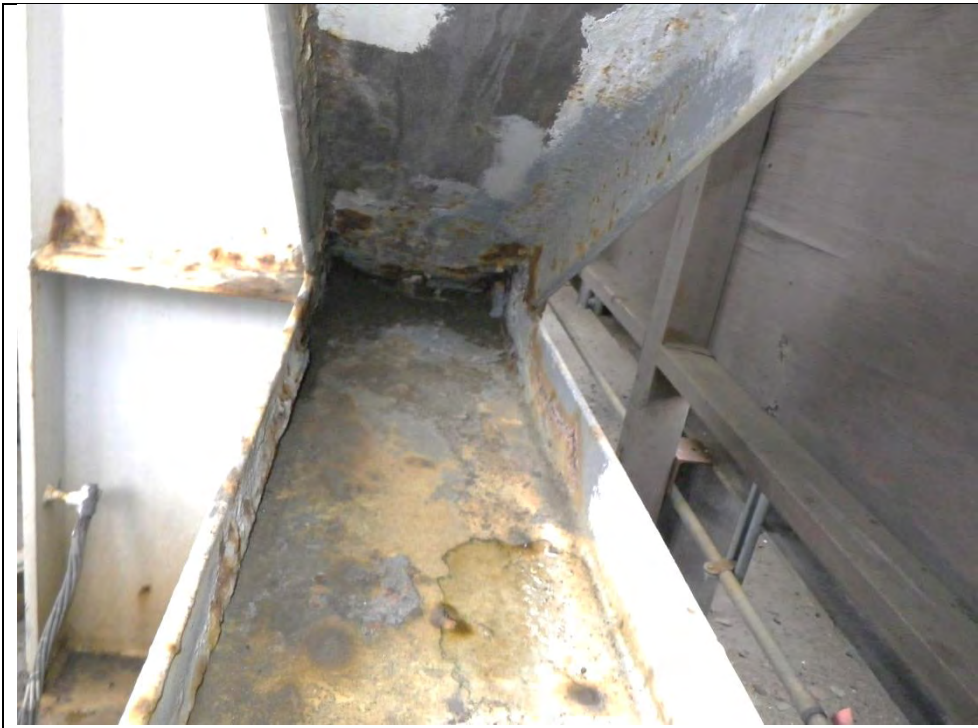
**JKM-111213-IMG0382**  
**LOCATION: SKAGWAY ORE TERMINAL SKAGWAY ORE TERMINAL**  
**DESCRIPTION: TOWER COLUMN BASE, NOTER CORROSION AT COLUMN TO BASE PLATE JOINT**

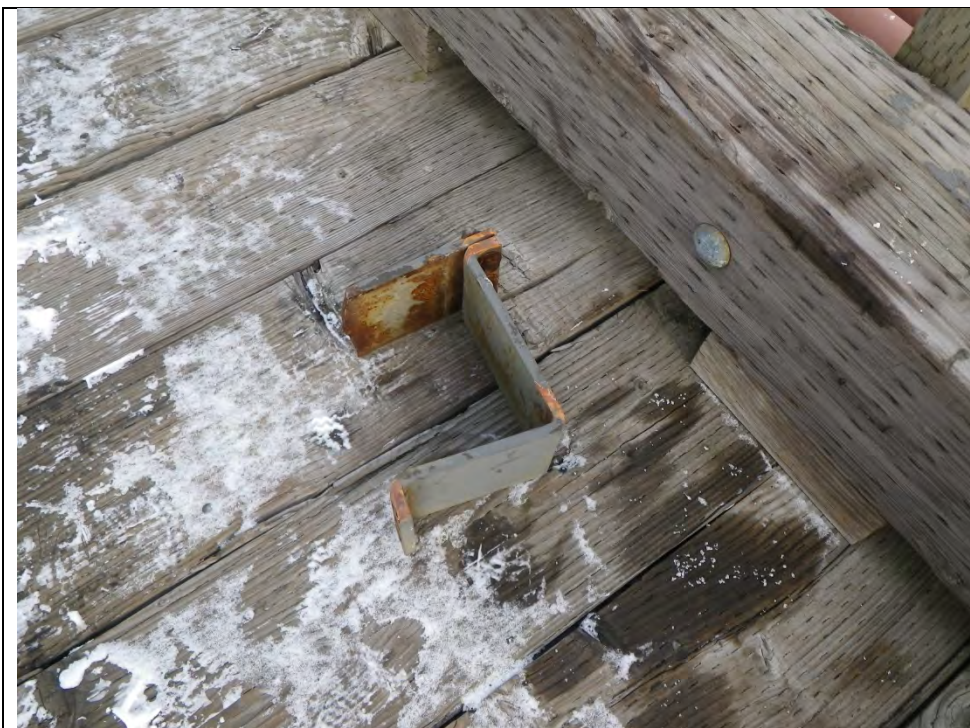
The gangway handling jib boom/hoist attached to the NE leg of the North Tower was found to be failed at the hinged connection bracket and with only one bolt still securing the assembly. MSI was notified and a man lift was moved to the SOT ship loader at the end of the climbing inspection for the day. MSI removed the hoist and jib boom. The mounting bracket assembly remaining on the column was removed by EAI the next day. Inspection of the NE column of the North Tower was not able to be done until this bracket was totally removed as it was not fastened to the column, presenting a hazard to personnel below.

**DESCRIPTION: GANGWAY HANDLING JIB CRANE FAILED BOOM BRACKET**

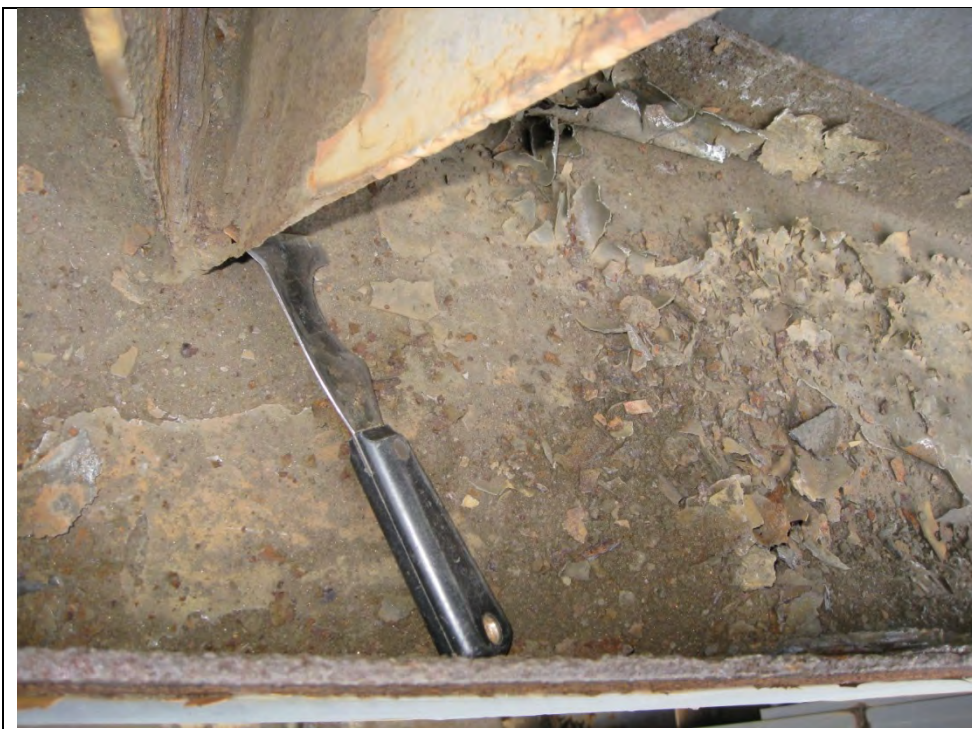
**SH-111213-08 SKAGWAY ORE TERMINAL SHIP LOADER**  
**LOCATION: 6 CENTER**  
**DESCRIPTION: 3/16-INCH LOSS TO V-BRACE WEBS, 3/32-INCH SECTION LOSS AT TRANSVERSE BRACE FLANGE FOR 36-INCH LENGTH.**  
**CONDITION STATE CS5**

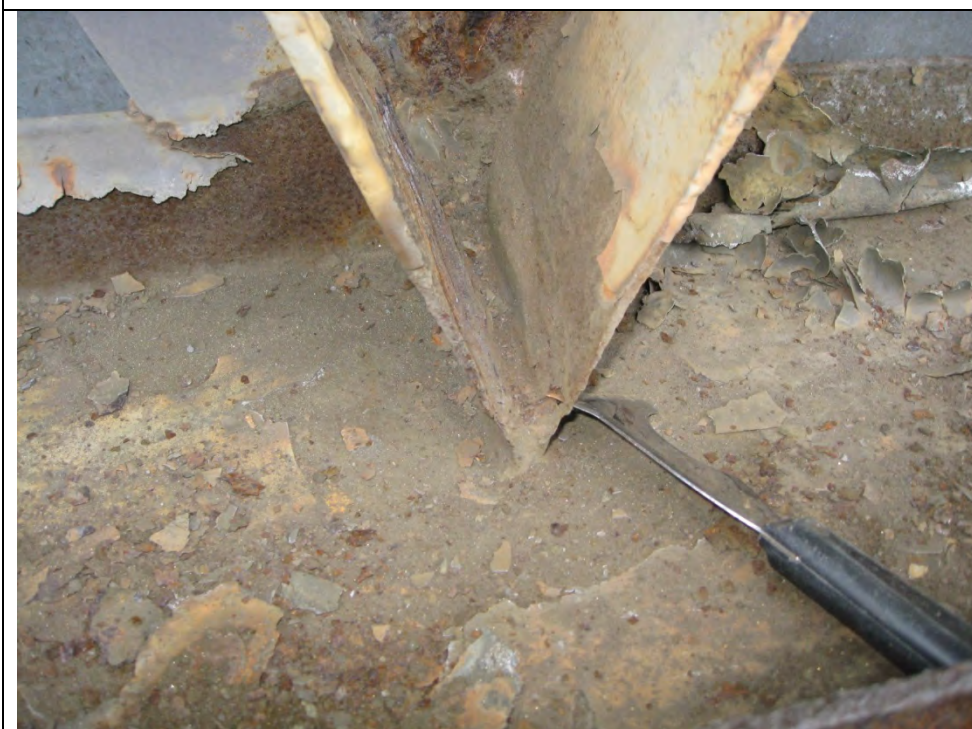
**SH-111213-07 SKAGWAY ORE TERMINAL SHIP LOADER**  
**LOCATION: 6 CENTER**  
**DESCRIPTION: 3/16-INCH LOSS TO V-BRACE WEBS, 3/32-INCH SECTION LOSS AT TRANSVERSE BRACE FLANGE FOR 36-INCH LENGTH.**  
**CONDITION STATE CS5**

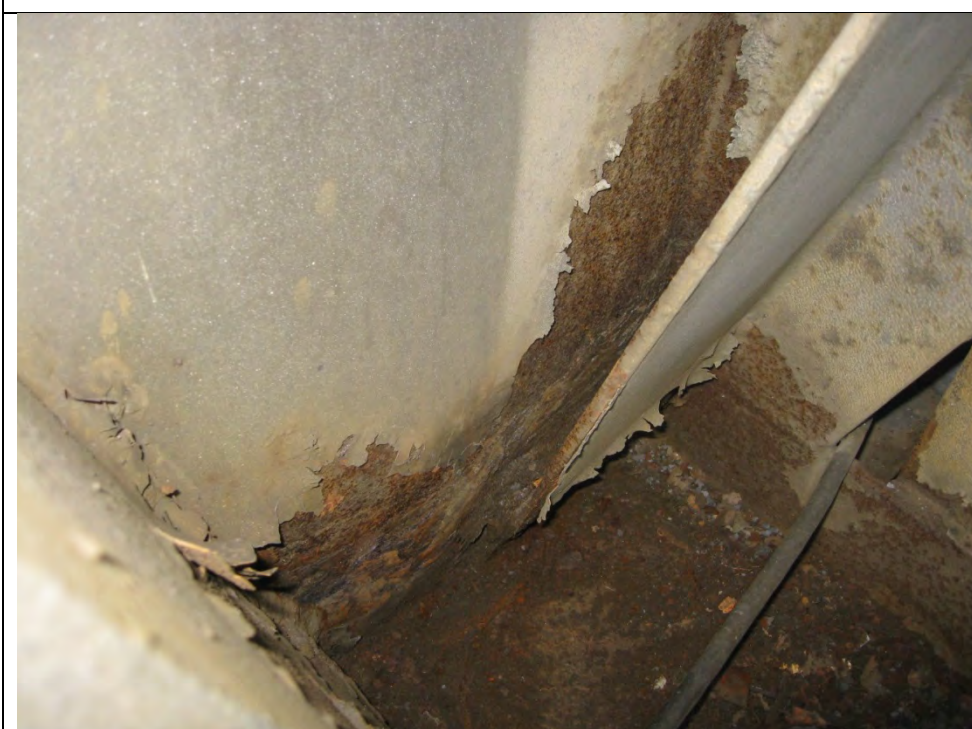
**SH-111213-06 SKAGWAY ORE TERMINAL SHIP LOADER**  
**LOCATION: 6 SOUTH**  
**DESCRIPTION: CS5 3/16 INCH SECTION LOSS IN AREA OF INTERSECTING WELDS, 12"x12" AREA TO 1/8-INCH LOSS IN AREA 8"x8", LOCATION 6 IS JUST ABOVE SPLICE PLATE (ACTUALLY WITH BOOM DOWN THIS WOULD BE JUST OUTBOARD FROM SPLICE PLATE).**  
**CONDITION STATE CS5**

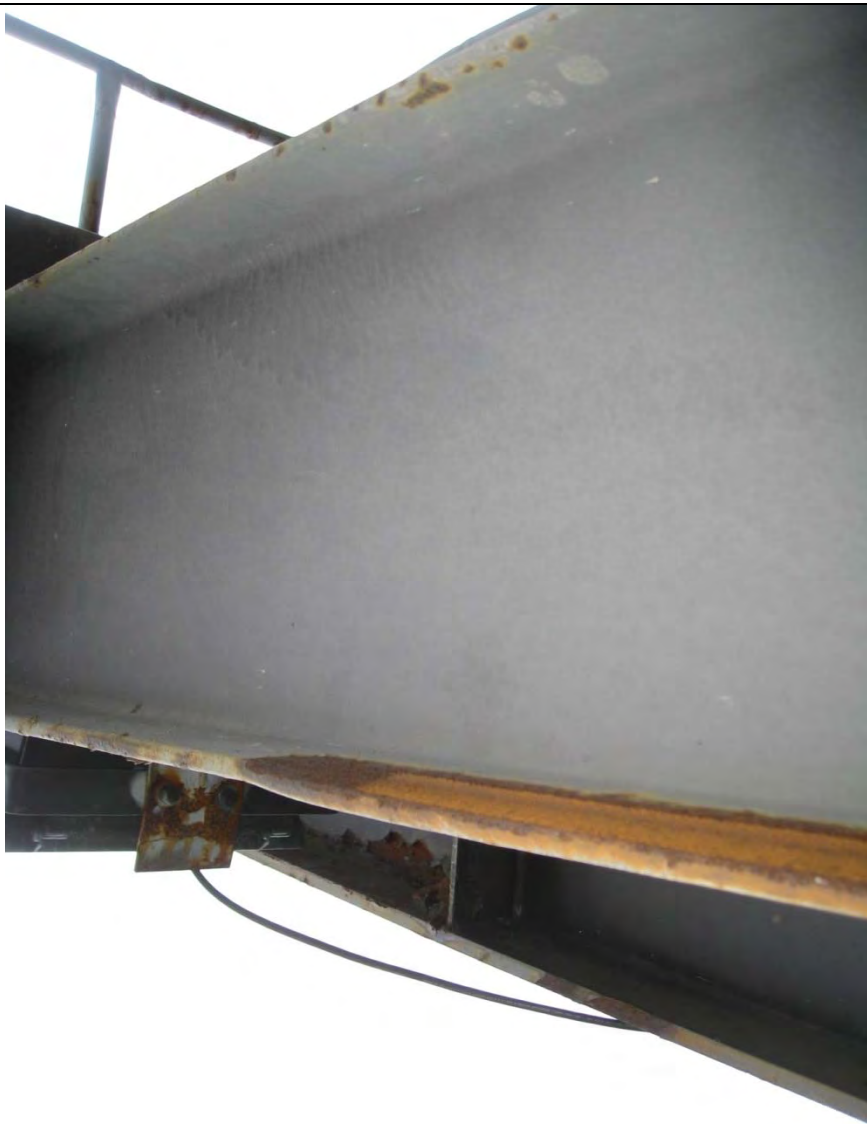
**SH-111213-01 SKAGWAY ORE TERMINAL SHIP LOADER**  
**LOCATION: 20-INCHES BELOW TOP OF BEAM ON SOUTH SIDE OF BOOM**  
**DESCRIPTION: LOWER FLANGE OF BEAM/RUNWAY BENT 5/8-INCH OUT OF PLANE DUE TO ROLLER AT HEAD CHUTE (DISCHARGE END) OF SHIP LOADING CONVEYOR (TYPICAL).**  
**CONDITION STATE CS3/4**

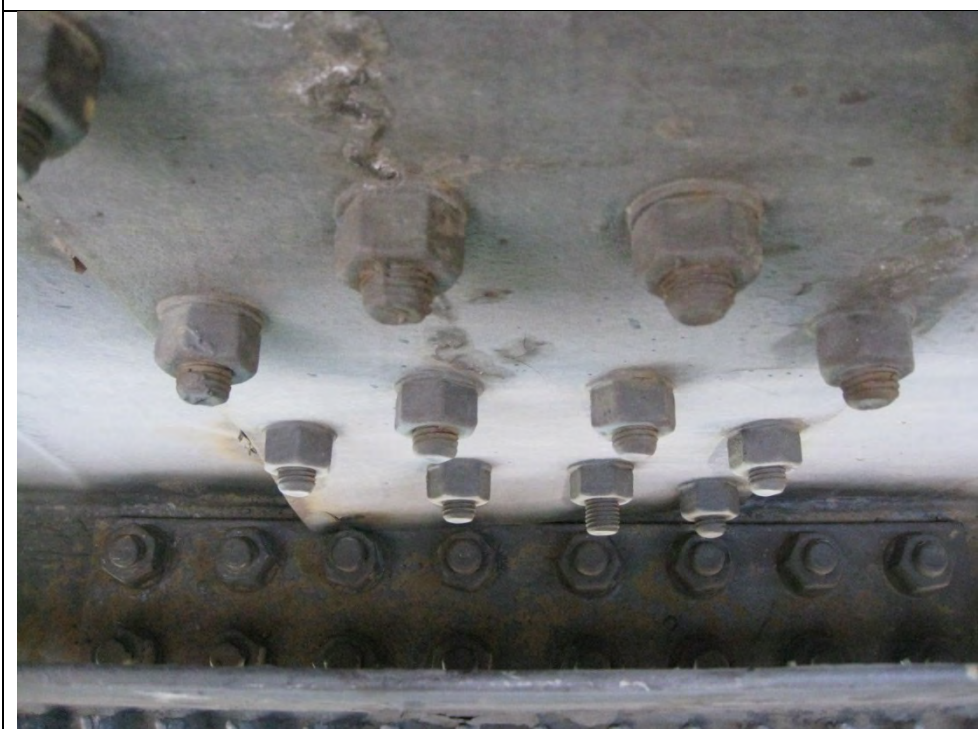
**SH-111313-11 SKAGWAY ORE TERMINAL SHIP LOADER**  
**LOCATION: SHIP LOADER BOOM SPLICE SOUTH INTERIOR**  
**DESCRIPTION: VIEW OF SPLICE PLATE CS2 EXCEPT FOR PACK RUST NEAR LOWER FLANGE. SEE PHOTOS 11/12/13**  
**CONDITION STATE CS2/3**

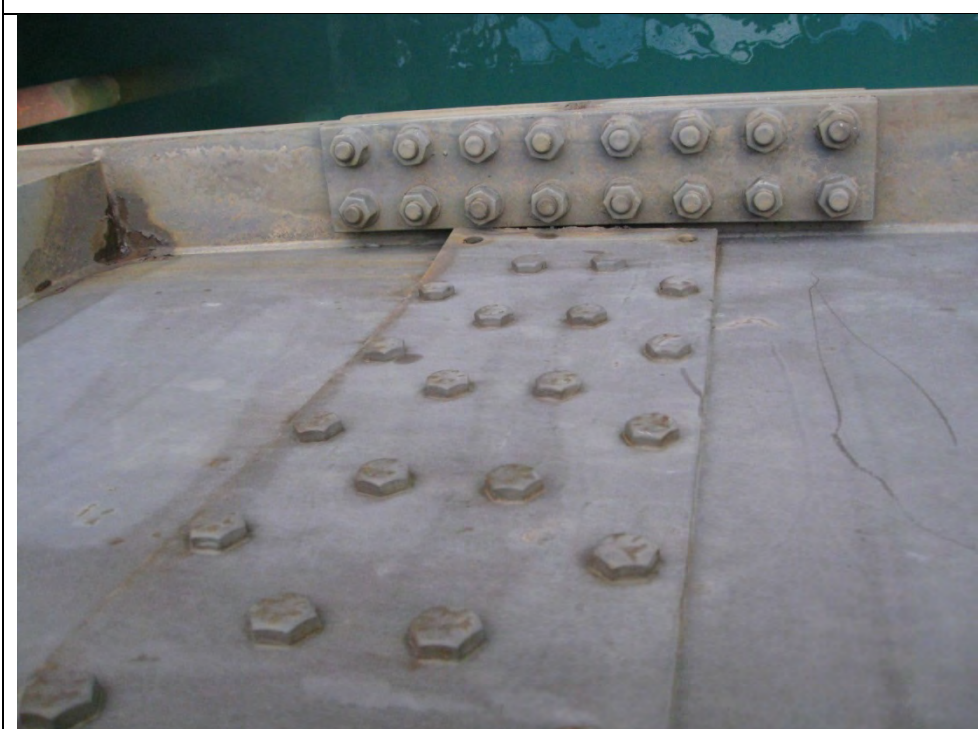
**SH-111313-10 SKAGWAY ORE TERMINAL SHIP LOADER**  
**LOCATION: SHIP LOADER BOOM SPLICE NORTH EXTERIOR OF WEB AND TOP OF BOTTOM FLANGE**  
**DESCRIPTION: VIEW OF SPLICE PLATES. CS2 EXCEPT FOR PACK RUST NEAR LOWER FLANGE. SEE PHOTOS 11/12/13**  
**CONDITION STATE CS2/3**

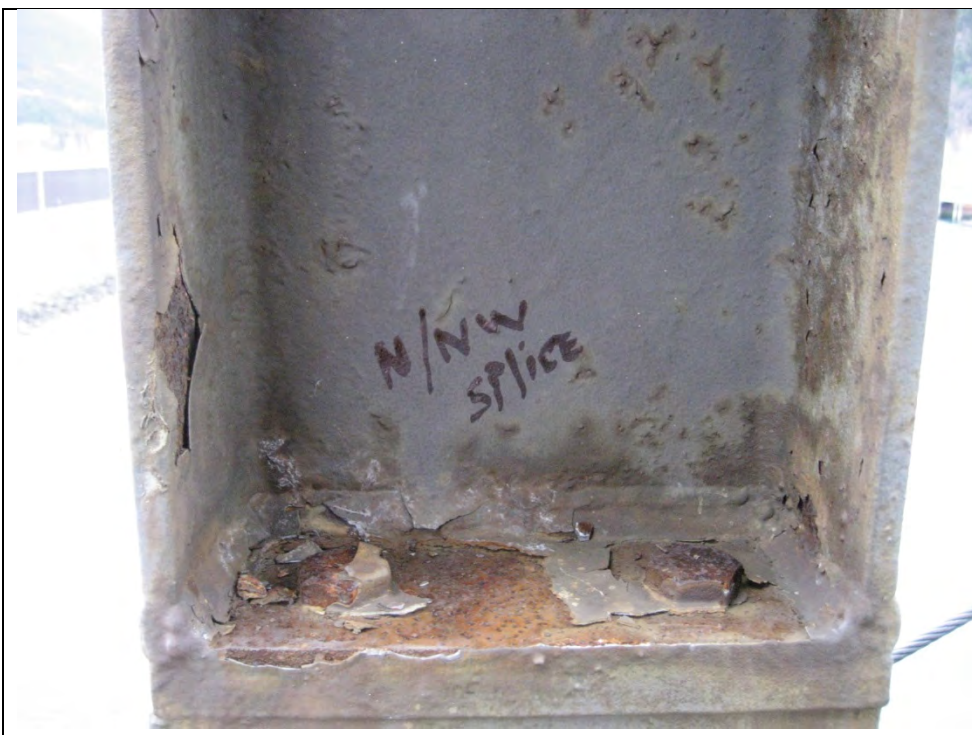
**PF-111213-14 SKAGWAY ORE TERMINAL SHIP LOADER**  
**LOCATION: NORTH SHIP LOADER TOWER NW LEG NORTH FACE INBOARD LEG SPLICE**  
**DESCRIPTION: PCS 4 LIGHT SURFACE RUST, LIGHT PITTING BOLT HEADS AND SPLICE PLATE**  
**CONDITION STATE CS4**

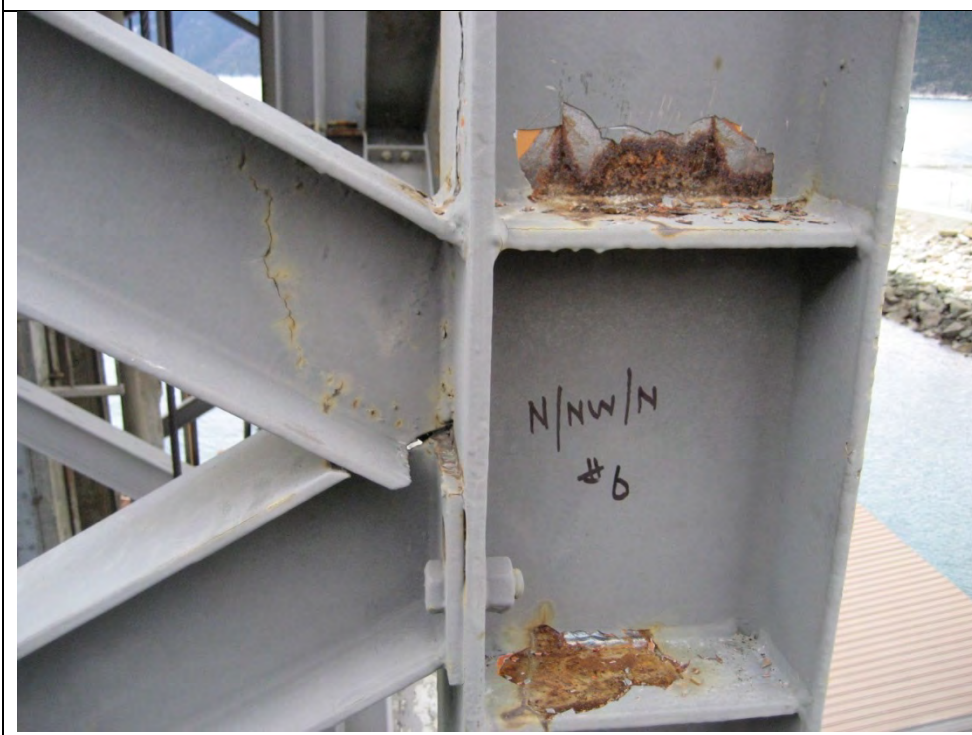
**PF-111213-13 SKAGWAY ORE TERMINAL SHIP LOADER**  
**LOCATION: NORTH SHIP LOADER TOWER NW LEG NORTH FACE #6 SOUTH SIDE N/NW/N #6**  
**DESCRIPTION: LOCALIZED PCS 4 AREASS OF EXPOSED BASE METAL AREAS ABOUT 4"X6", LIGHT SURFACE RUST**  
**CONDITION STATE CS4**

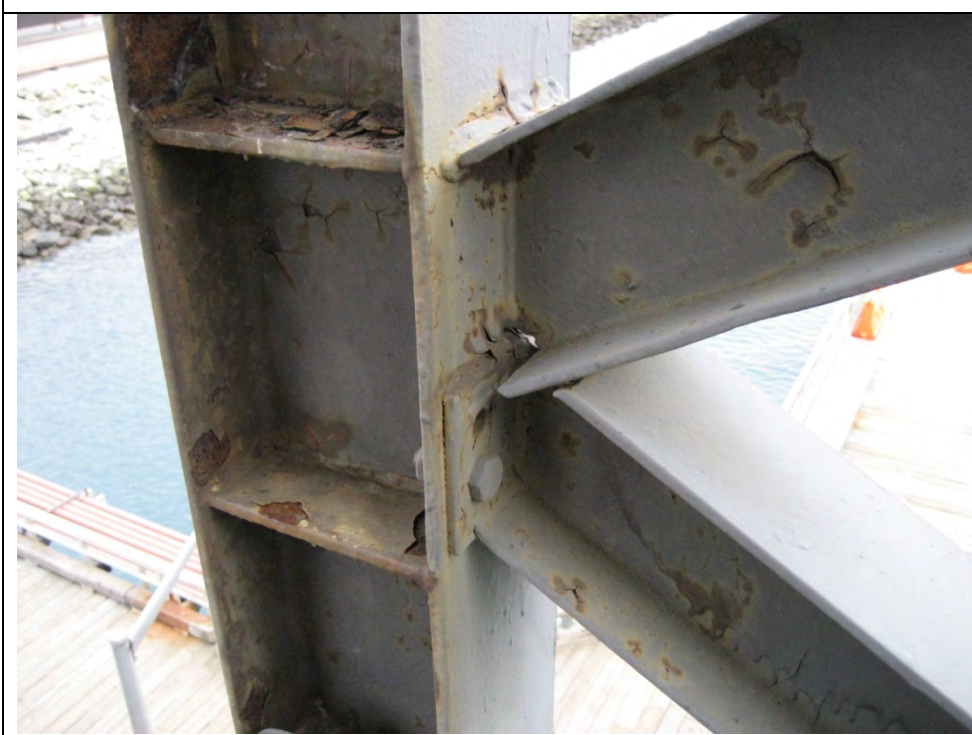
**PF-111213-12 SKAGWAY ORE TERMINAL SHIP LOADER**  
**LOCATION: NORTH SHIP LOADER TOWER NW LEG NORTH FACE #6 N/NW/N #6 SEE ALSO PHOTO F-111213-11 BELOW**  
**DESCRIPTION: VIEW OF INBOARD SIDE OF LEG. MODERATE RUST SCALE ABOUT 3/16 INCH ON LEG FLANGES + WEB STIFFENER. LEG SPLICE JUST BELOW THIS LOCATION, UPPER DIAGONAL WELDED ON WEB AND TOP FLANGE ONLY, LOWER DIAGONAL HAS 2 BOLTS FOR CONNECTION.**  
**CONDITION STATE CS4**

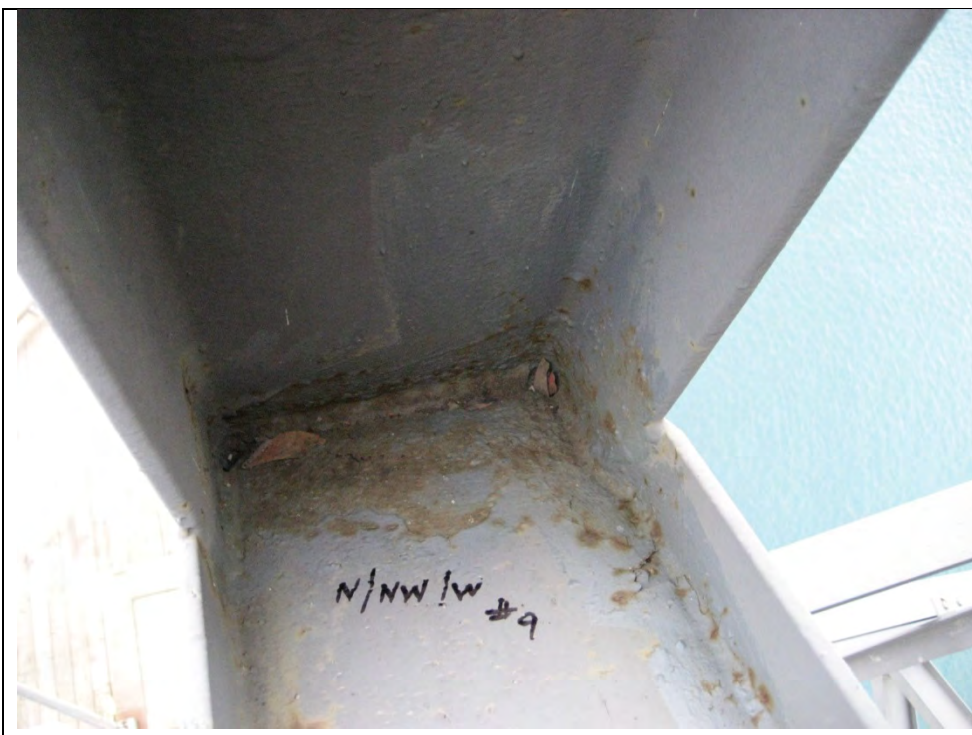
**PF-111213-05 SKAGWAY ORE TERMINAL SHIP LOADER**  
**LOCATION: NORTH SHIP LOADER TOWER NORTH WEST LEG WEST FACE #9 N/NW/W #9**  
**DESCRIPTION: PCS 3, NOEXPOSED BASE METAL, RUST BLEED TYHROUGH, DRAIN HOLES ON EACH SIDE OF WEB, EAST SIDE PLUGGED)**

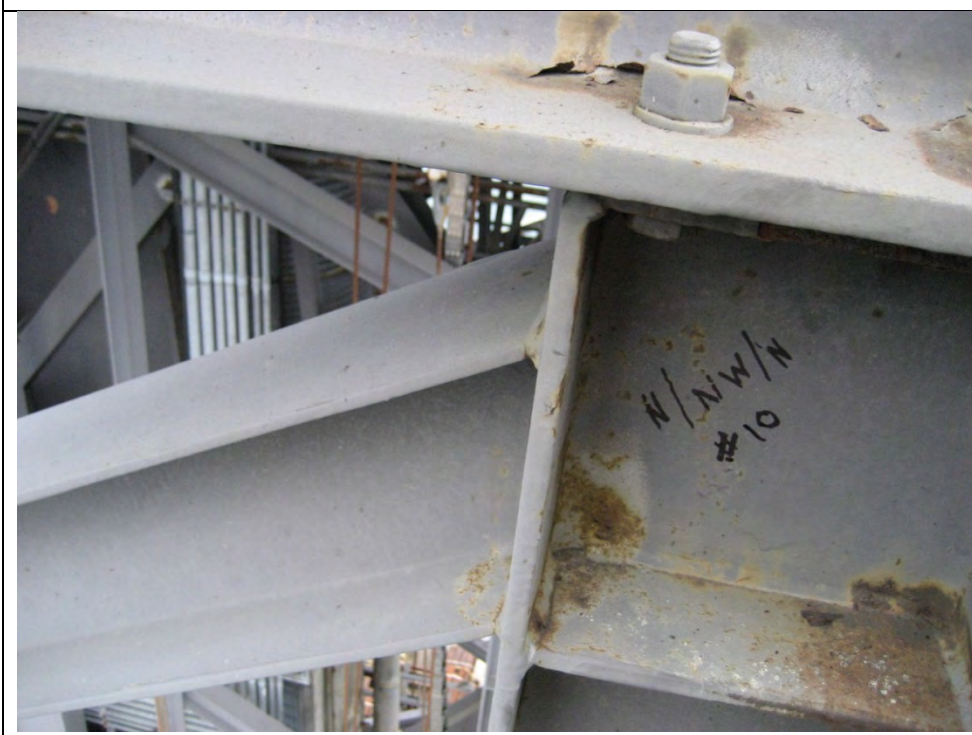
**PF-111213-04 SKAGWAY ORE TERMINAL SHIP LOADER**  
**LOCATION: NORTH SHIP LOADER TOWER NORTH WEST LEG NORTH FACE #10 N/NW/N #10**  
**DESCRIPTION: SOME FLAKING PAINT (PCS 3) LIGHT SURFACE RUST (ON SOUTH SIDE OF LEG)**

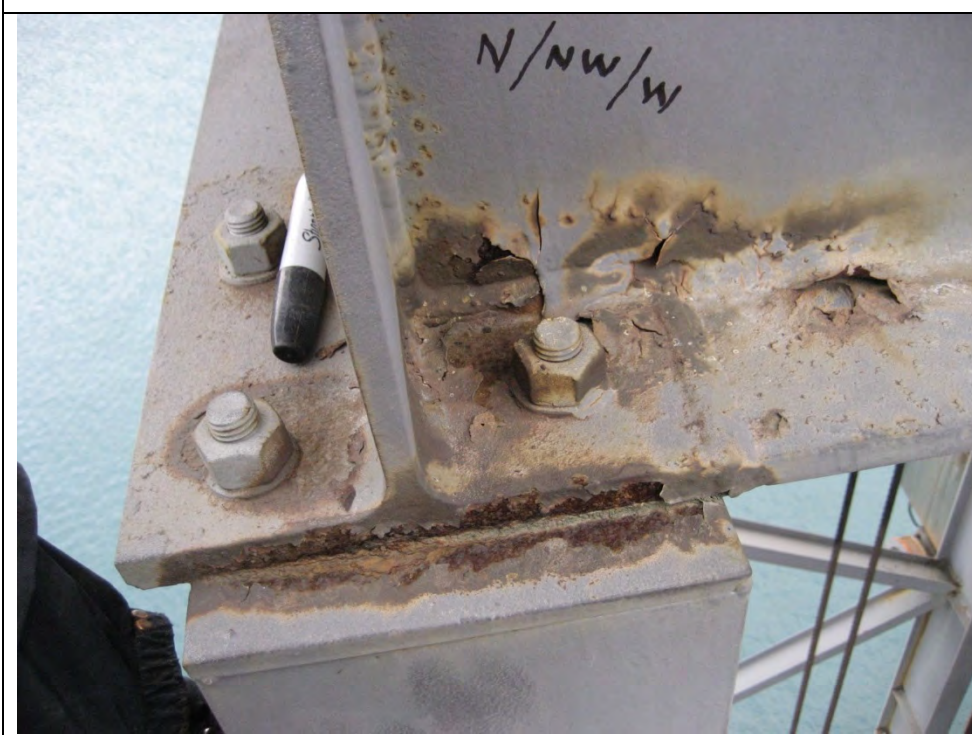
**PF-111213-03 SKAGWAY ORE TERMINAL SHIP LOADER**  
**LOCATION: NORTH SHIP LOADER TOWER NORTHWEST LEG WEST FACE N/NW/W**  
**DESCRIPTION: PAINT CONDITION 3, LOCALIZED PAINT FAILURE EXPOSED BASE METAL, MODERATE SURFACE CORROSION**

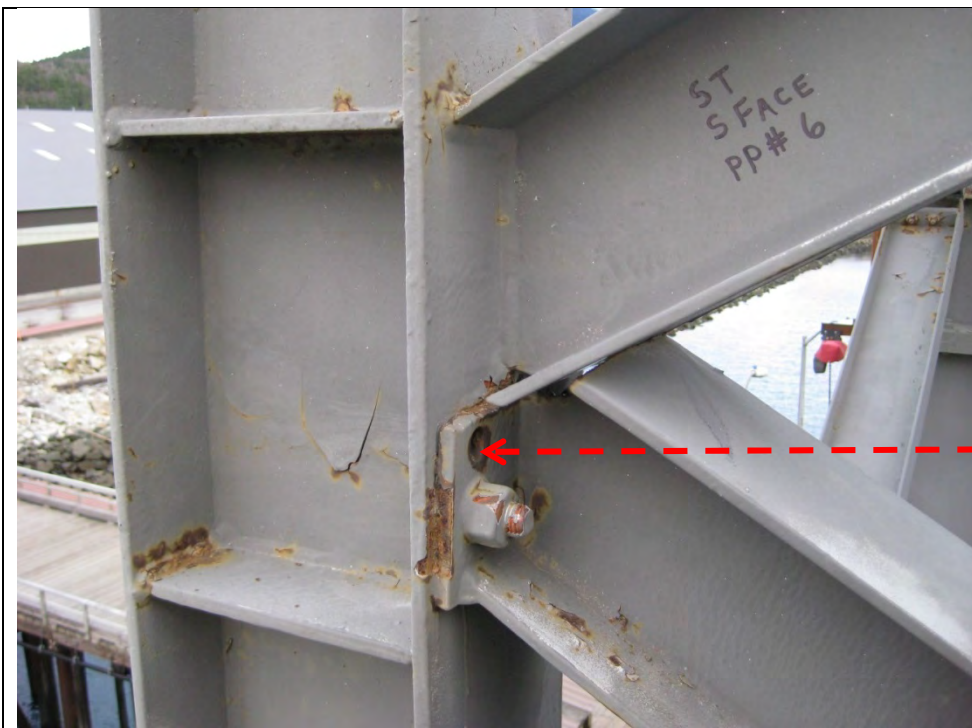
**JG-111213-19 SKAGWAY ORE TERMINAL SHIP LOADER**  
**LOCATION: SOUTH SHIP LOADER TOWER S FACE AT SW CORNER PP#6**  
**DESCRIPTION: LOWER DIAGONAL BRACE IS BOLTED TO LEG. BOTH DIAGONAL BRACES HAVE RUST FORMING AROUND JOINT FACES AND WELDS (COMMON).**  
**-MISSING BOLT**  
**CONDITION STATE CS3**

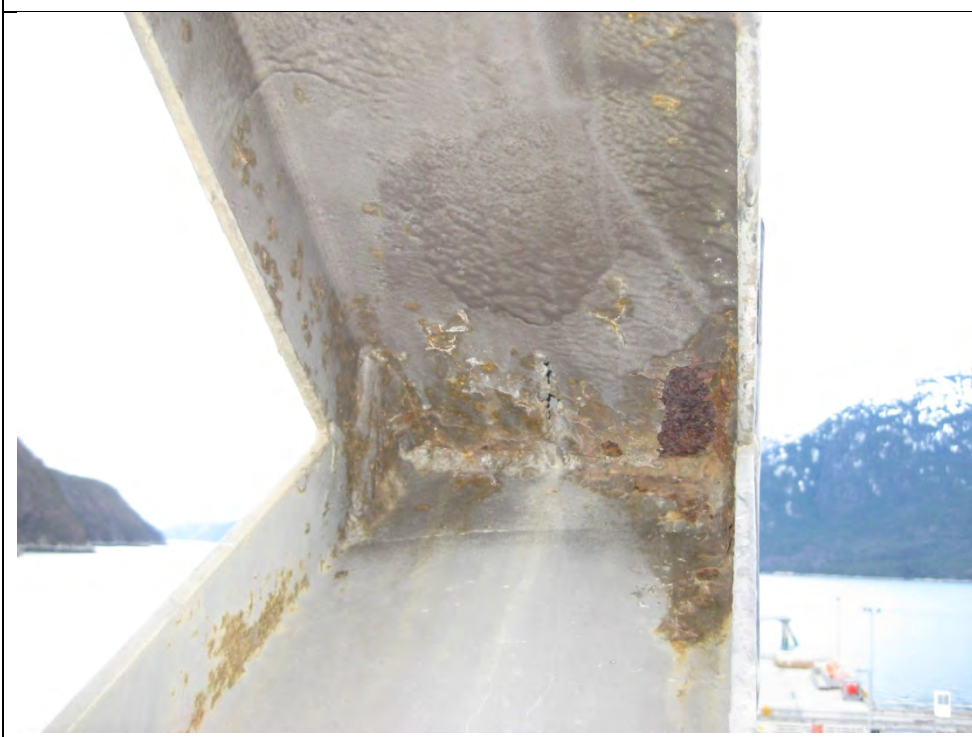
**JG-111213-18 SKAGWAY ORE TERMINAL SHIP LOADER**  
**LOCATION: SOUTH SHIP LOADER TOWER W FACE AT SW CORNER PP# 7**  
**DESCRIPTION: VIEW OF TORCH-CUT DRAINS AND COMMON SO FAR TO FIND MODERATE RUST FORMING UNDER PAINT AT THESE LOCATIONS.**  
**CONDITION STATE CS3/4**

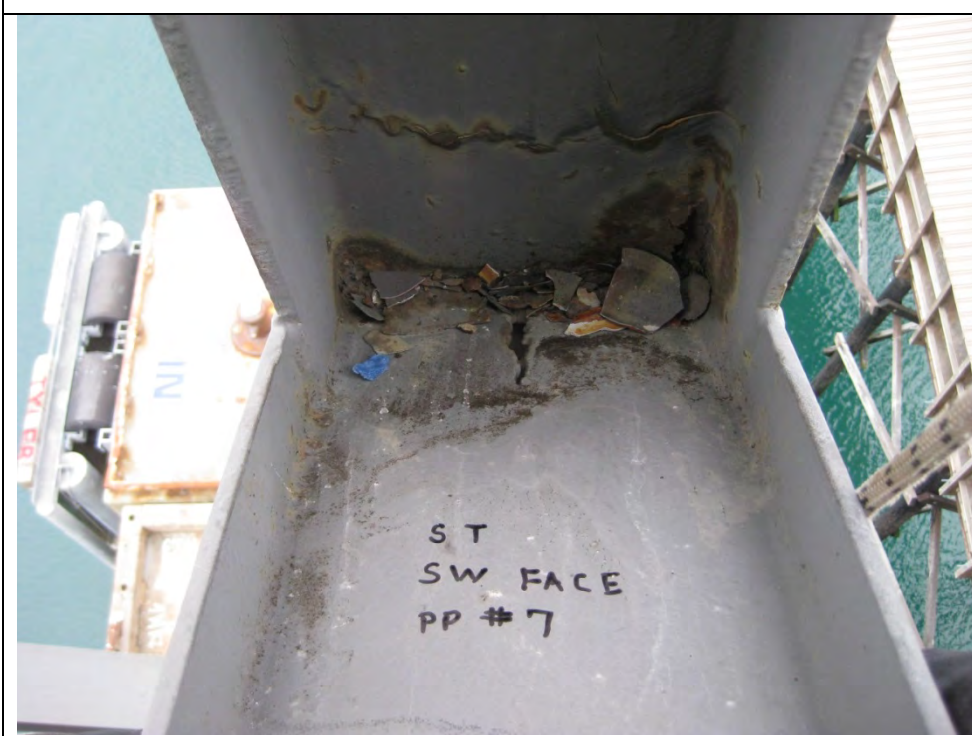
**JG-111213-17 SKAGWAY ORE TERMINAL SHIP LOADER**  
**LOCATION: SOUTH SHIP LOADER TOWER SW FACE PP#7**  
**DESCRIPTION: DEBRIS BUILT UP, PAINT IS CRACKING AND PEELING AWAY FROM STEEL WITH MODERATE RUST FORMING UNDER (TYPICAL)**  
**CONDITION STATE CS3/4**

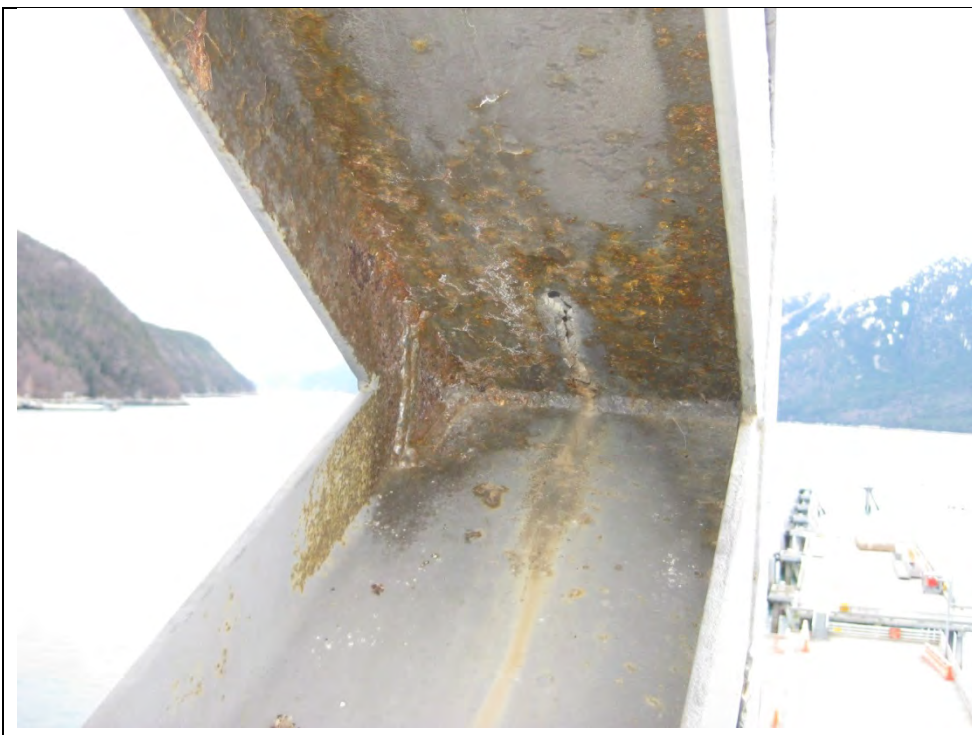
**JG-111213-13 SKAGWAY ORE TERMINAL SHIP LOADER**  
**LOCATION: SOUTH SHIP LOADER TOWER SW PANEL POINT 10**  
**DESCRIPTION:VIEW OF LIGHT LAMINAR RUST FORMING AT CONNECTION TO TOWER LEG.**  
**CONDITION STATE CS2/3**

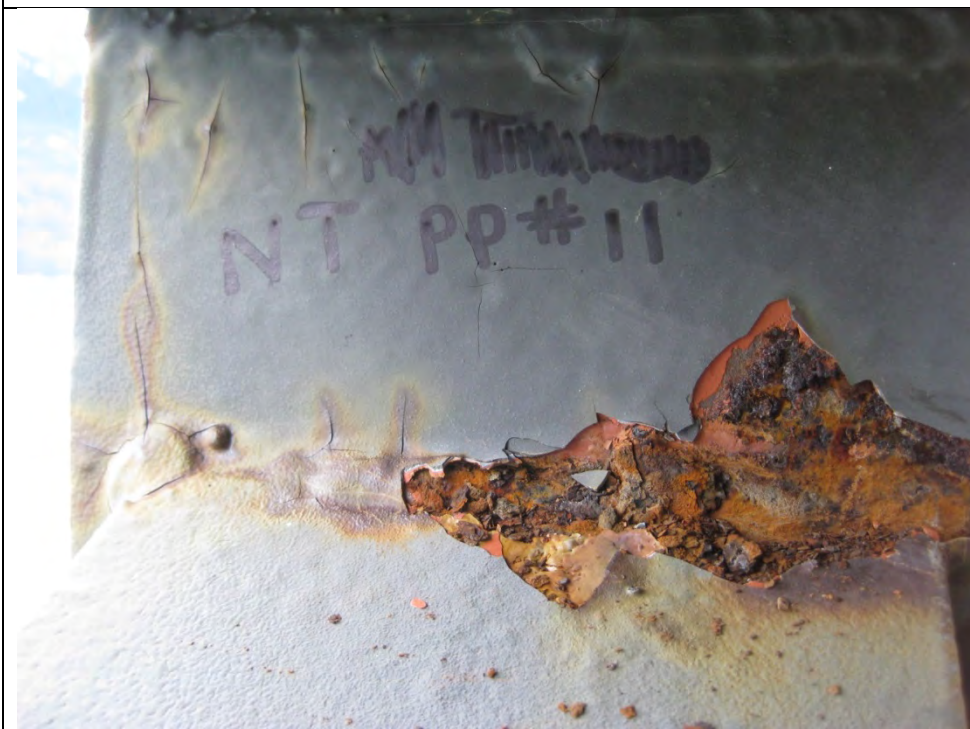
**JG-111213-09** SKAGWAY ORE TERMINAL SHIP LOADER  
**LOCATION:** SOUTH SHIP LOADER TOWER S PANEL POINT #11  
**DESCRIPTION:** 1-INCH LONG AREA ALONG TOP WELD HAS MODERATE LAMINAR RUST FORMING UNDER PAINT AND LIGHT PITTING STARTING TO FORM. ELEMENT MISMARKED AS NT)  
**CONDITION STATE CS4**
