# 2016 BULK FUEL UPGRADES LETTER REPORT

## BEAVER, ALASKA

AUGUST 2016

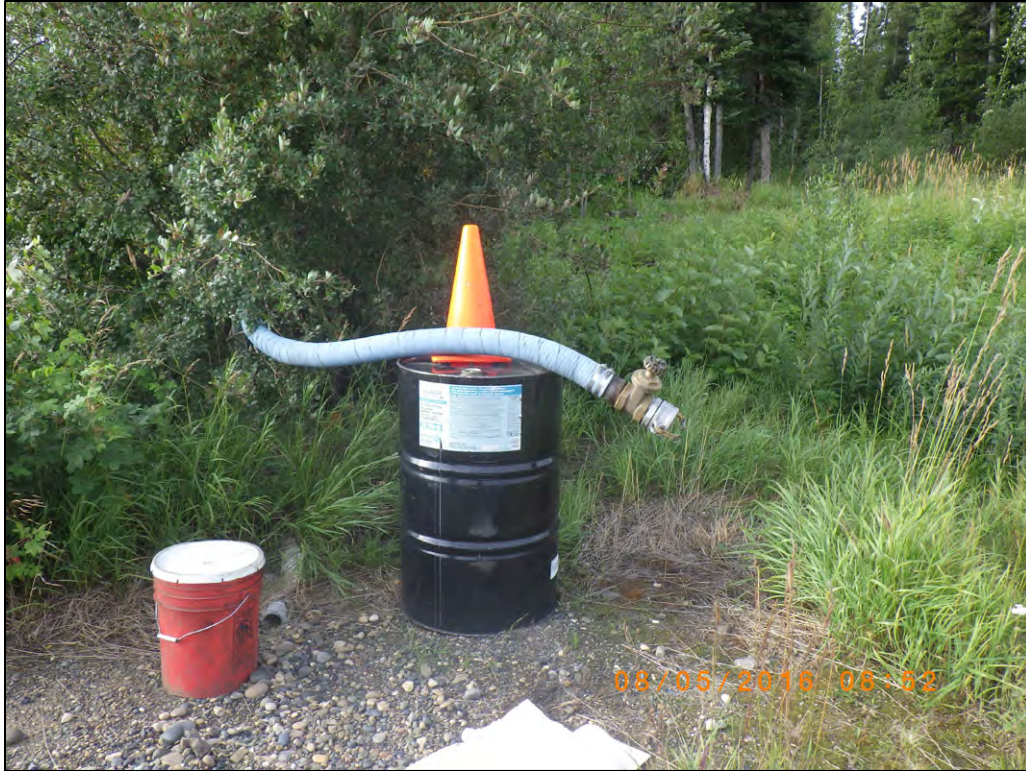
Photograph 1: Airstrip fill header

The airstrip fuel fill header replacement would include the installation of a new swing check valve and a stainless steel ball valve. The header fill point would be enclosed in a fuel cabinet with a 90 gallon capacity.

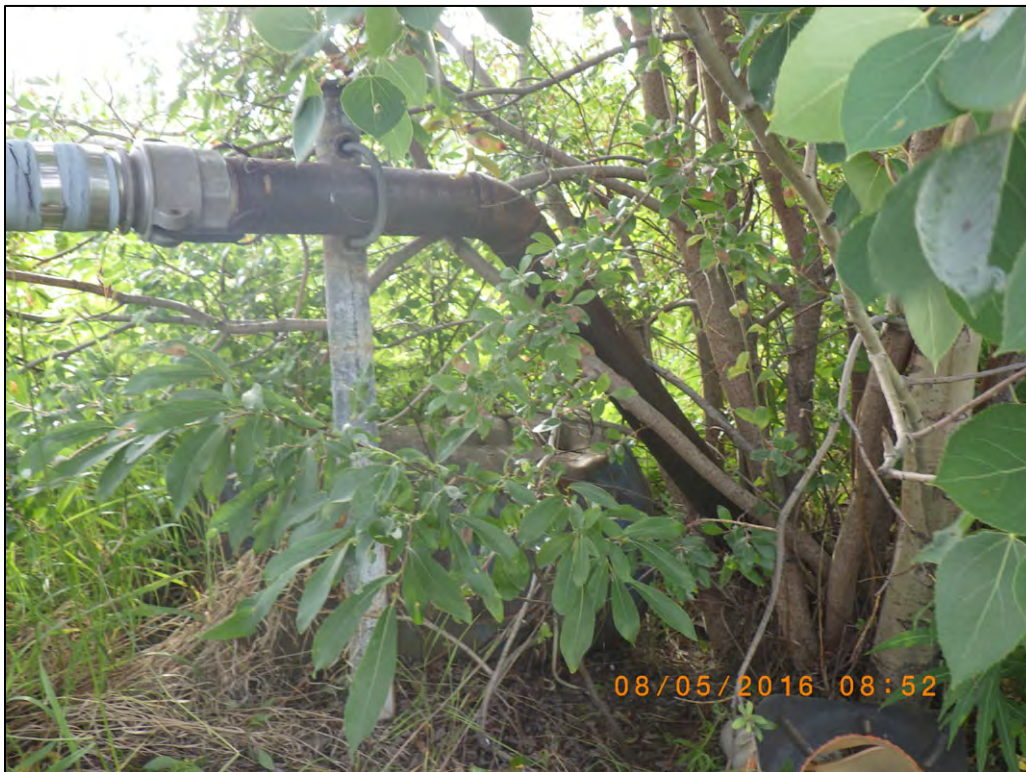
Photograph 2: Airstrip fill header

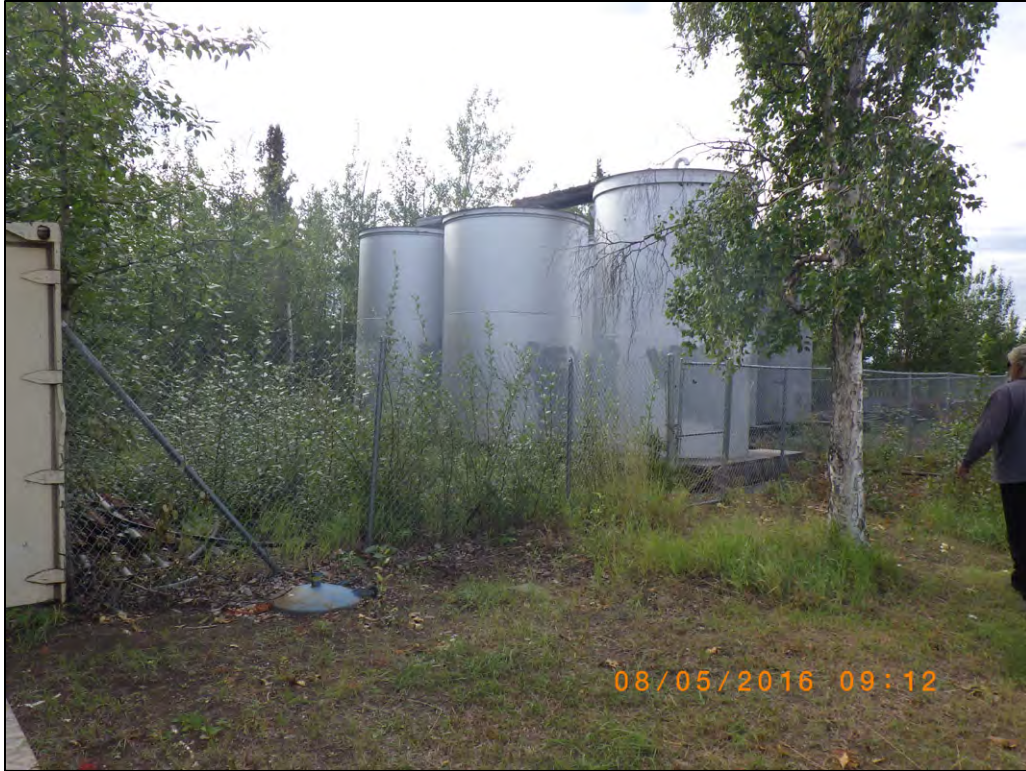
Photograph 2: Tank Farm #1; Cruikshank School and Village of Beaver tanks

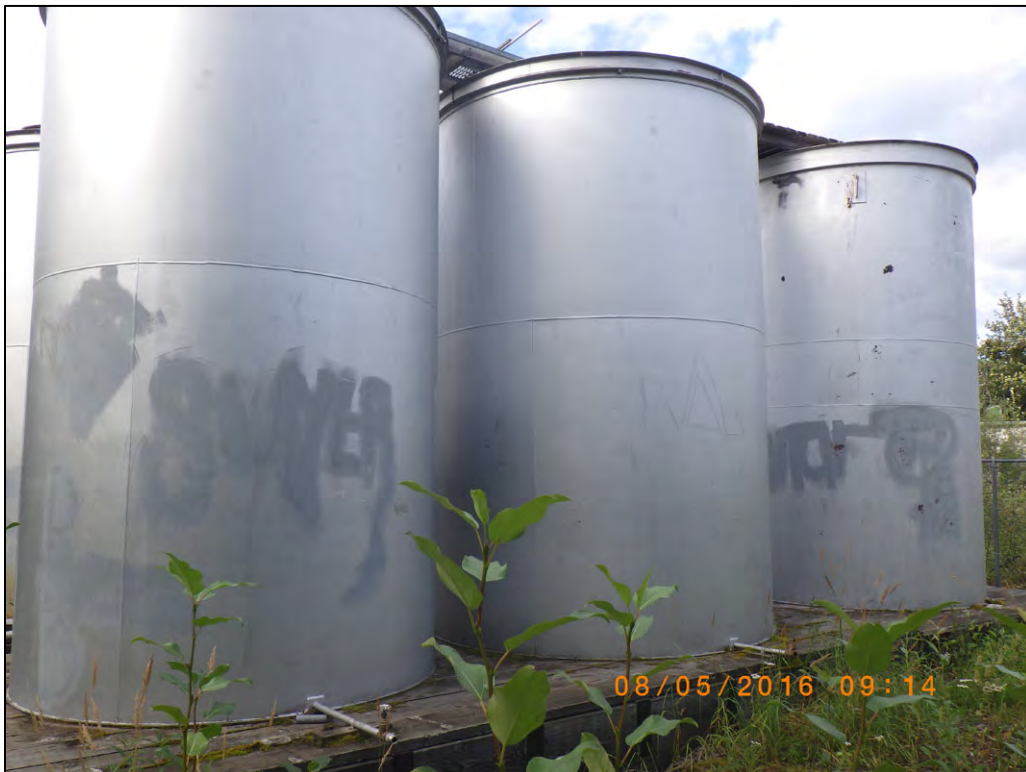
Photograph 3: Tank Farm #1; Cruikshank School and Village of Beaver tanks

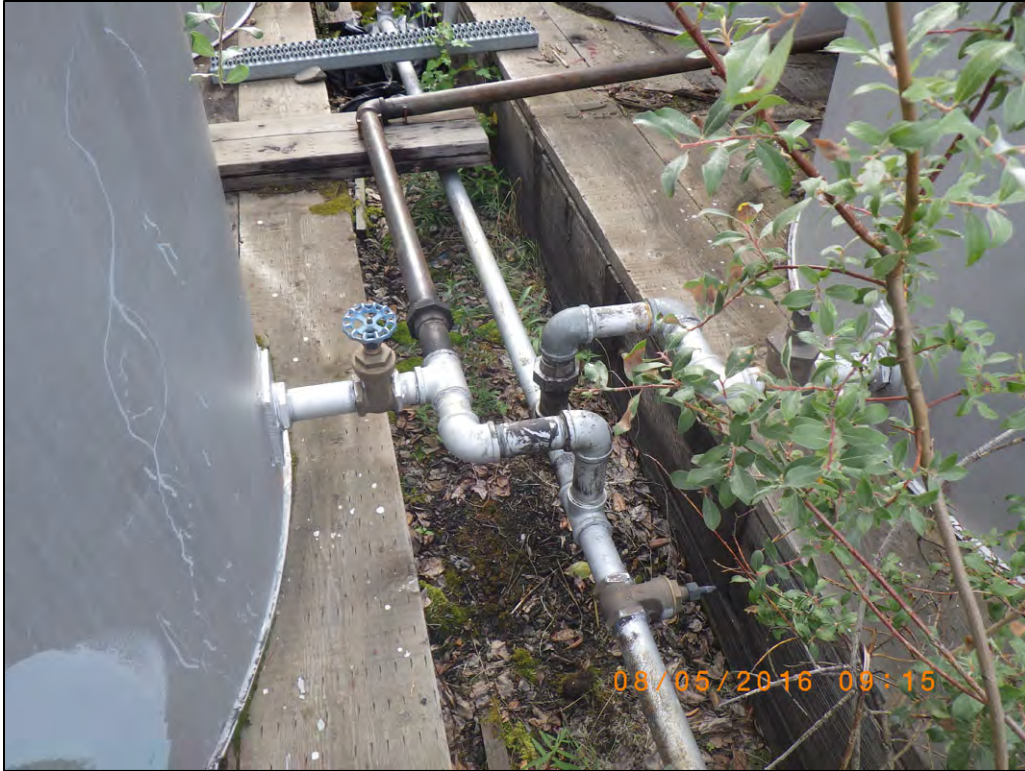
Photograph 4: Tank Farm #1 manifold piping

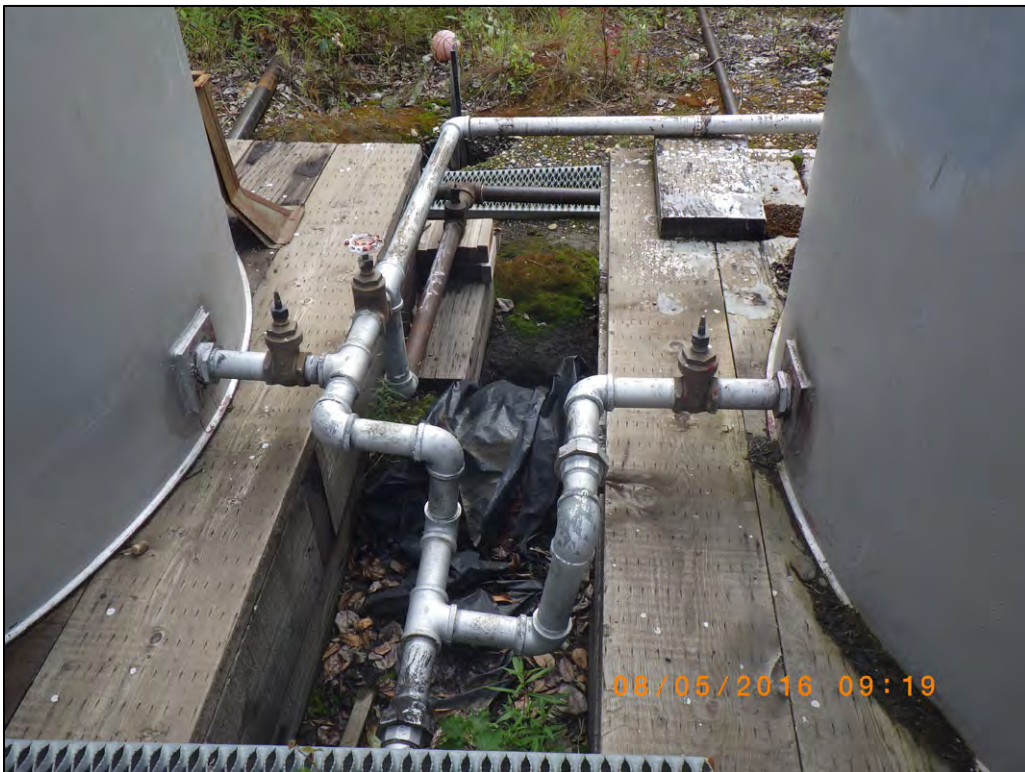
Photograph 5: Tank Farm #1 manifold piping

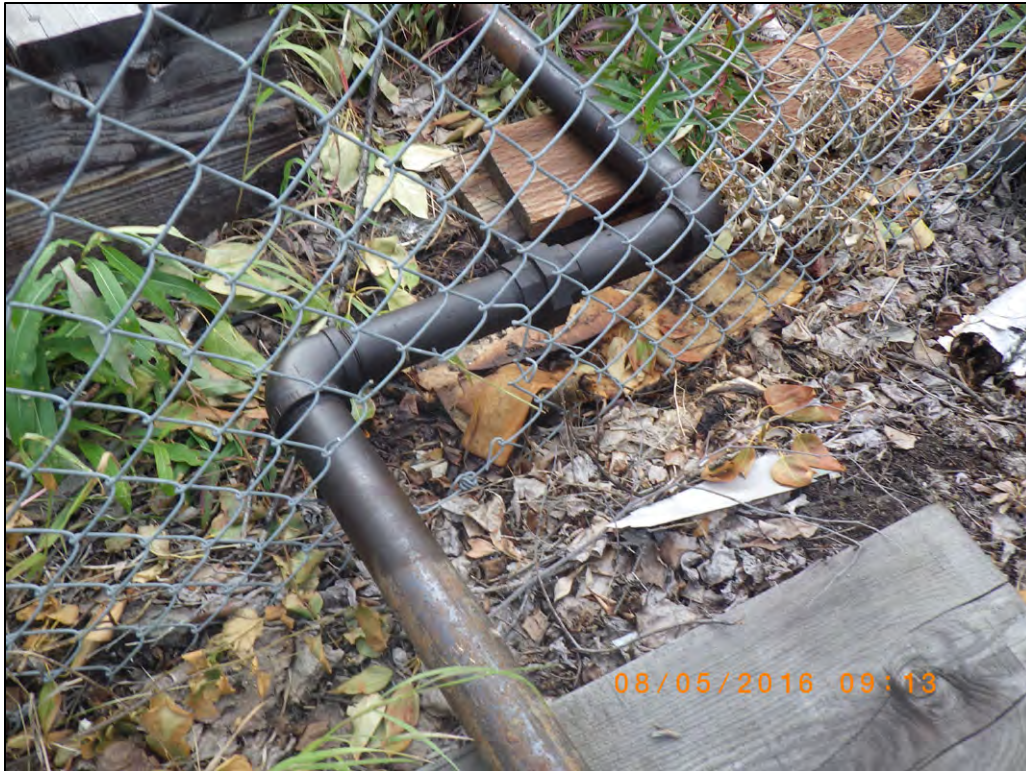
Photograph 6: Leaking feed pipe from Tank Farm #1 to the maintenance shop; no containment

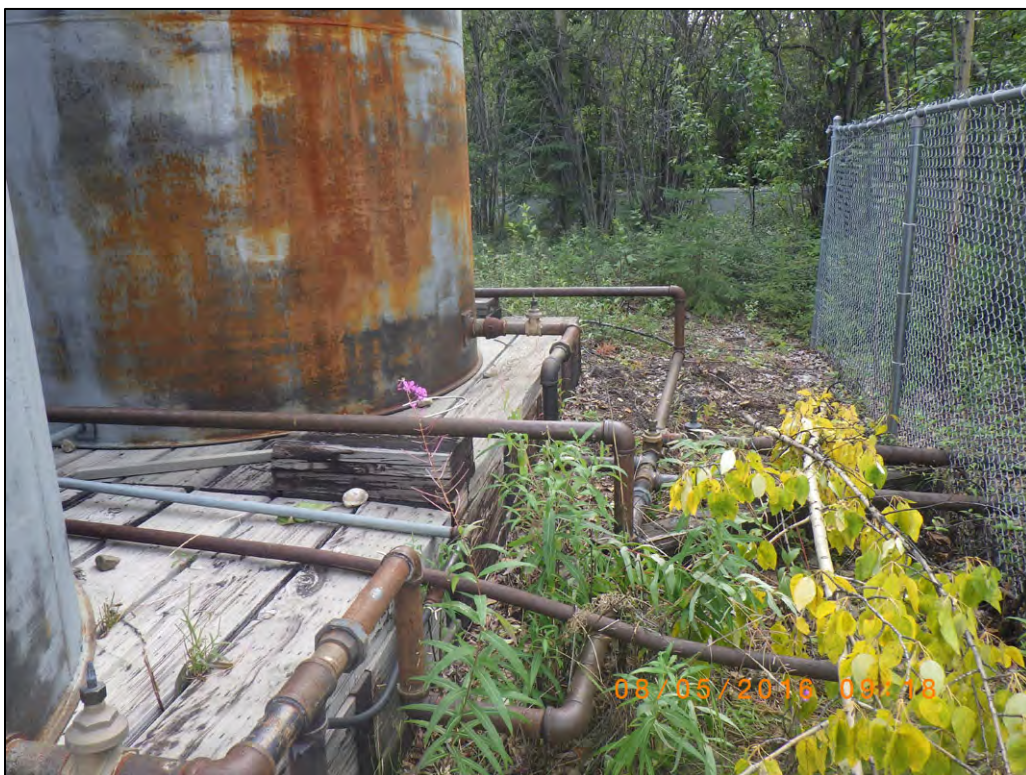
Photograph 8: Beaver Village tanks not-in-service at Tank Farm #1

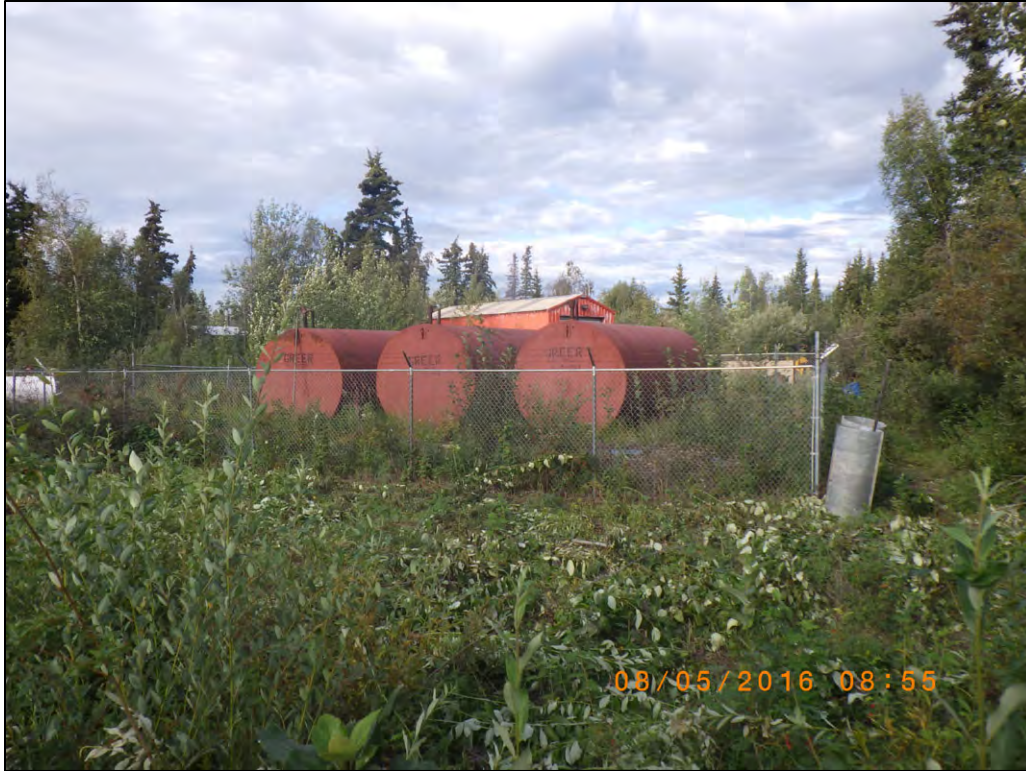
Photograph 9: Tank Farm #2 Beaver Village tanks

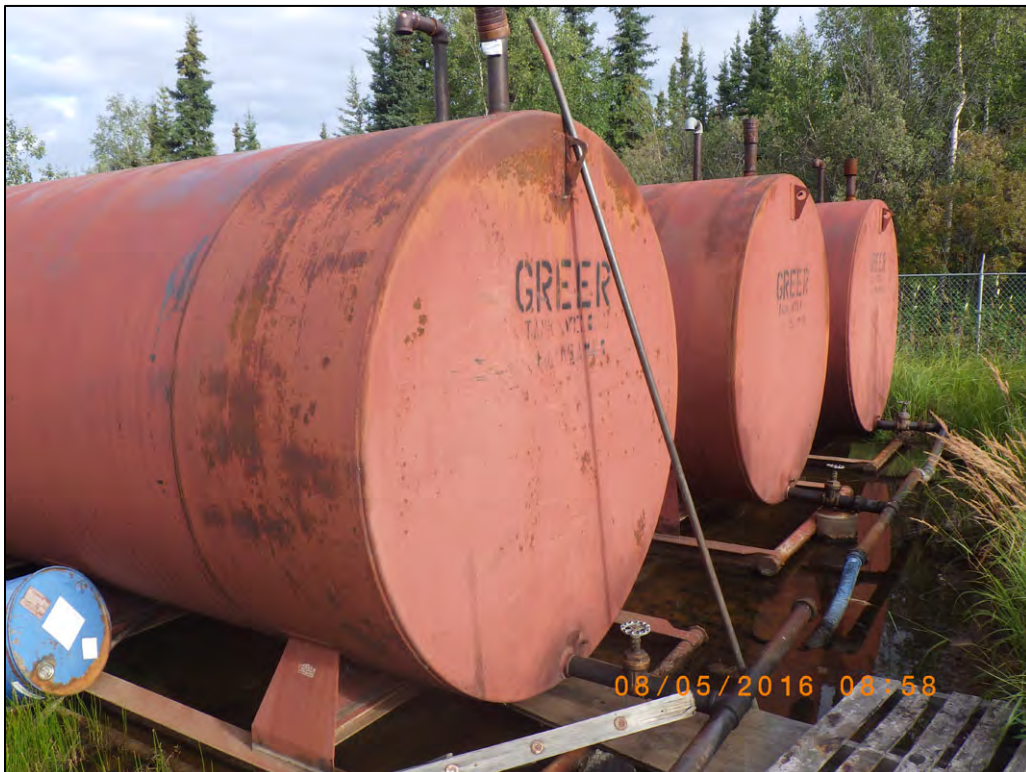
Photograph 10: Tank Farm #2 Beaver Village tanks; only tank #1 in foreground is in service

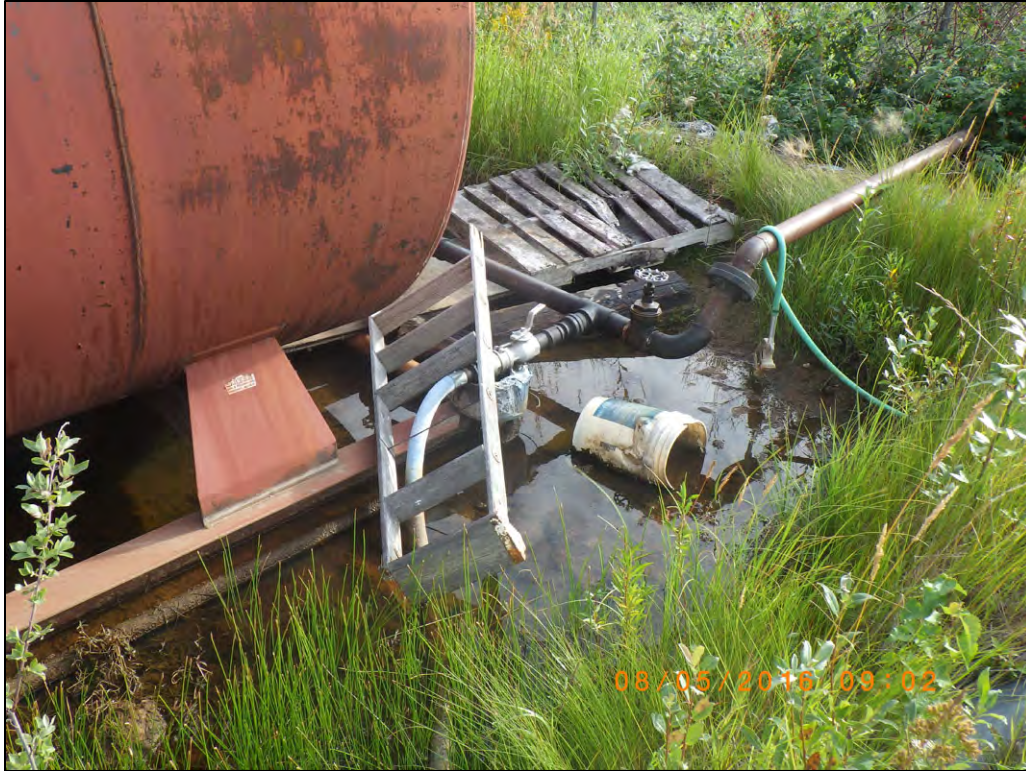
Photograph 11: Tank Farm #2 manifold piping

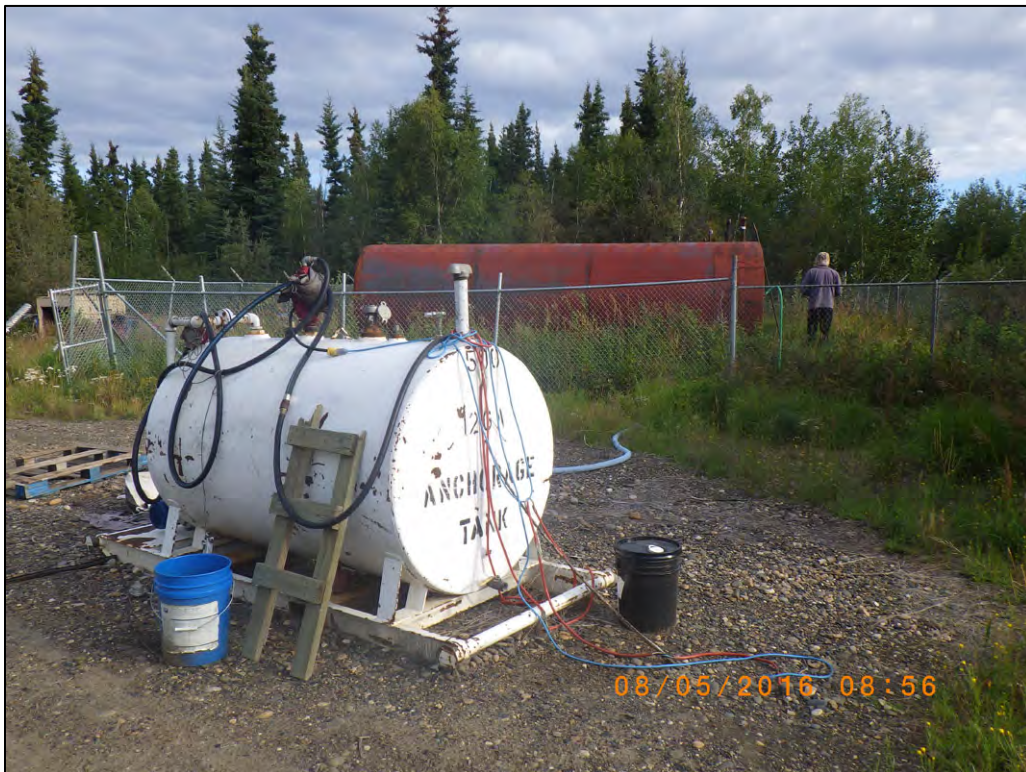
Photograph 12: 500 gal intermediate tank used to transfer fuel into the fuel trailer tank

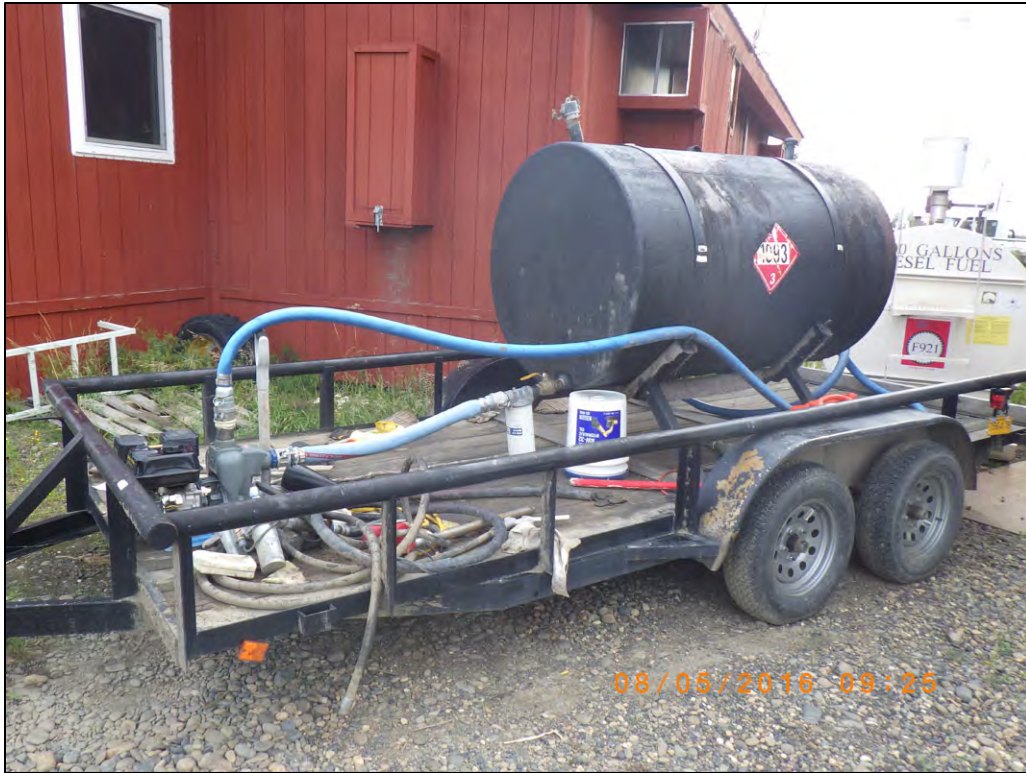
Photograph 13: 500 gal fuel trailer tank; generator house supply tank in background

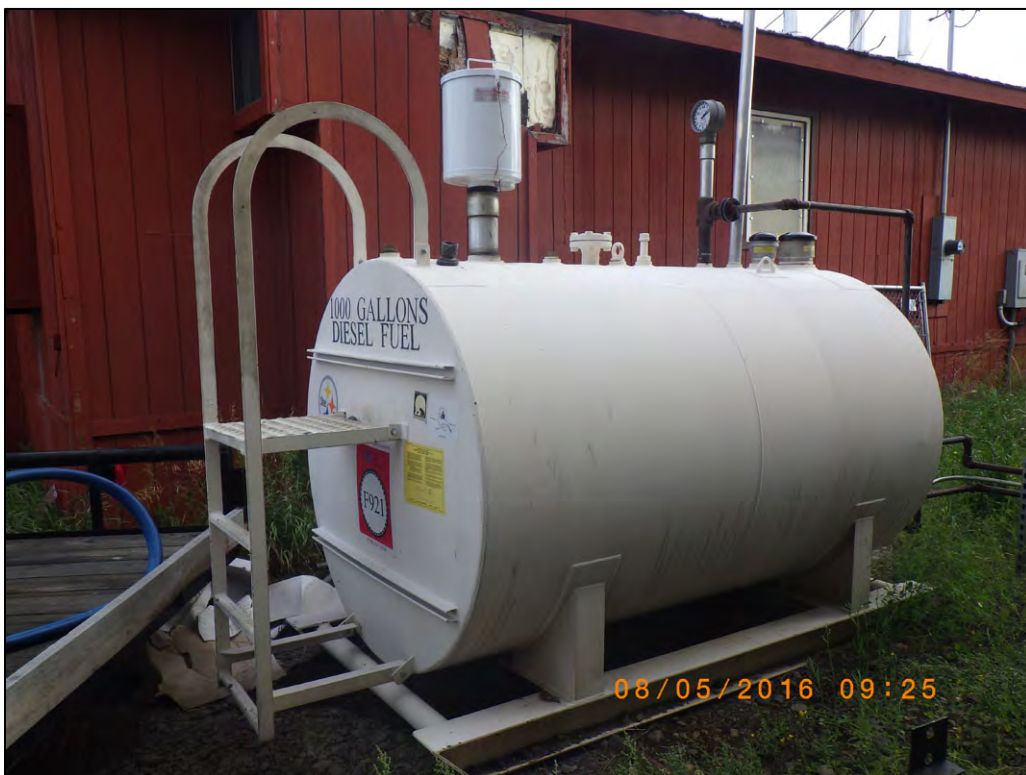
Photograph 14: generator house supply tank

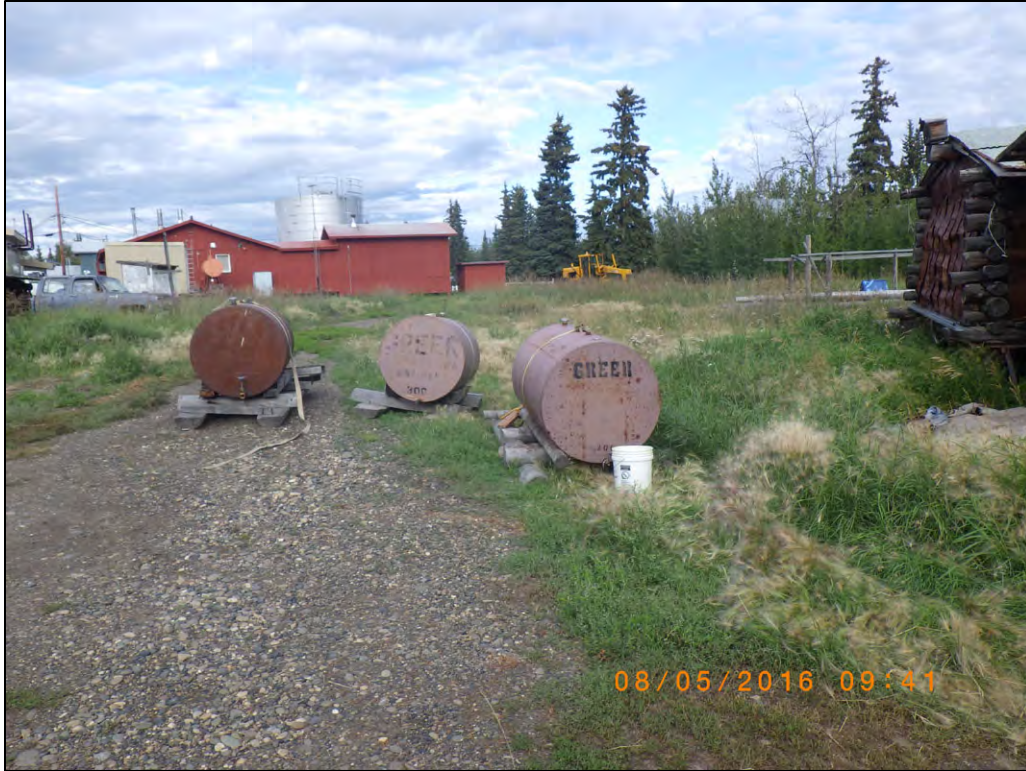
The BVC transfers gasoline from the airstrip to the dilapidated “gasoline shack” using three 300-gallon, steel, single-wall tanks. The 300-gallon tanks are mounted on deteriorated home-made wooden skids. Gasoline is transferred from the 300-gallon tanks to 55-gallon drums in the gasoline shack via hand pump. Fuel is then transferred from the drums to end users via hand pump into 5-gallon gas cans.

Photograph 15: 300 gal "Gasoline Shack" tanks on wooden skids

In addition, a Fireguard® tank and dispensing pump could be installed for retail gasoline sales to replace the gasoline shack. An 800-gallon mobile tank trailer could be purchased to replace the current method used to transfer retail gasoline, which consists of skidding 300-gallon tanks. An alternative to transferring diesel #1/heating oil from TF2 to the generator house intermediate tank with a mobile tank trailer would be to install a buried, coated, 1.5-inch, welded steel pipeline with CP. A dispensing pump could be installed at TF2 to provide retail diesel #1/heating oil.

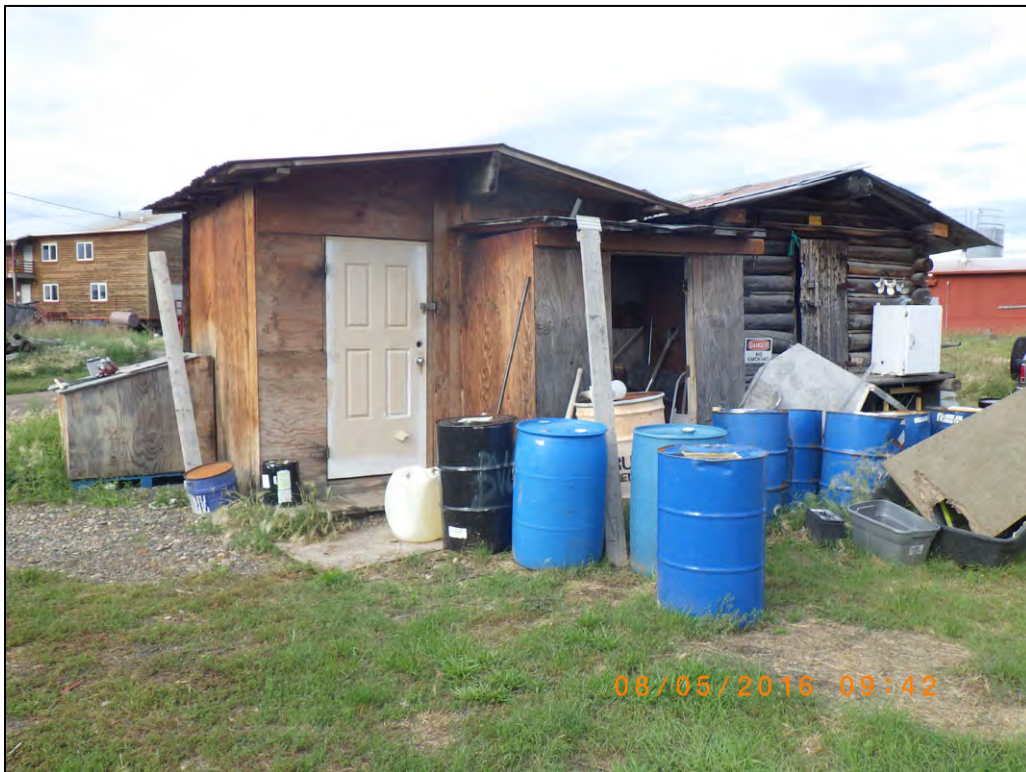
Photograph 16: "Gasoline Shack"; locked with 55-gal drums inside used for retail sale

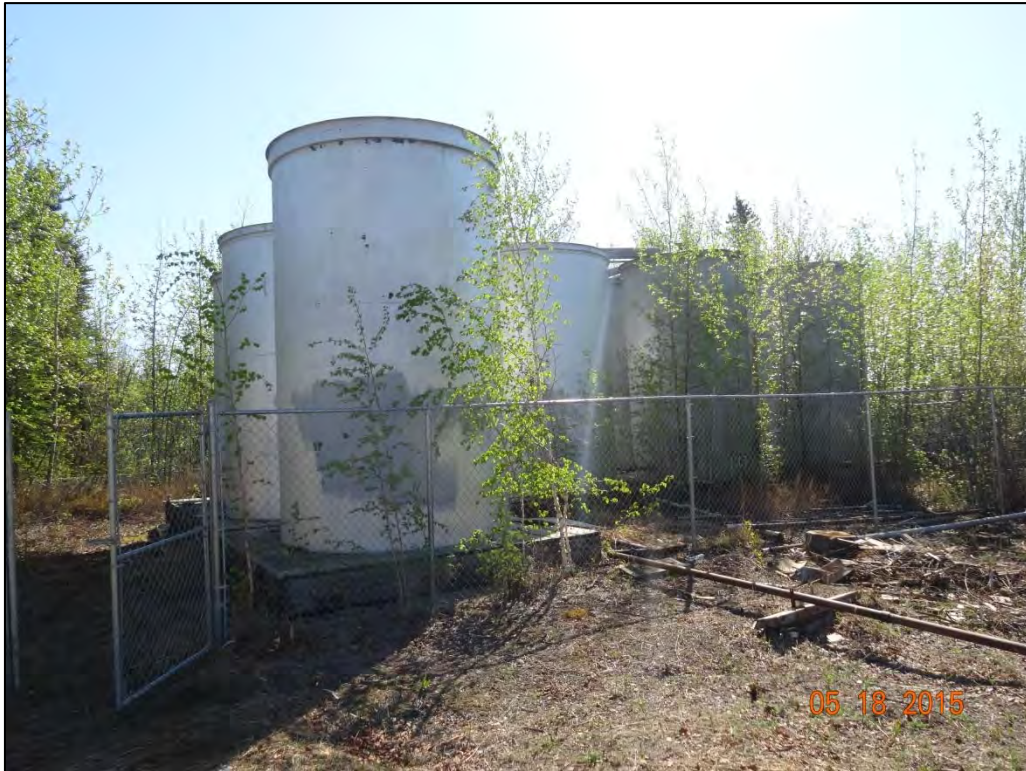
**Photo 1 – School Tank Farm**

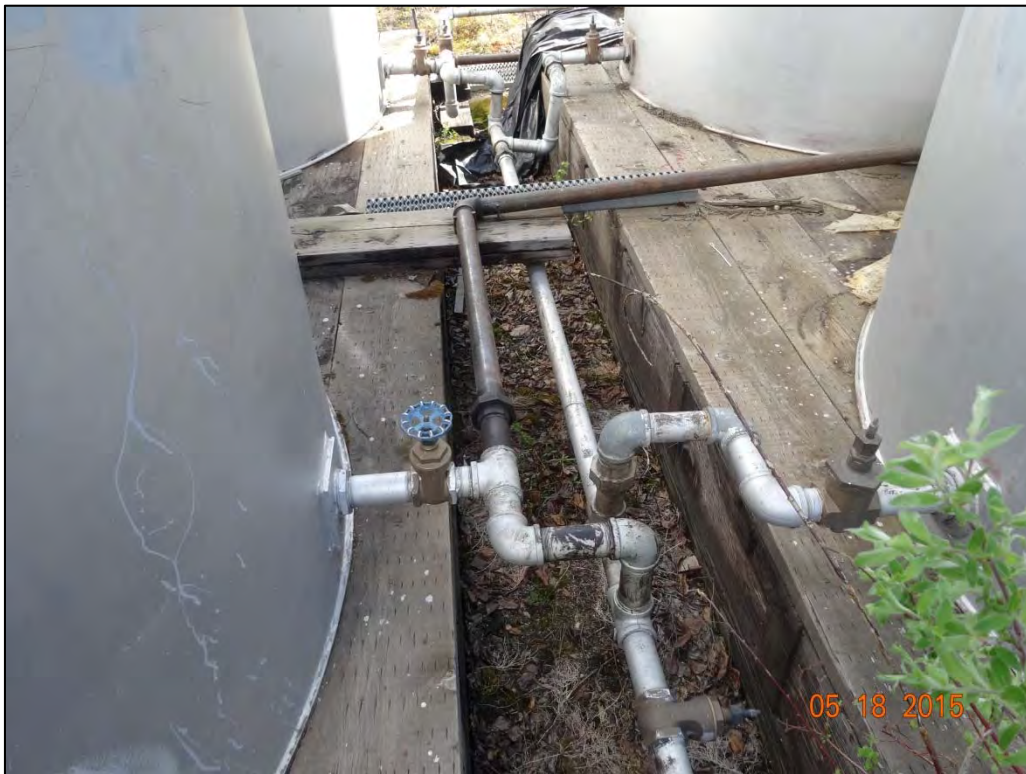
**Photo 2 – School Tanks Manifold Piping**

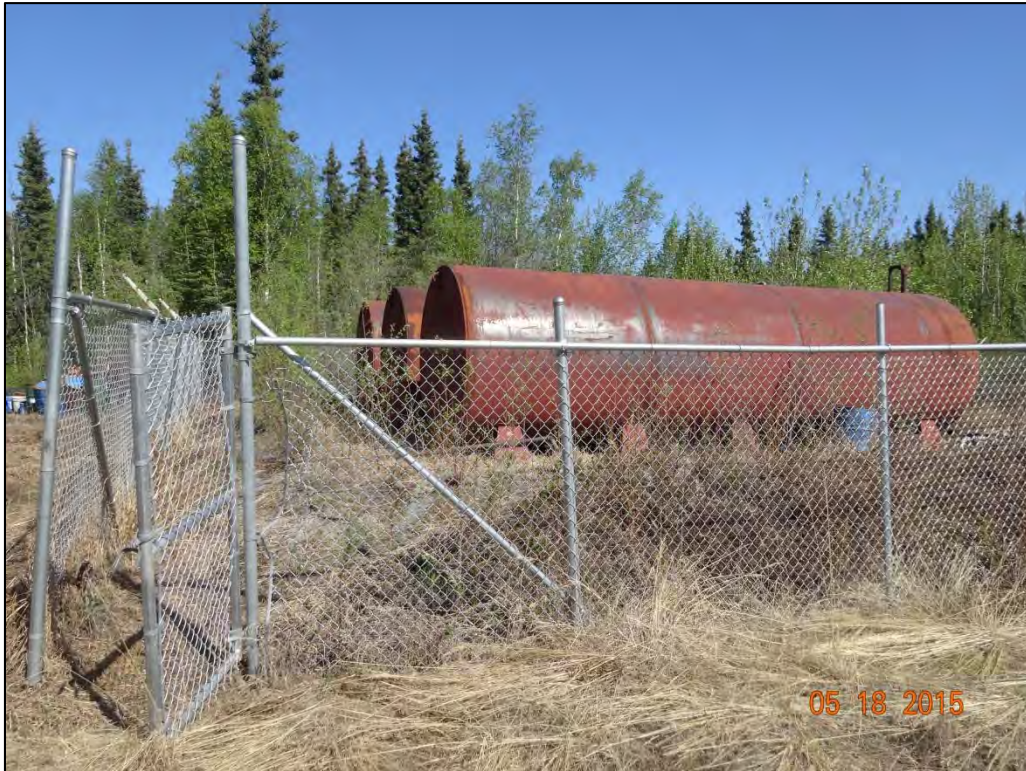
**Photo 1 – Tank Farm 2**

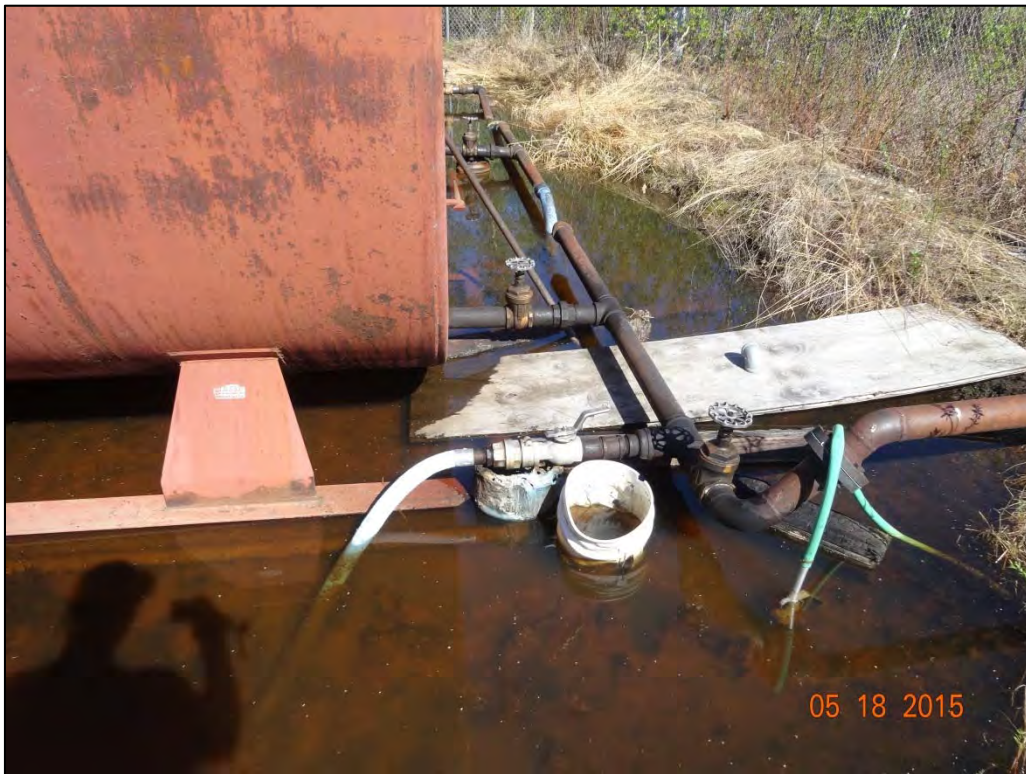
Secondary containment exists at TF2 and appears to be liquid-tight as it has been observed to contain a significant volume of water for over a decade. The containment at TF2 would be dewatered, debris and vegetation would be removed, and a sump pump would be installed. Vegetation growing around the containment berm would be removed and the chain-link security fence would be repaired.

**Photo 2 – Tank Farm 2 Piping and Inundated containment**
