BULK FUEL ASSESSMENT REPORT

Scammon Bay, Alaska

May 2015

CRW Engineering Group, LLC
3940 Arctic Boulevard, Suite 300
Anchorage, Alaska 99503

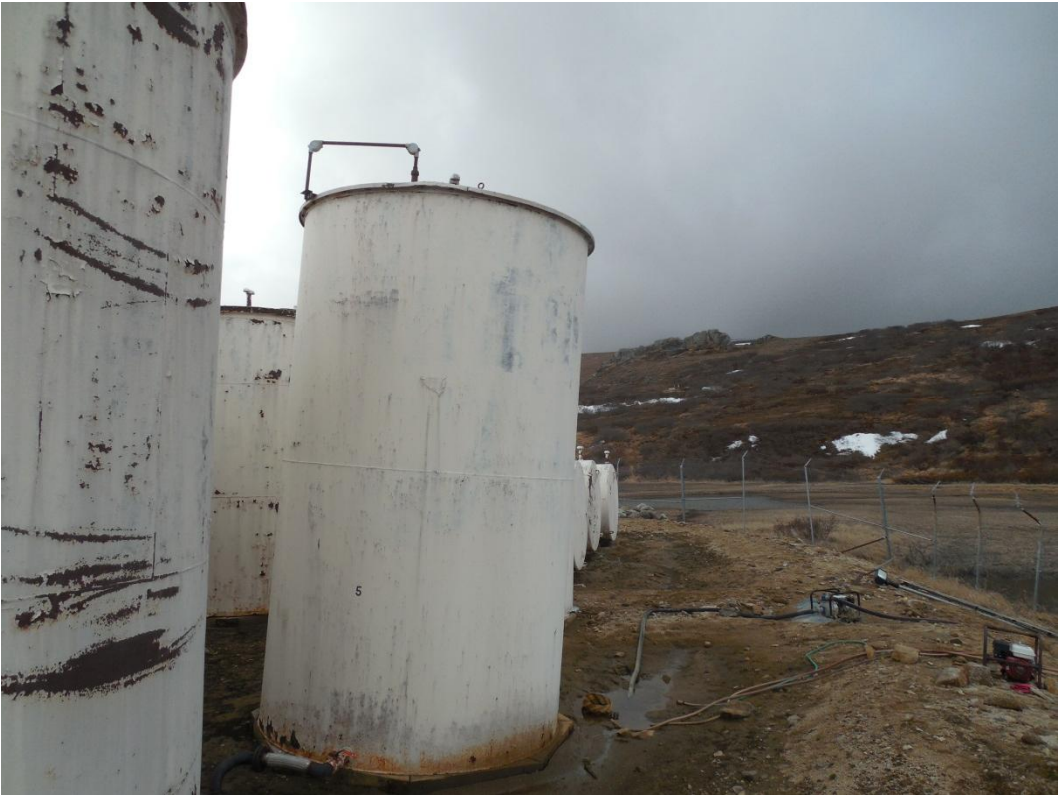
The Askinuk Corporation tank farm is located west of the community. The tank farm includes seventeen single wall, welded steel ASTs (twelve vertical tanks, four horizontal tanks, and one horizontal, dual product dispensing tank). The dispensing tank is supported on steel skids and the remaining horizontal and vertical tanks are supported on timbers. Several tanks are severely dented and exhibit deep pitting. The facility is within a lined earthen dike. Although the liner appears liquid tight, several dike walls have settled, substantially reducing the capacity of the containment dikes. The fill material below the tanks appeared to contain a high fine content which has caused some significant settlement and several tanks are leaning. The facility is fenced.

Photo 2 – Leaning Tank and Dike Settlement

Recommend facility replacement.

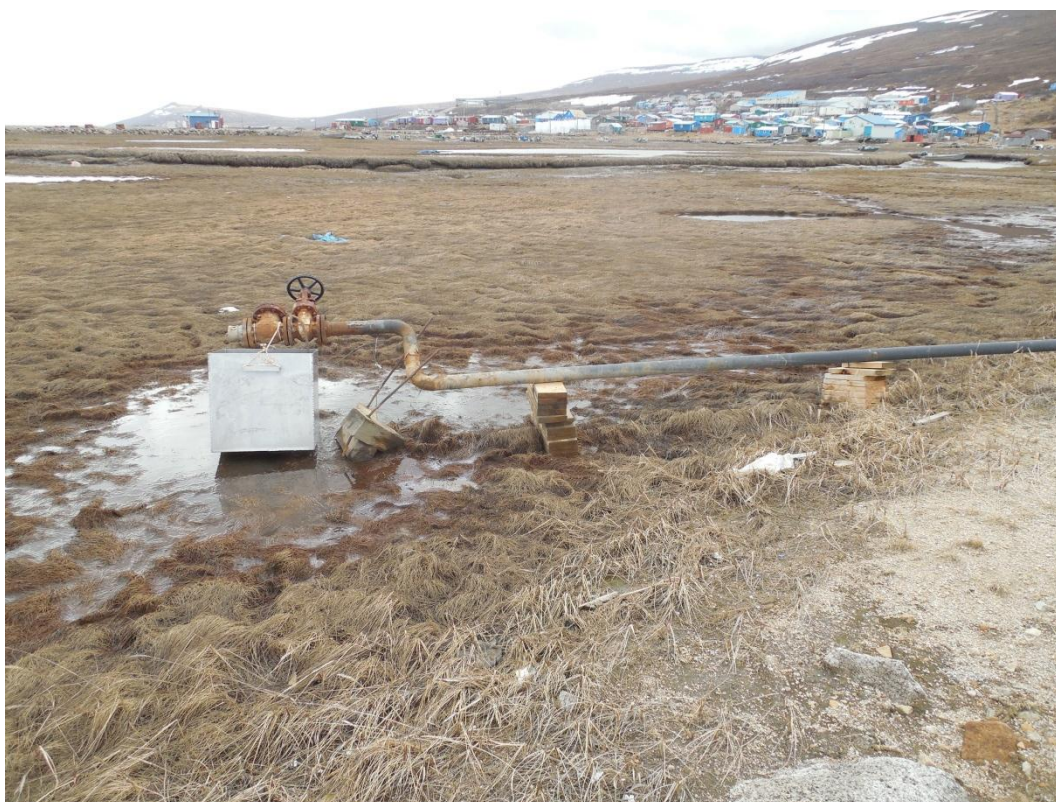
Fuel is purchased from a regional fuel provider and delivered by barge. The tank farm is filled via a 3" barge header and 700 LF of 3" welded steel fill pipeline. The barge header and fill pipeline experience significant damage from a past flood which bent much of the pipeline and relocated the header.

Photo 4 – Barge Header
