# **BULK FUEL ASSESSMENT REPORT**

# Venetie, Alaska

May 2015

Alaska Energy Authority

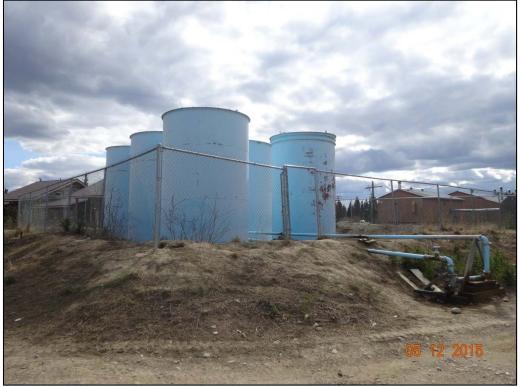
Photo 1 – Venetie School Tank Farm

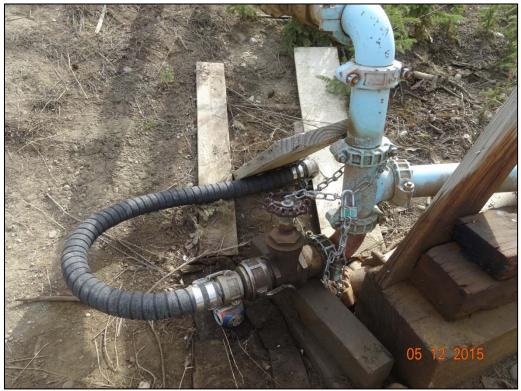
Photo 2 – Venetie School Tank Farm Truck Fill Header

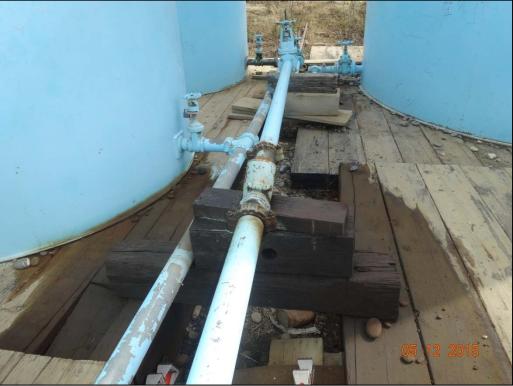
The school tanks have severely peeling paint and are in need of scraping and painting. Many of the victaulic fittings are weeping and should be replaced.

Photo 3 – Weeping Victaulic Fittings in Manifold

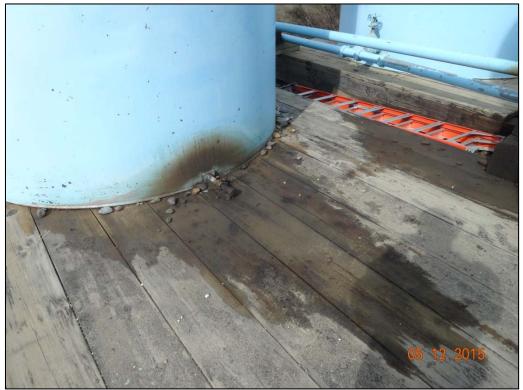
Photo 4 – Fuel Staining Emanating from Threaded Water Drain Fitting

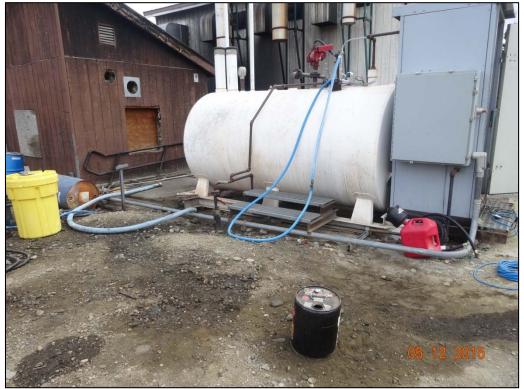
Photo 1 – Tank 3

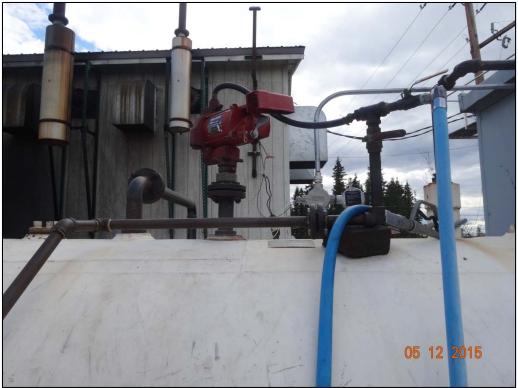
There is also a top mounted dispensing pump on Tank 3 used for equipment fueling and retail dispensing. The dispensing pump is jury-rigged with exposed wiring, rubber hose connected with hose clamps and bronze ball valves. No shear, fusible link, anti-siphon, or solenoid valves are present.

Photo 2 – Jury-Rigged Dispensing Pump on Tank 3

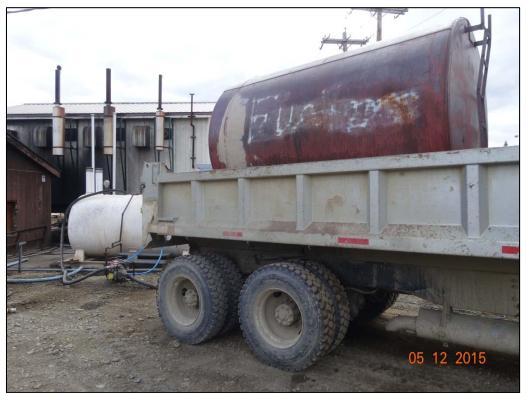
☑ Other (specify): <u>The fuel transfer process was observed (Photo 3)</u>. No spill containment was <u>used and fuel actively leaked onto the ground emanating from cam-lock fittings</u>.

Photo 3 – Fuel Transfer Process at Tank 3

Recommend resolving above issues. Facility is in overall poor condition.

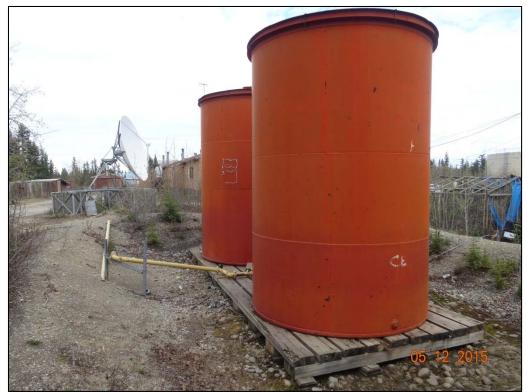
Photo 4 – Tank 1 and Tank 2 (Not in Service)

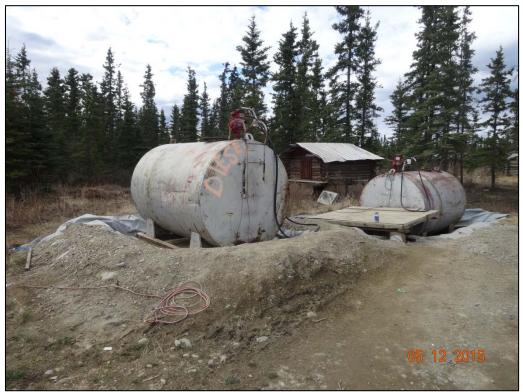
Photo 1 – Tank Farm 3

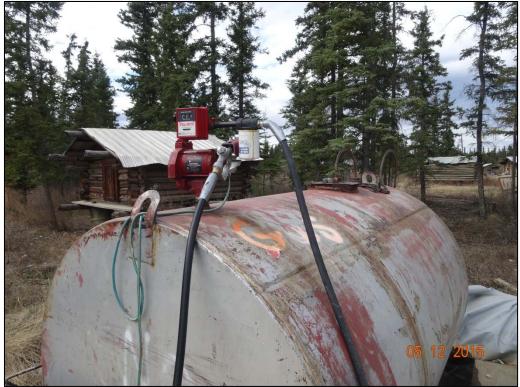
Photo 2 – Tank 1 Dispensing Pump

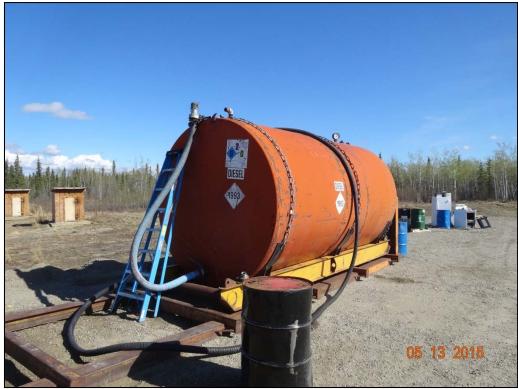
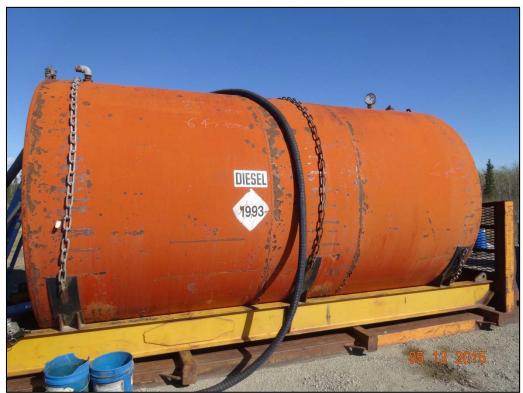
Photo 1 – Tank Farm 4

Photo 2 – Tank Farm 4
