CONDITION SURVEY
REPORT

AIDEA Building
813 W. Northern
Lights
Anchorage, AK

RSA Engineering, Inc
670 W Fireweed Lane, Ste 200
Anchorage, AK 99503

Dustin McCleskey, PE, Tim Hall, PE
RSA No. M0150

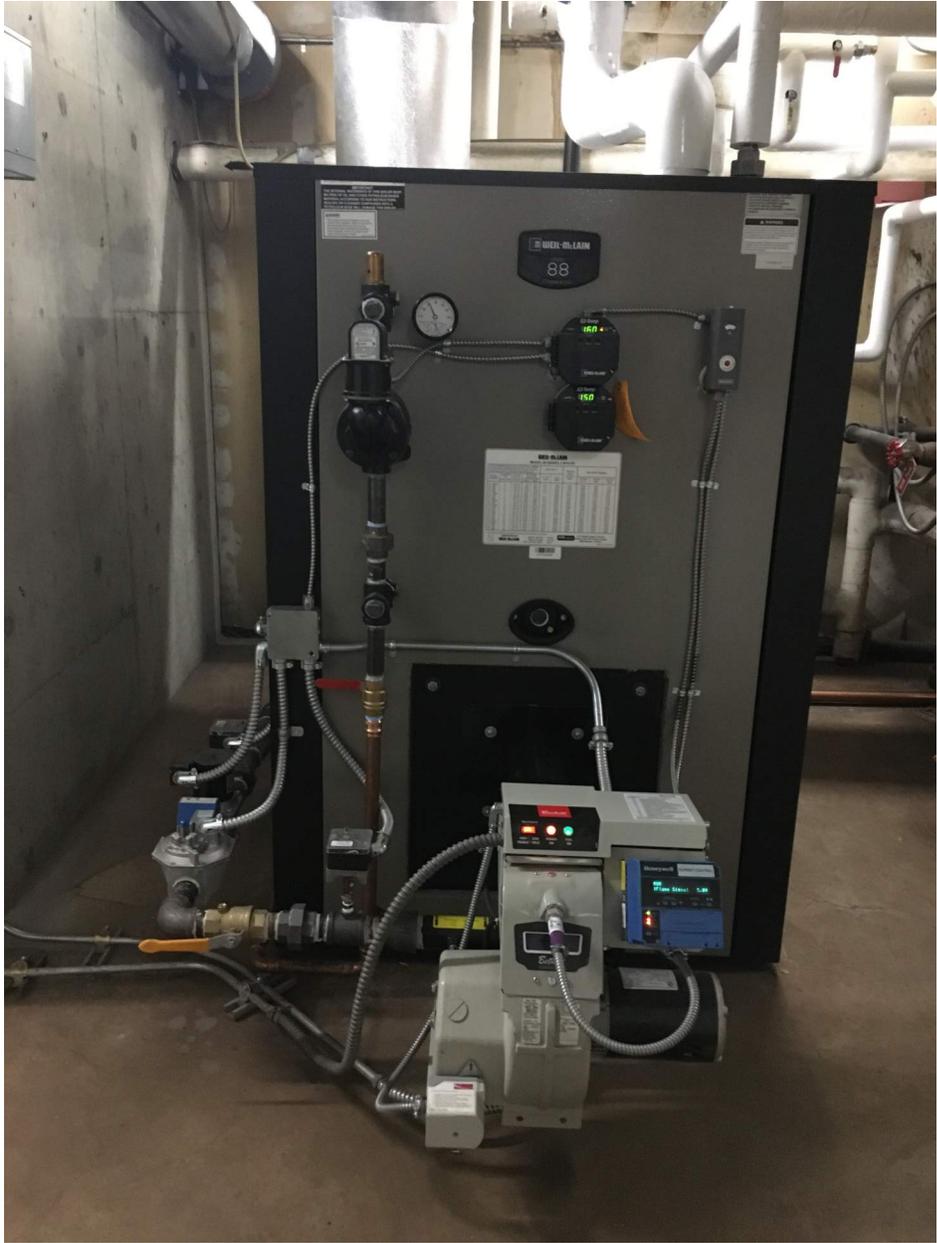
Photo M1

- a. Heating Boilers: The facility is heated with two standard efficiency non-condensing gas fired boilers. The boilers are Weil McLain series 88 model 988 with a gas input of 2,737 MBH and heating output of 2,274 MBH. The boilers were installed in 2019 after the November 2018 earthquake and are in good working condition, but are not as efficient as condensing type boilers. The service life of this type of boiler is around 35 years. See photo M1.

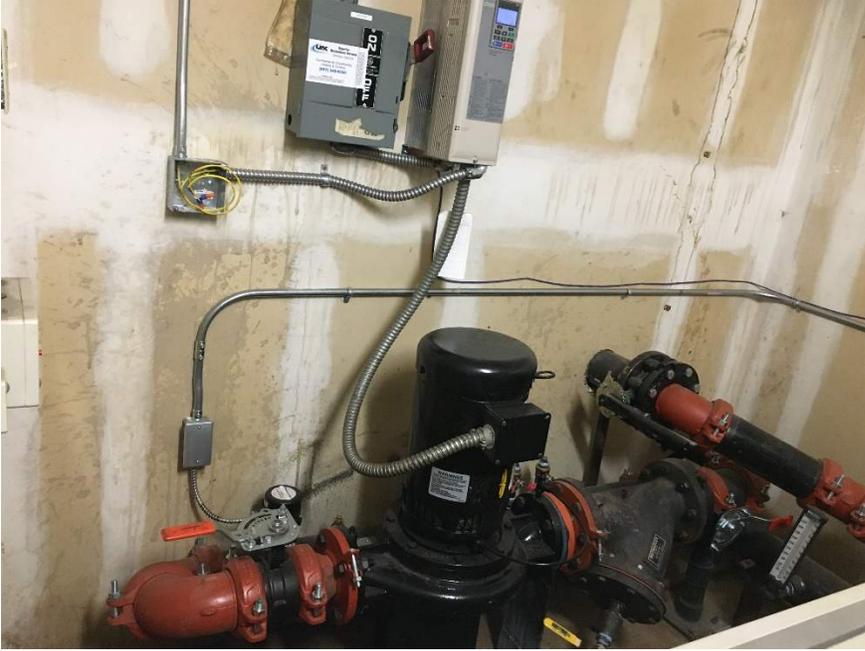
Photo M2

- a. Chillers: The facility is cooled by a modular Multistack chiller system. The chillers are water cooled with two compressors per chiller. One chiller consists of two 15 ton compressors, the other has two 20 ton compressors. The unit voltage is 460V/3ph. The chillers appear to be well maintained and in good working condition and were installed in 2016.
- b. Pumps: There are two chiller pumps that operate in a primary standby mode. The pumps are Bell and Gossett vertical inline pumps rated for 7.5 HP at 460V/3ph. Both pumps are connected to VFD's. The pumps are in good condition and were installed in 2016 as part of the chiller project. See photo M2.

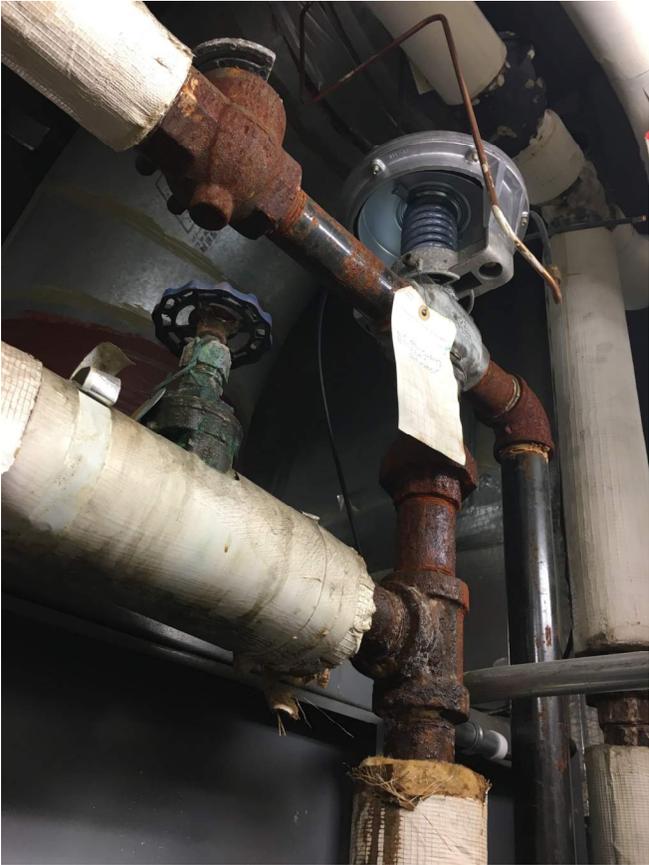
Photo M3

- a. F-4: Air handling unit number F-4 provides ventilation for the First floor south mezzanine and 1st floor floor grilles. The unit is constant volume and has a mixing box, filter, heating coil, cooling coil, and supply fan. The unit is in fair to poor condition and appears to be original to the facility. It does appear to have been well maintained over the years. The piping connections to the heating and cooling coil are in poor condition with one having an active leak at the time of inspection. The 3-way control valves are pneumatic and also corroded. The motorized dampers for the mixing box are electric. The insulation for the piping in the fan room containing F-4 is falling apart at points and possibly contains hazardous materials. AHU body itself is not seismically restrained to the floor. A typical AHU frame has a 40 year service life. See photo M3.

- a. Ventilation Fans: Ventilation Fans F-1, F-3 and F-4 are original to the building and at the end of their usable life. Fan F-4 in the basement could be replaced in kind with reasonable effort. Modern Air Handling Units can be delivered to the site knocked down so all pieces fit through a standard door, then re-assembled in the fan room. Fans F-1 and F-3 located in the penthouse pose a bigger challenge to replace. A fair amount of demolition would be necessary to bring new units in, possibly removing O/A louvers or walls of the penthouse.

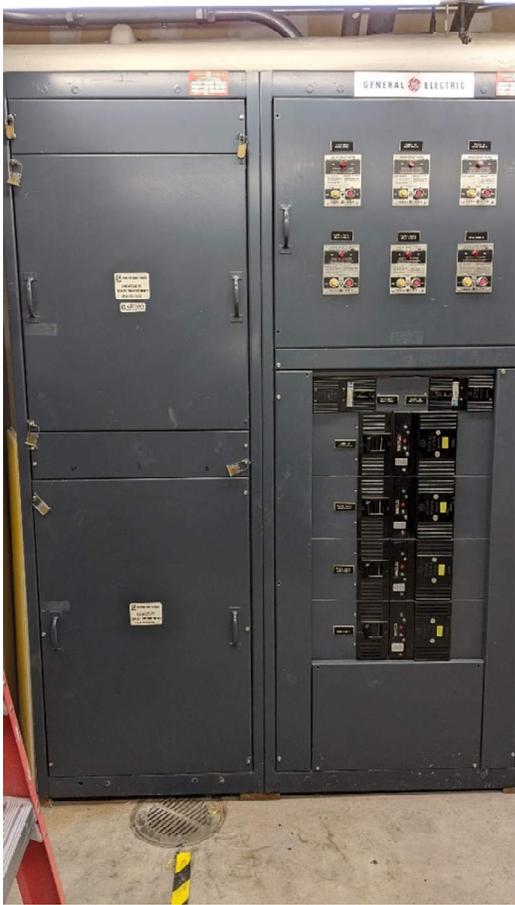
MDP in Basement Electrical Room

Condition: The MDP was manufactured by General Electric in the early 1970's. The unit is an AV-line switchboard and is rated for 600 ampere (A), 277/480V, 3-phase, 4-wire. The existing switchboard appeared to be in average condition for its age and usage. At this point, we have not heard many complaints about finding spare parts for this equipment. However, as the equipment gets older, maintenance and repairs on the systems become increasingly more difficult.

Based on a 1-year demand history provided by ML&P, the calculated demand load is approximately 142 kilowatts (kW), or 213A at 480V. Therefore, the existing MDP is sized adequately for the existing load, as well as any additional load that may added under a similar office use and the current building footprint. Although the MDP is sized for the building loads, there is no physical space to add more circuit breakers. Additionally, per NEC article 230.71 the maximum number of main disconnects is 6. Therefore, any equipment added to the MDP that

Recommendations: At this time, we do not feel that upgrades to the MDP are necessary. However, the owner should weigh the possibility of prolonged outages at the facility in the case of a failure of equipment without access to spare parts. Also, if any upgrades involve the addition of major electrical loads, a service upgrade would be required. We feel that replacement of the MDP should be in a 10-year maintenance schedule.

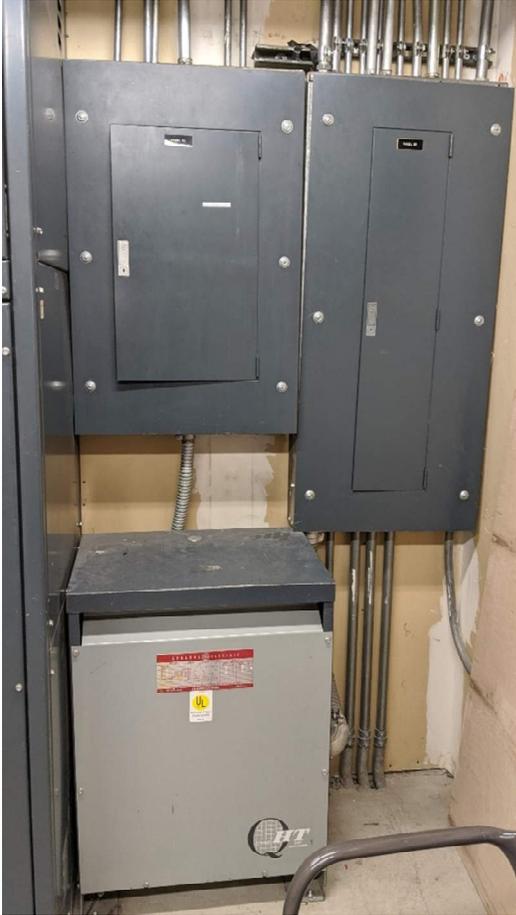
Condition: Panel "BL" is fed from the 2nd main breaker in the MDP and it is the basement lighting panel. The panel was manufactured by General Electric in the early 1970's. The panel is an NHB panelboard and is rated for 100A at 277/480V, 3-phase, 4-wire. The panel is in fair condition based on age and use. Panel BL feeds the following: basement lighting, parking lot lighting, building exterior lighting, and panel "BP". The panel has (1) 70A, 3-pole spare and (3) single pole circuit spaces. Panel "BP" is the power panel for the basement equipment and is a 120/208V, 3-phase, 4-wire panelboard of the same vintage as panel "BL".

The step-down transformer that feeds panel "BP" is located directly below panel "BL". Per NEC article 110.26, working clearances must be maintained around all electrical equipment that may require "examination, adjustment servicing or maintenance while energized". In this case, the transformer encroaches into the 42" deep x 30" wide x 78" tall working space required for panel "BL" and panel "BP". This code requirement was established before the original construction so this would have been a code violation when it was installed, therefore it would not be considered for "grandfathering" by local code enforcement.

relocated

Panels "BL and "BP" with transformer to be

Recommendations: At this time, panel "BL" and "BP" are in operable condition and there does not appear to be an imminent likelihood of the equipment failing. However, the equipment is almost 50 years old and in fair condition so accordingly, the Owner should start considering whether to replace the panel. We would put this task in a 5-year maintenance schedule.

The transformer needs to be relocated to allow adequate working clearance for Panel "BL". The existing transformer is approximately 50 years old and also in fair condition and can remain in

service. However, since it will need to be relocated this may be a good opportunity to replace the unit.

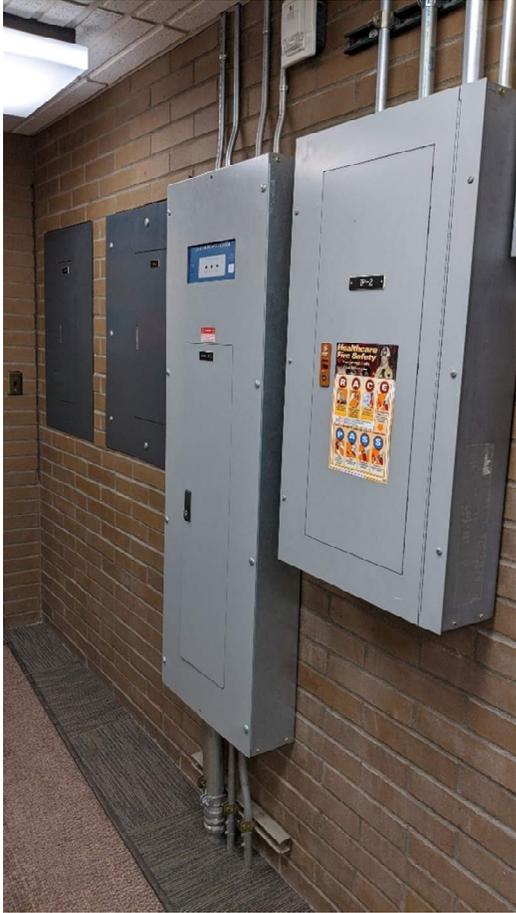
Panels 1L, 1P, 1P-2, and 1P-3

Condition: Panel "1L" is fed from the 3rd main breaker in the "MDP" and is the main lighting panel for the 1st floor. Under the original construction, the feeder to panel "1L" appears to have been tapped to feed the lighting panels on the mezzanine and 2nd floors (panels "ML" and "2L"). In addition, a 480V to 120/208V, 3-phase, 4-wire, step-down transformer (located above the ceiling) is fed out of the lighting panel for each floor and feeds a power panel for general-purpose outlets and other 120V loads (Panels "1P", "MP" and "2P"). Panels "1L", "ML", and "2L" are similar in type and vintage to panel "BL", as are panels "1P", "MP", and "2P" to panel "BP". All panels are in fair condition

Since the building was constructed, several 120/208V, panels have been added to the system in subsequent remodel work and fed from panel "SDP", including Panels "1P-2", "1P-3", and "2P-1". Panel "1P-2" is a 100A, 30-circuit GE A-Series panelboard with transient voltage surge suppression (TVSS) and appears to have several spares. Panel "1P-3" is a 100A, 42-circuit Cutler Hammer PRL1a panelboard with TVSS and 25 circuit spaces. Panel "2P-1" is a 100A, 30-circuit Cutler Hammer PRL1a panelboard with TVSS and 11 circuit spaces. These panels are in good condition.

It was reported that there have been several overloading problems with the general-purpose outlet circuits. Several of the problems have been attributed to the used of electric space heaters by the building occupants. Based on the NEC article 220.12, the load calculation for general lighting and receptacle load for an office building of this size should be 165 kVA or 200A, at 480V. The existing feeder to panel "1L" is rated for 225A, at 277/480V, 3-phase, 4-wire. The original feeder for the general lighting and receptacles appears to have been marginal for the current functions. With the panels that have been added, there appears to be enough power for the general-purpose loads. However, presumably the original branch circuits have more receptacles per circuit than the circuits installed later and are most likely the cause of the overloaded circuits. More circuits could be added to split up some of the more troublesome circuits, in order to maintain smaller loads on all circuits.

Recommendations: At this time, panel "1L", "ML", "2L", "1P", "MP" and "2P" are in operable condition and there does not appear to be an imminent likelihood of the equipment failing. However, the equipment is almost 50 years old and in fair condition, accordingly the Owner should start considering whether to replace the panel. We would put this task in a 5-year maintenance schedule. Panels "1P-2", "1P-3", and "2P-1" are in good condition and can remain as-is for many more years.

We recommend identifying the circuits that have tripping problems due to overloading. The number of outlets on these circuits should be reduced, especially if there are several electric heaters plugged into the circuits. To do this properly, receptacle outlets should be removed from the circuits in question and new circuits added to reconnect the removed receptacles. Otherwise,

additional circuits could be provided for electric heaters in the distressed areas and the heaters removed from the questioned circuits.

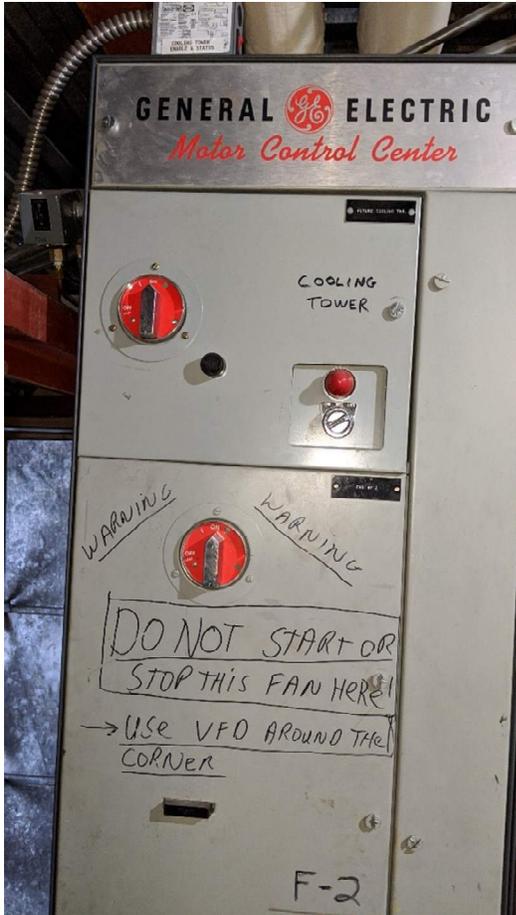
Penthouse Motor Control Center

Condition: The penthouse motor control center is fed from the 4th main breaker. The MCC is from the original construction and is a GE IC 7700 Line. The MCC is of early 70's vintage and is in poor condition. We have heard complaints about GE equipment of this vintage and the difficulty in getting spare parts.

Recommendation: At this time, PMCC is in operable condition and there does not appear to be an imminent likelihood of the equipment failing. However, it is in poor condition and many other clients have expressed difficulties in getting spare parts for similar equipment. Therefore, we suggest the owner starts looking at replacement of the equipment. We would put this on a 3-year maintenance schedule.

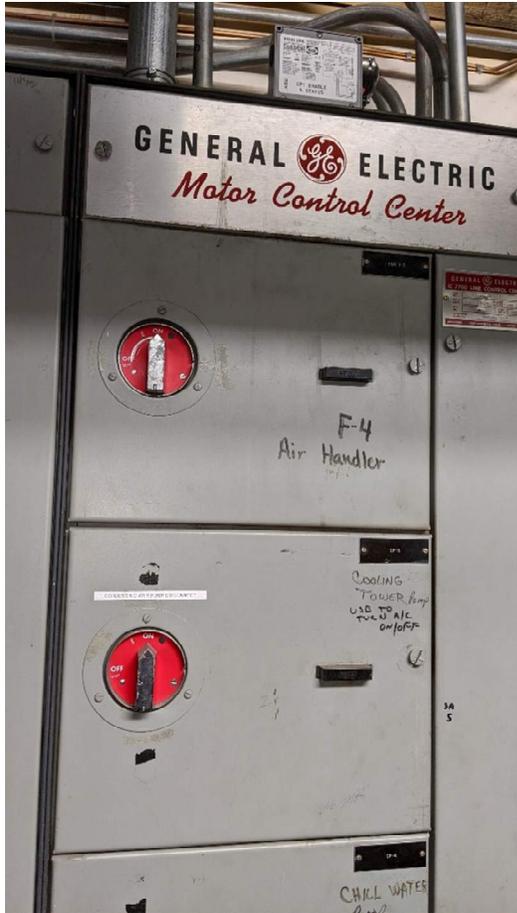
Basement Motor Control Center

Condition: The basement motor control center is fed from the 5th main breaker. The MCC is from the original construction and is a GE IC 7700 Line. The MCC is of early 70's vintage and is in fair condition. We have heard complaints about GE equipment of this vintage and the difficulty in getting spare parts.

Recommendation: At this time, BMCC is in operable condition and there does not appear to be an imminent likelihood of the equipment failing. However, it is in fair condition and many other clients have expressed difficulties in getting spare parts for similar equipment. Therefore, we suggest the owner starts looking at replacement of the equipment. We would put this on a 5-year maintenance schedule.

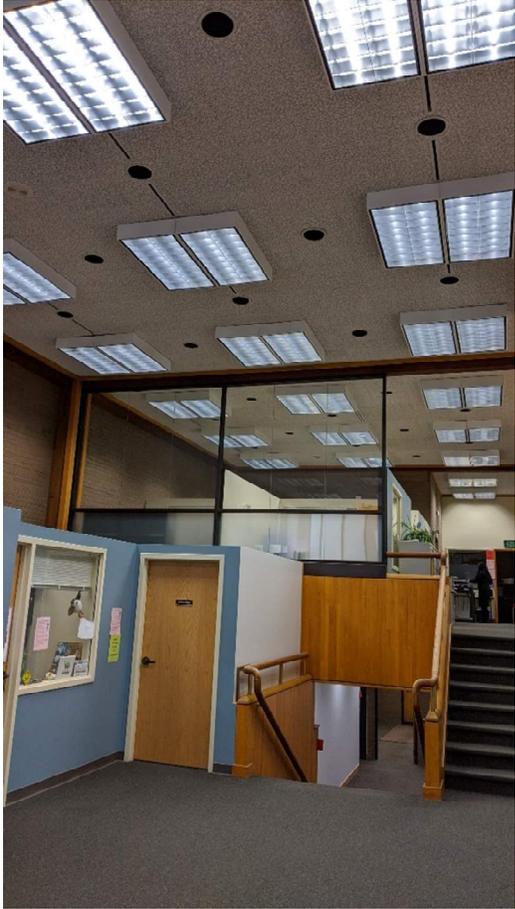
General Office Lighting

Condition: The existing lighting systems consist mostly of linear fluorescent fixtures the original T8 lamps have been replaced with LED retrofit lamps. The fixtures for the most part are surface-mounted parabolic style that we would estimate are from the late 1990s or early 2000's. The fixtures are in good condition, but the technology is out of date. Substantial energy savings could

be achieved with a lighting and controls retrofit. For the most part, the lighting levels appear to comply with the IES recommendations. Areas that fell short of IES recommended levels were generally small and if concerns arise, the lighting levels could be increased with the use of small task lighting fixtures. There also are many circuits of recessed can lighting that are currently not used.

Recommendations: Although the lighting in general is in good condition and operating effectively, a lighting retrofit could provide energy savings.

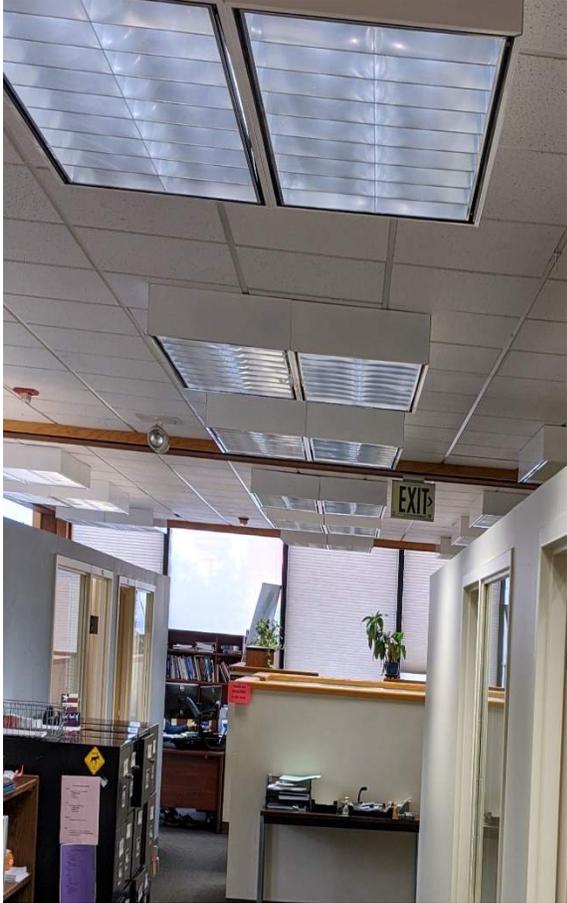
Emergency Bug-eye and exit sign.

Condition: The existing emergency lighting is accomplished using “bug-eye” style battery packs. For the most part, the units appeared to be properly spaced. There were a few locations, especially in the basement, that proper lighting levels for emergency egress were not met.

Recommendations: We recommend adding bug-eye emergency lights as necessary to meet 1-foot candle minimum average lighting levels along the path of egress, per IBC 1008.2.1. Otherwise, if a lighting retrofit is pursued, we recommend using battery-powered drivers in the standard fixtures to provide egress illumination.

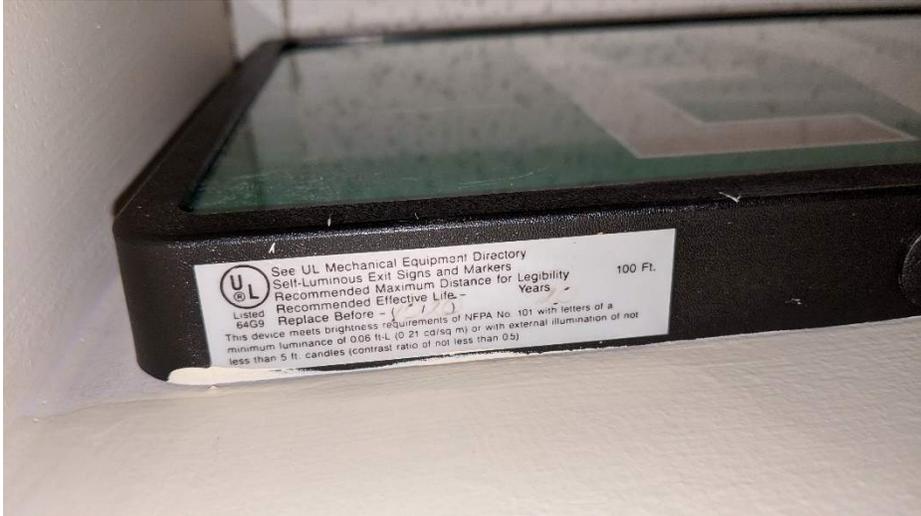
Also, in the basement there were some self-illuminated exit signs. Many of these signs did not have a replacement date marked on them. Of the ones that, did we found 10/2020 as the replacement date so there is a good chance that most of the signs will be at the end of their rated life in a couple of months.

Self-luminous exit sign

expiration

We recommend providing additional lighting to illuminate the photoluminescent exit signs, and to make sure that these lights do not have local control so they remain on when the building is occupied (i.e. nightlights). Otherwise, they should be replaced with another technology. The self-illuminated exit signs that are at the end of their life should be replaced.

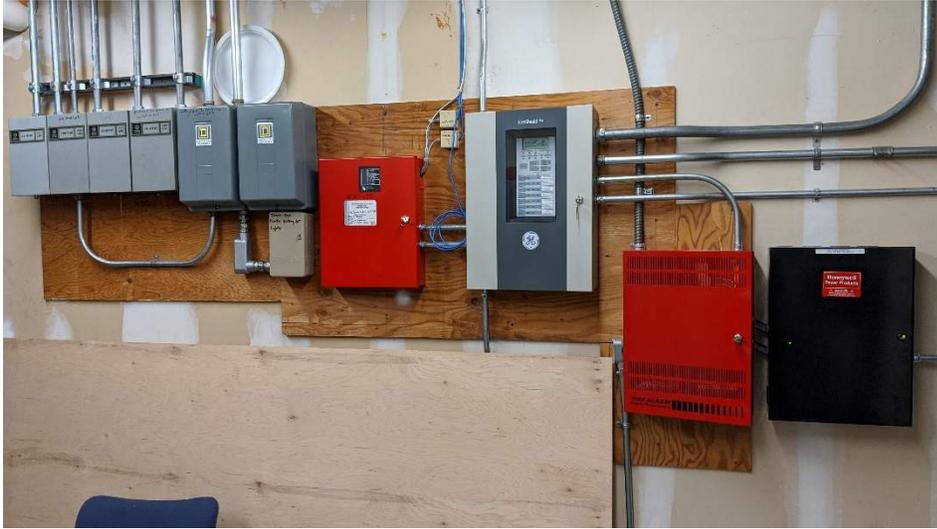
Main Fire Alarm Panel

Condition: The existing fire alarm system is in operable condition and appears to have been last tested in November of 2019. The system appears to be relatively new and in good operating condition.

Recommendation: We recommend maintaining yearly inspection and repairing any deficiencies noted in the inspection report.

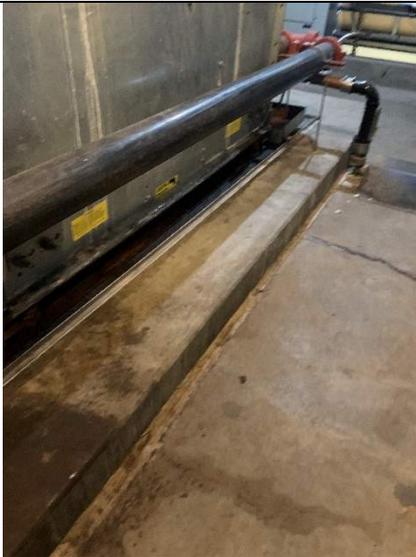
Photograph No. 2

- b. The basement floor slab contained few 1/8" cracks, likely due to minor shrinkage of the building over time and do not represent a structural or foundation issue. Both the CMU and concrete walls at this level were in good condition as well, with only hairline cracks that don't compromise the structural integrity of the system.

Description: Basement floor

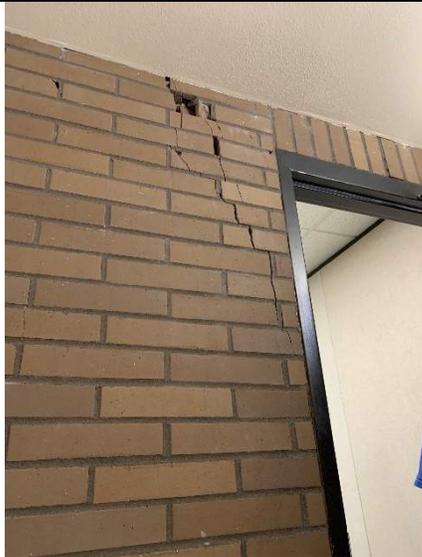
Photograph No. 6

- c. The CMU walls were in good condition with an exception of a single location near the plan west third floor stairwell, shown in Photograph No. 6. These large diagonal cracks were likely caused by shear failure around the door opening.

Description: CMU wall damage

- a. Veneer in south stairwell may be repaired by demolishing the damaged veneer brick and replacing in kind. Note that upon demolishing the veneer, the CMU behind the veneer should be checked for any signs of damage: cracking, exposed reinforcement, etc. If damaged, the CMU should be repaired prior to replacing the brick veneer.
- b. Due to the age of the structure and multiple construction types, multiple deficiencies in the lateral resisting system are expected. These would include roof and floor diaphragm continuity, connections between diaphragm and CMU walls and seismic collectors for a complete lateral load path.
