# Letter of Transmittal

## REINSPECTION REPORT (ASBESTOS)

AIDEA FACILITY INSPECTED: 813 W. Northern Lights Blvd. DATE: April 5, 2005

AIDEA/AEA  
813 West Northern Lights Blvd.  
Anchorage, Alaska

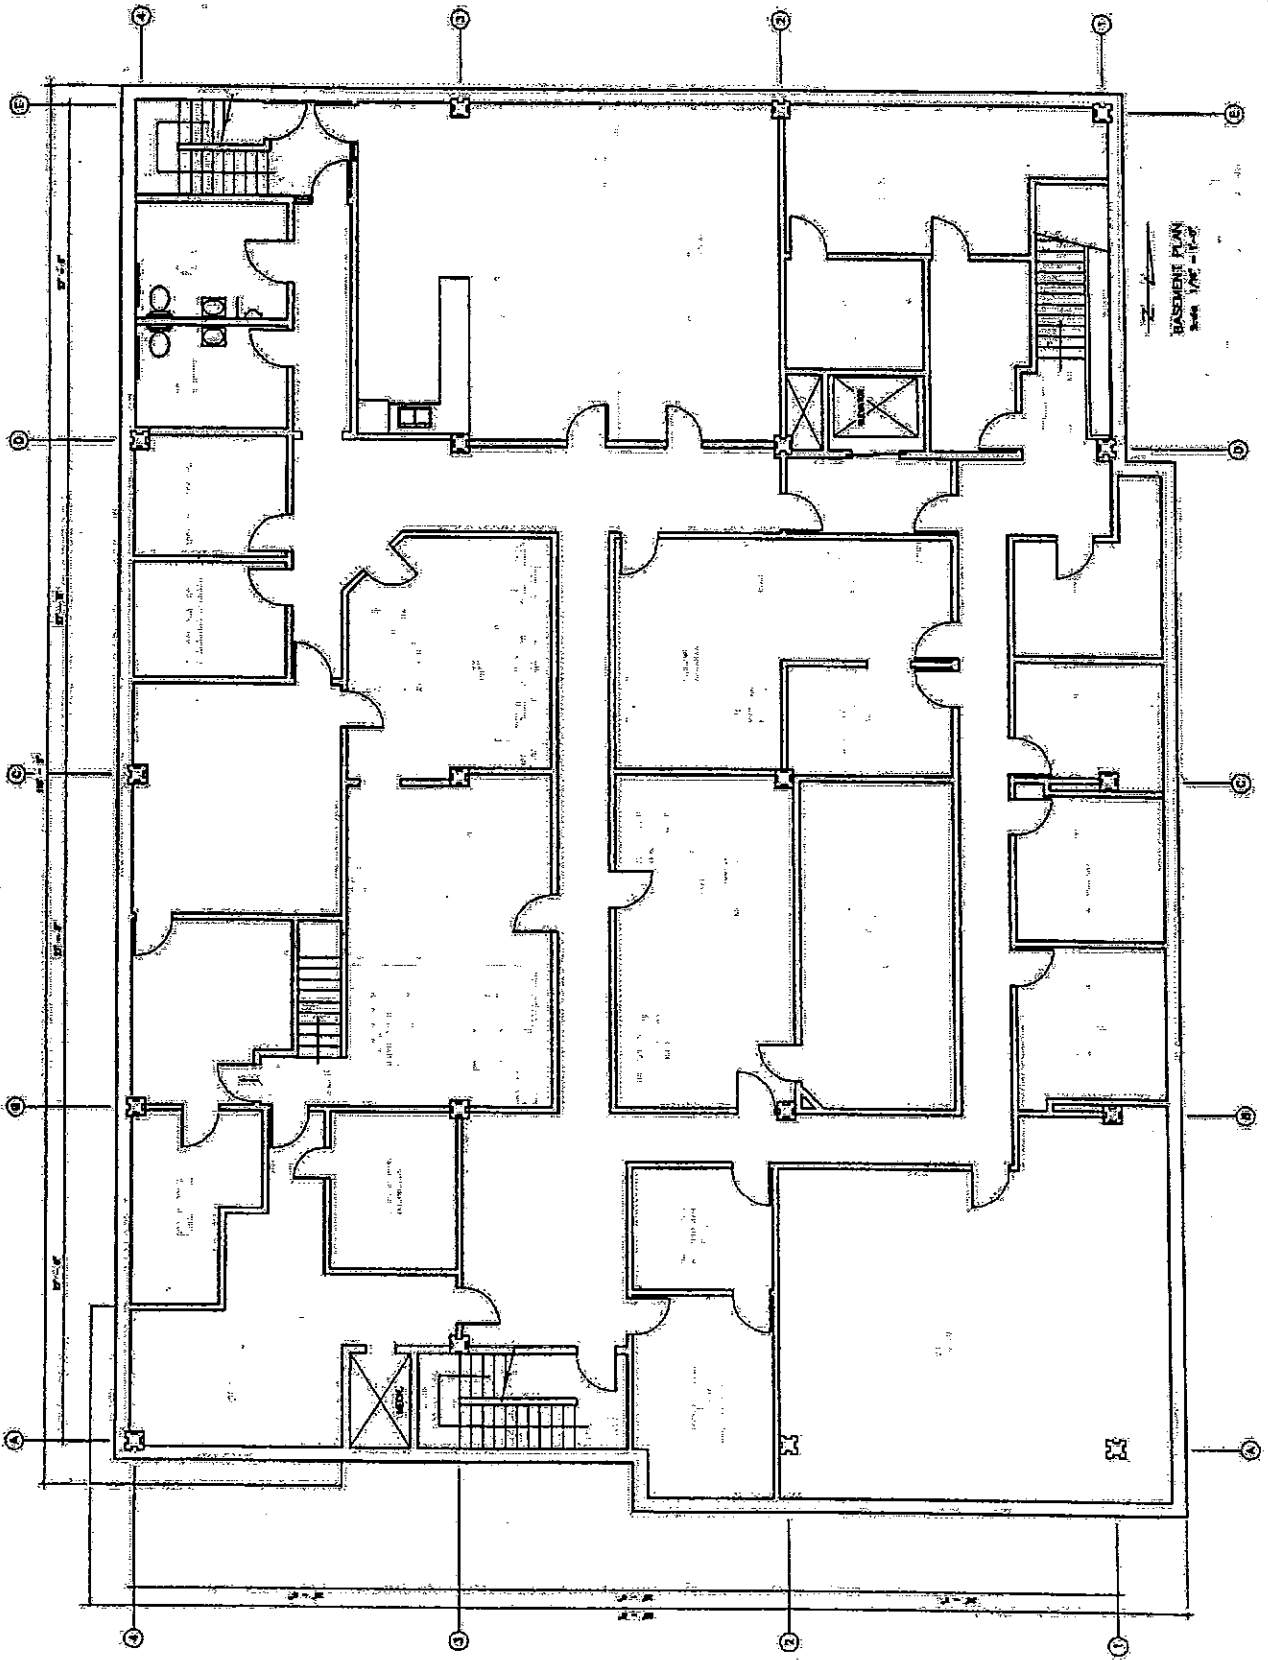
Asbestos Re-Inspection - Revised Floor Plan

| Asbestos-Containing Material | Location | Condition |
|---|--|---|
| Red and tan duct sealant or adhesive | Basement Storage and Mechanical Rooms, and Penthouse | Duct sealant was in good condition. Some duct sealant appeared to have been painted and to match surrounding components. All duct sealant is assumed to contain asbestos regardless of apparent color. |

| Asbestos-Containing Material | Location | Condition |
|---|--|---|
| Hard fittings on pipes | Basement Storage and Mechanical Rooms, and Penthouse | Only a few fittings containing asbestos remain in the building. Those remaining were in good condition. Any cementitious pipe insulation is assumed to be asbestos-containing. |

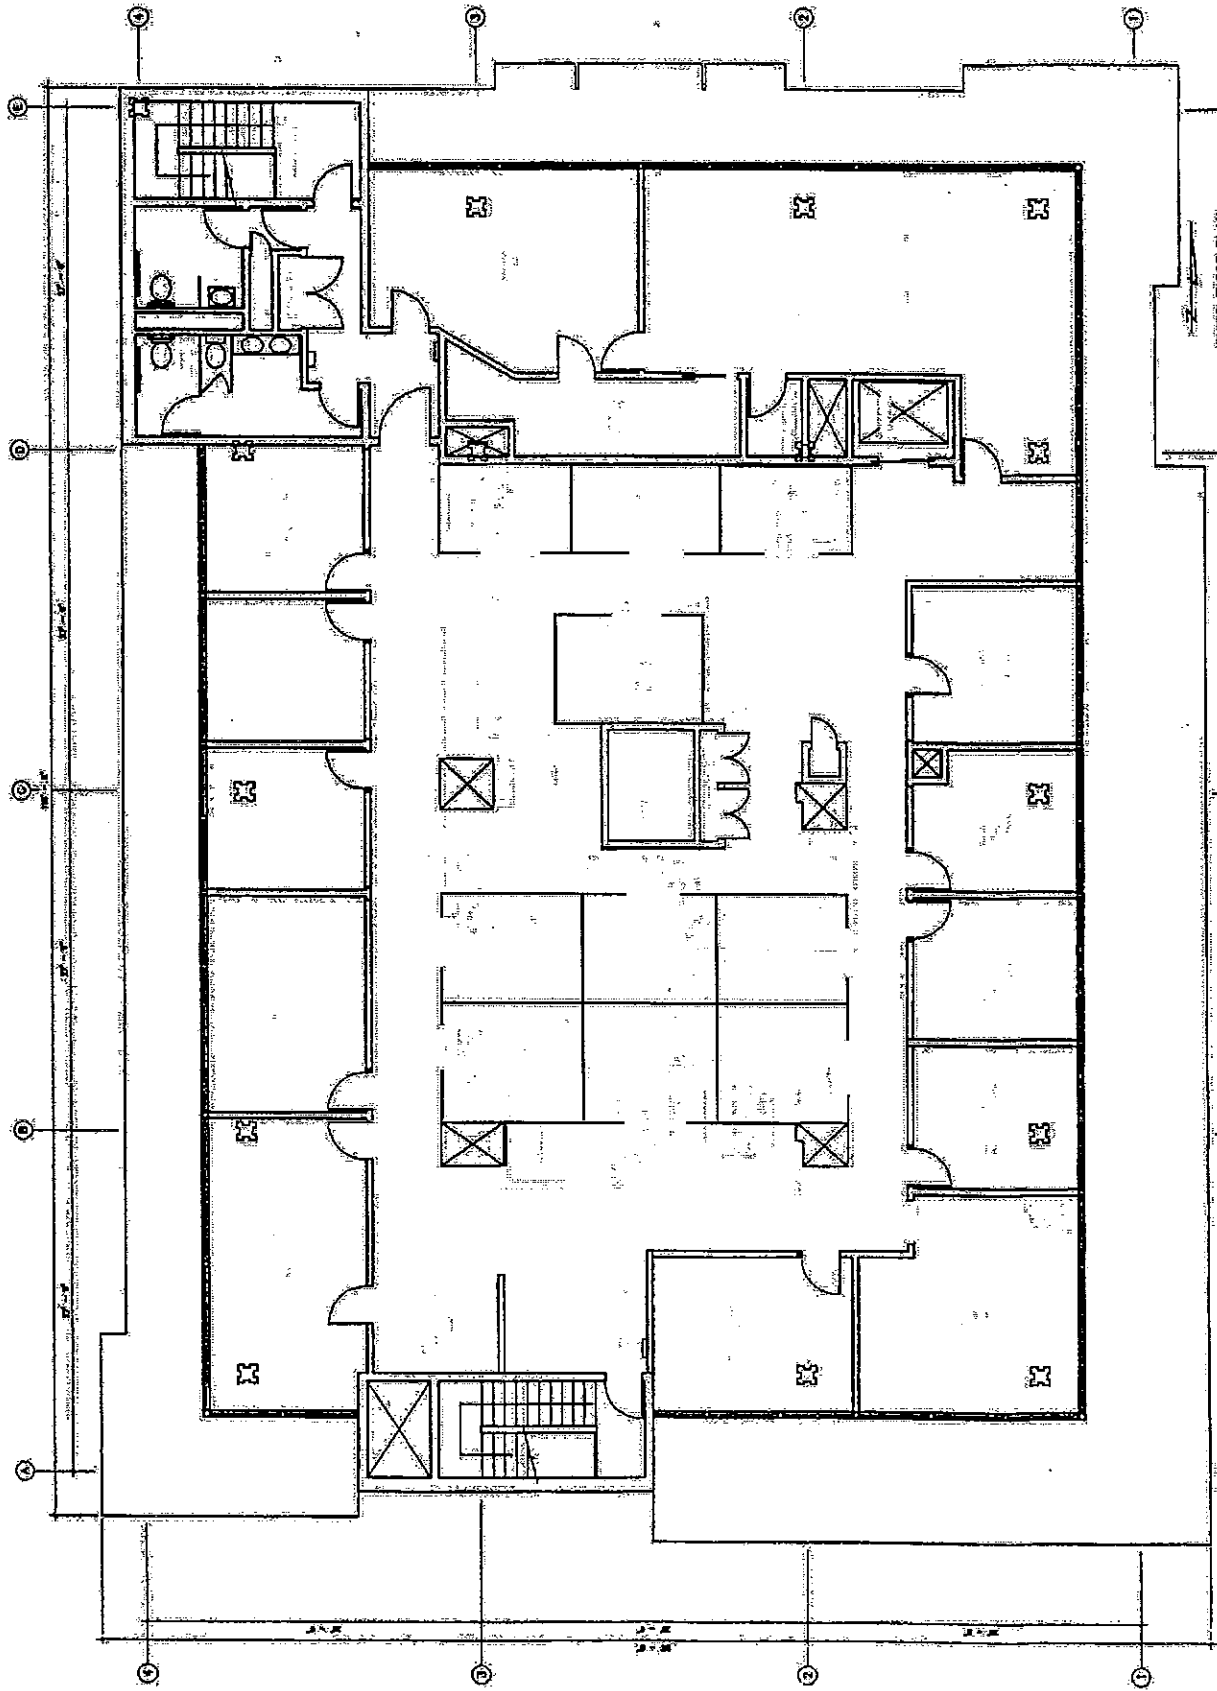
**Asbestos Re-Inspection - Revised Floor Plan**

| Asbestos-Containing Material | Location | Condition |
|---|--|---|
| Fire caulking | Penthouse, HVAC | Fire caulking is still present and in good condition |
| Gaskets on fans and boilers | Basement Boilers in Mechanical Rooms, and Penthouse HVAC | Gaskets appear to be in good condition. |
