**ALASKA INDUSTRIAL DEVELOPMENT AND EXPORT AUTHORITY**  
**SKAGWAY ORE TERMINAL**  
**SHIP LOADER STRUCTURAL INSPECTION**  
**November 11, 12 and 13, 2013**

**R&M Consultants, Inc.**

December 17, 2013

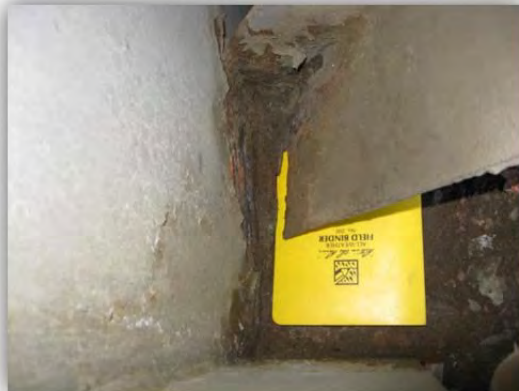
**Example of extreme CS5 deteriorated condition in boom conveyor support framing**

It was found that virtually all of the 29 frame joints containing a diagonal frame element are **CS5** and frame joints where members that are in a horizontal position (when the boom is raised and parked)

including framing between the main girders of the boom and between the main girders and I-beam shuttle track/runway were all found to be **CS4/5** to **CS 5** condition in some portion of the element based on material loss in the structural materials. The extensive corrosion encountered could be explained by the boom being luffed up to a vertical position for parking/storage between uses. This position allows water, dirt and residual concentrates to accumulate in the pocket formed by the joint when in a vertical boom position which promoted failure of coatings and corrosion of the steel elements.

***In short, the structural framing joints throughout the ship loader boom structural system are CS5 and require extensive remedial repairs for the equipment to operate safely.***

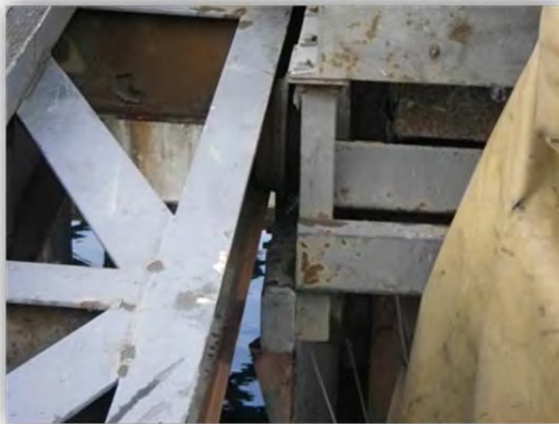
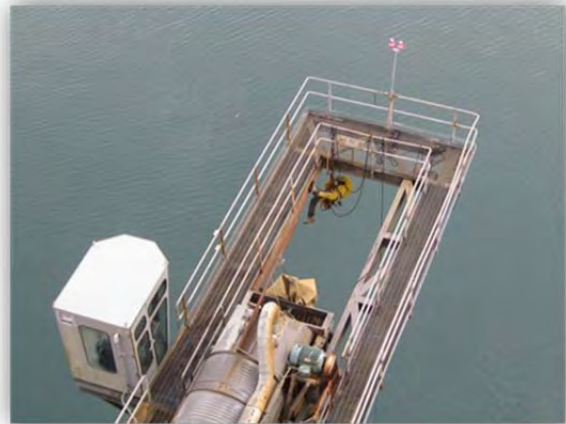
The head chute/drive end of the ship loader conveyor is supported by steel wheels that run on the bottom inside of the I-beam flange. The wheels have a truncated cone shape and this induces a level of lateral thrust to the I-beam runway/track that supports the head chute assembly. The I-beam is laterally supported by the boom girder by way of transverse “blocking” provided by short sections of steel I-beam. Diagonal structural Tee members provide additional lateral support and essentially form a horizontal truss to maintain the left and right runway/track members in relationship one to the other and prevent change in gage that would allow the shuttle to drop through the open area of the spout shuttle slot at the outboard end of the ship loader boom. The right hand (south) shuttle runway track has reduced lateral support due to extreme deterioration and loss of steel section in some of the lateral support blocking and diagonal Tees. This has allowed the gage to increase so the shuttle has less bearing area to support the steel wheels. Also, the left half of the lower flange of the runway/track beam has been bent downward 5/8-inches and the right hand set of wheels on the head chute/drive end of the shuttle has less bearing than the design.

**Right hand spout shuttle wheel, runway/track beam and failing lateral support.**

***The conveyor head chute/drive end shuttle needs urgent remedial repairs to restore the runway/track beams back to correct gage to maintain safe operating condition for the shuttle and head chute.***

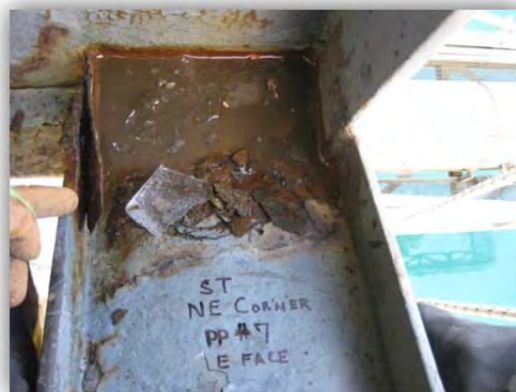
The structural joints where the lateral framing members between the load bearing columns of the North and South Guide Towers of the Ship Loader are configured to catch and hold water, dirt and residual concentrate were found to have significant coating loss and steel corrosion in and around the joints; this is primarily framing in the West and East faces of the towers. This is caused by water, dirt and residual concentrates being trapped in pockets formed in the joints by structural member orientation in joints. In some cases joints forming pockets were provided with drain holes which greatly reduced the corrosion problem if the drain holes were large enough and were kept clear of material plugging the hole. **However, in the two towers of the 44 joints of concern at least 23 are classed as CS4/5 or CS5. Another 28 are classed as CS 3/4 or CS 4.**

**Typical tower frame joint of configuration that pools water; CS5.**

***Guide Tower structural elements urgently need remedial repairs and all joints where water can collect need drain hole of sufficient size to prevent pooling of water.***

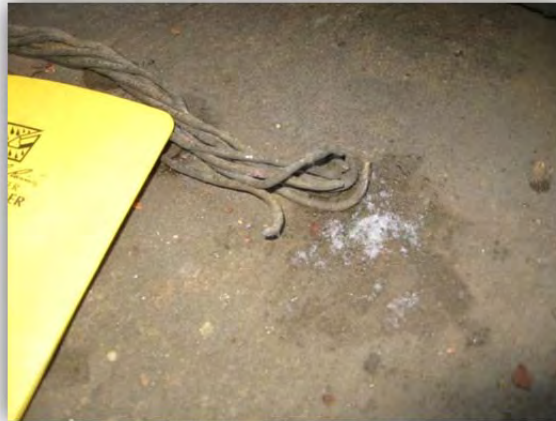
The base plates of Guide Tower columns and all static and operating elements anchored to the pile cap/base slab need close attention to ensuring grounding strap cables are intact and providing competent ground. In at least one instance the ground cable has broken strands and is in marginal condition at the point it emerges from the base slab.

**Example of partially failed ground strap at column base; CS5**

***Detailed inspection of the Grounding System was not done as part of this inspection, but, incidental observations indicate the system needs attention by qualified person(s).***

3. The electrical grounding system for the ship loader structure be closely inspected and tested and any broken, damaged or ground straps not in compliance with grounding requirements be replaced.

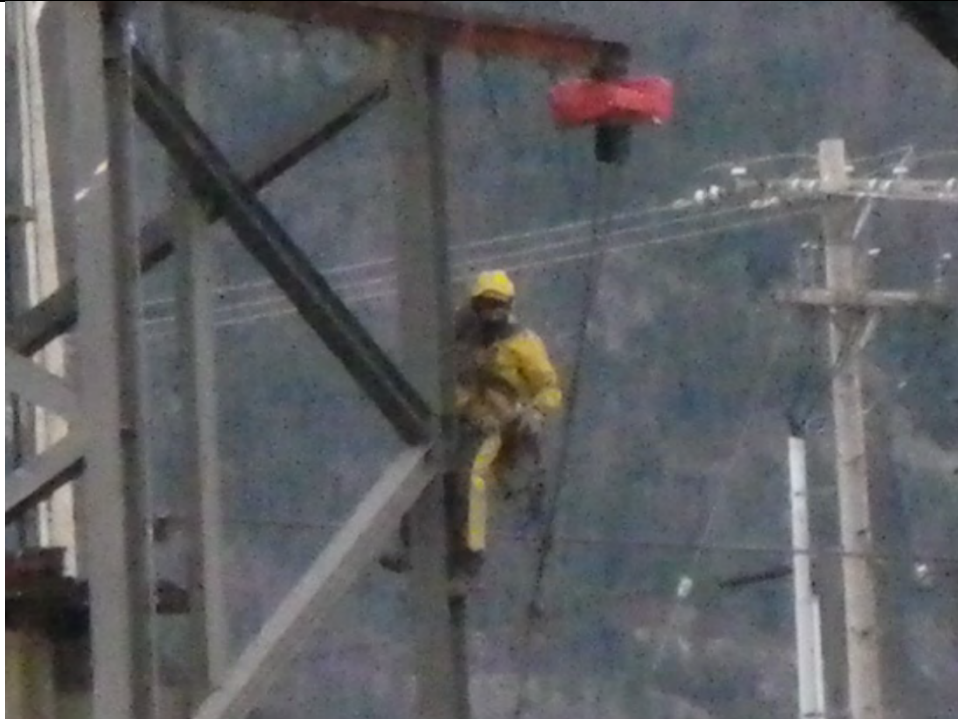
**JKM-111213-IMG0426**  
**LOCATION: SKAGWAY ORE TERRMINAL SHIP LOADER**

**DESCRIPTION: INSPECTOR AT NW COLUMN OF NORTH TOWER, INSPECTING STEEL MEMBERS AND CONNECTIONS;**  
**NOTE HOIST ON JIB BOOM, THE ENTIRE BOOM AND HIOIST INSTALLATION WAS REMOVED BY MSI WHEN CLIMBERS DISCOVERED ATTACHMENT TO NE COLUMN OF NORTH TOWER WAS FAULTY AND ABOUT TO FAIL. INSPECTION OF THE NE TOWER COLUMN COULD NOT BE SAFELY PERFORMED WITH JIB BOOM IN PLACE. SEE PHOTO JKM-111313-IMG0446 OF FAILED BRACKET.**

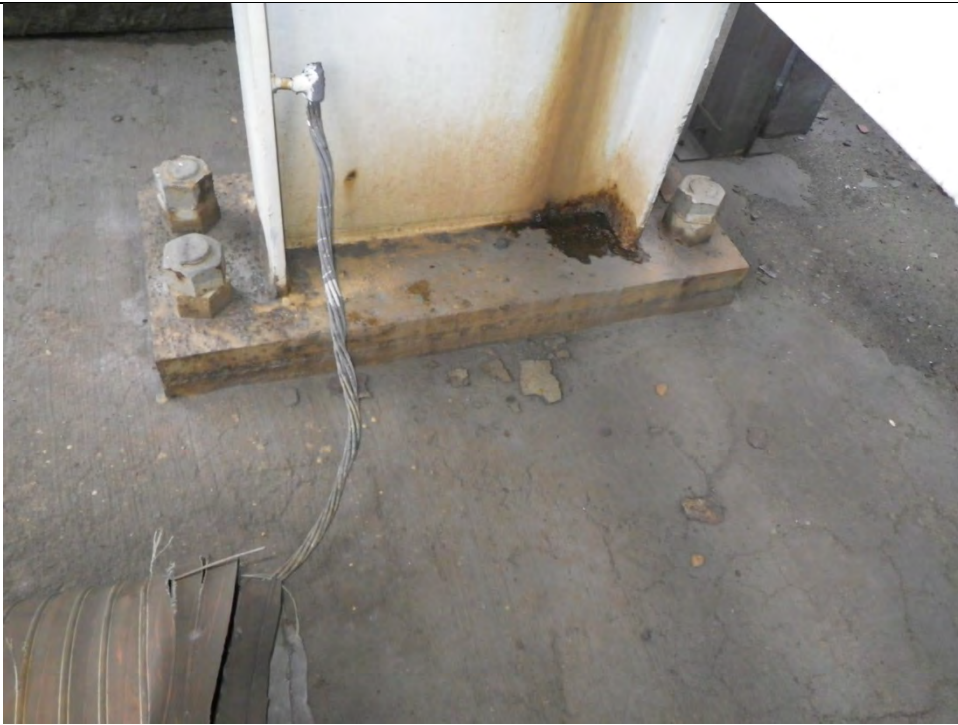
**JKM-111213-IMG0382**  
**LOCATION: SKAGWAY ORE TERMINAL SKAGWAY ORE TERMINAL**  
**DESCRIPTION: TOWER COLUMN BASE, NOTER CORROSION AT COLUMN TO BASE PLATE JOINT**

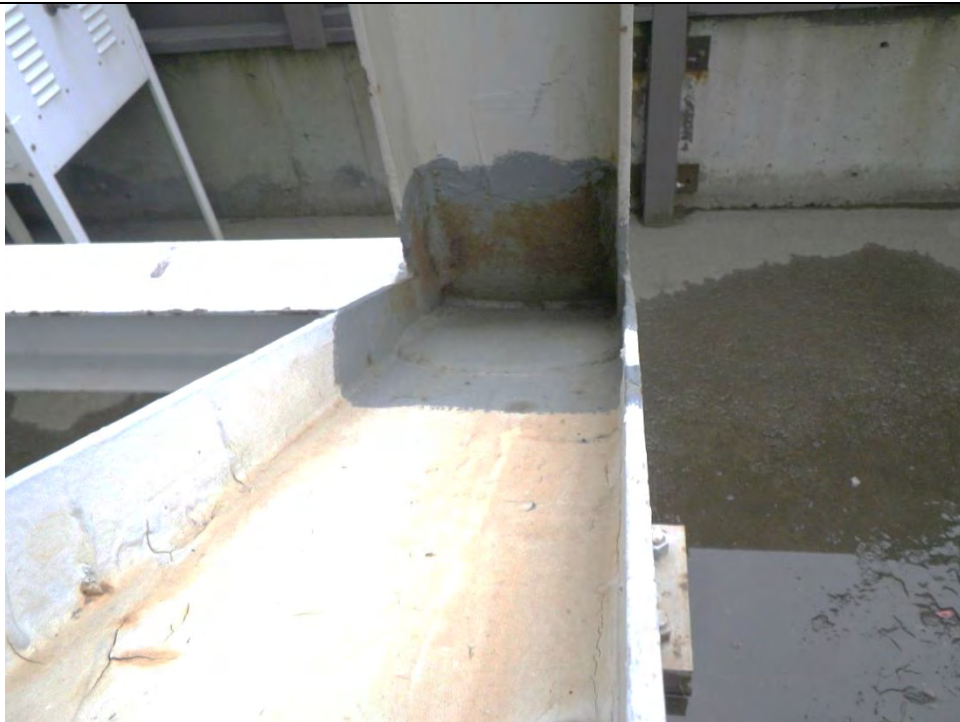
**JKM-111213-IMG0374**  
**LOCATION: SKAGWAY ORE TERMINAL SHIP LOADER**  
**DESCRIPTION: SW COLUMN OF SOUTH TOWER; SHOWING WATER TRA IN WF CONNECTION WITH DRAIN HOLE; AIR MONITOR UNIT IN BACK LEFT OF PHOTO**

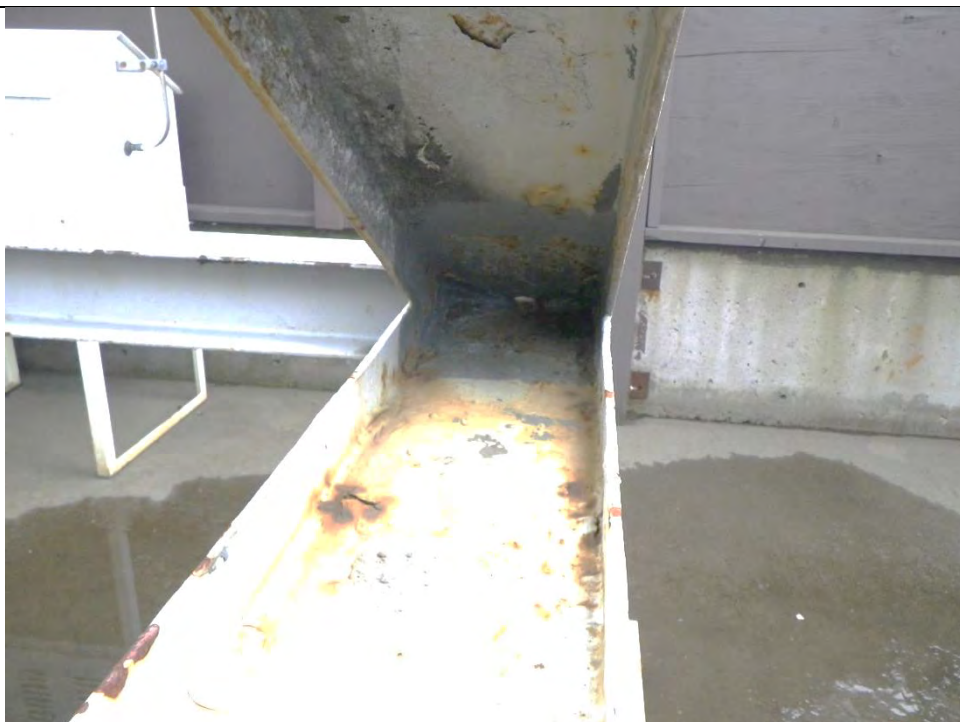
**JKM-111213-IMG0373**  
**LOCATION: SKAGWAY ORE TERMINAL SHIP LOADER**  
**DESCRIPTION: SW COLUMN OF SOUTH TOWER; SHOWING WATER TRA IN WF CONNECTION WITH DRAIN HOLE; AIR MONITOR UNIT IN BACK LEFT OF PHOTO**

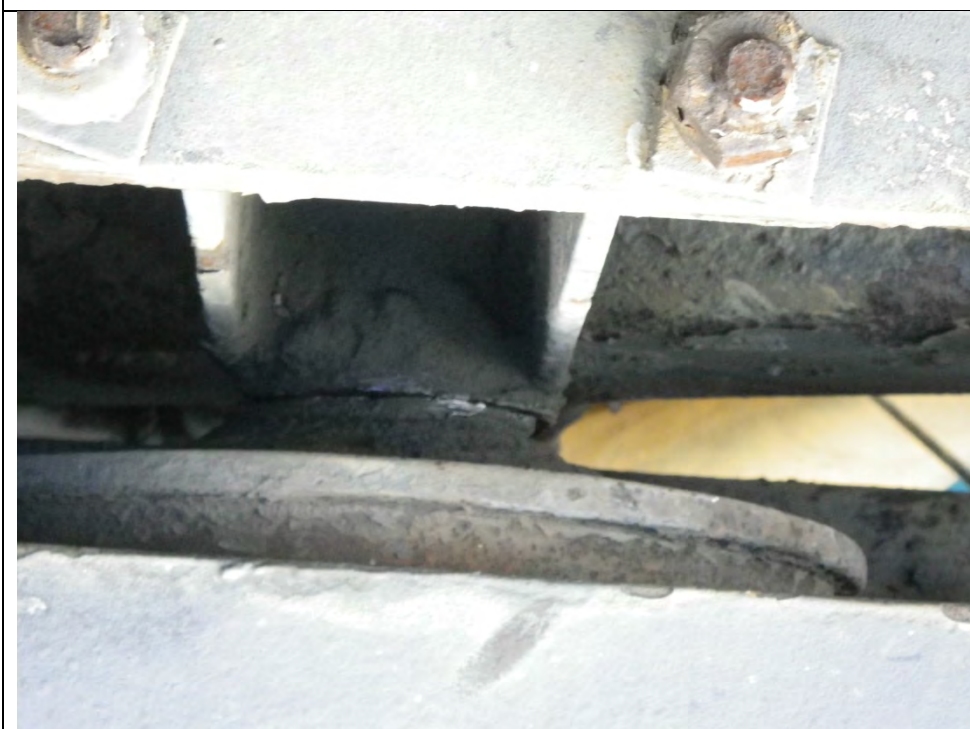
**DESCRIPTION: RIGHT (SOUTH) SHUTTLE CARRIER WHEEL AND SHUTTLE SUPPORT BEAM AND RUNWAY. NOTE GAP BETWEEN WHEEL FLANGE AND RUNWAY BEAM FLANGE**

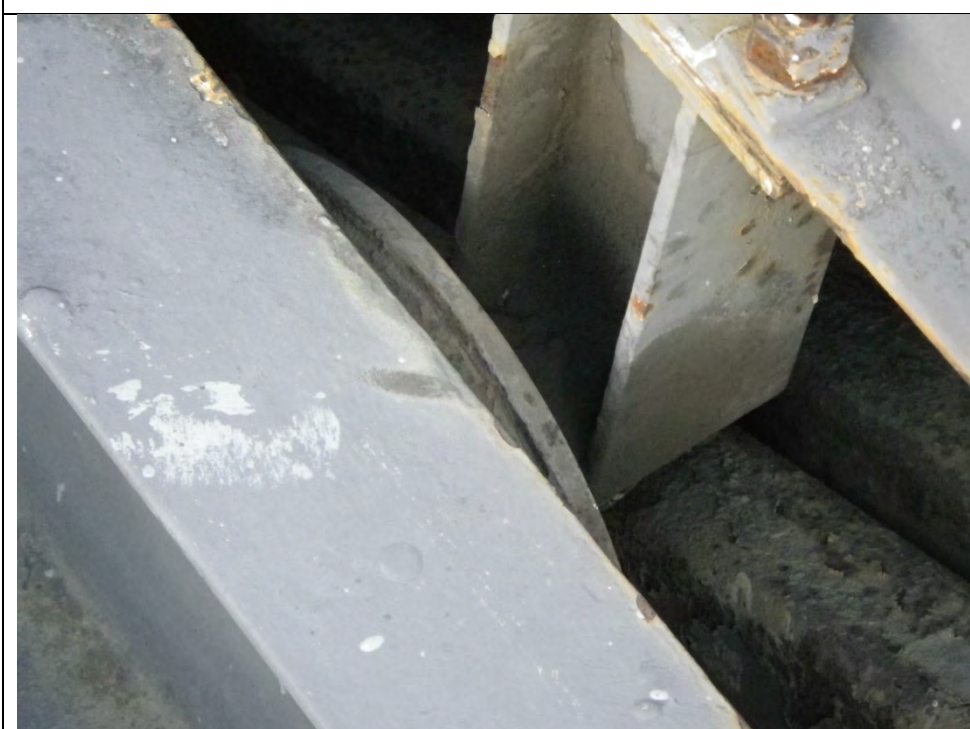
**DESCRIPTION: RIGHT (SOUTH) SHUTTLE CARRIER WHEEL AND SHUTTLE SUPPORT BEAM AND RUNWAY. NOTE GAP BETWEEN WHEEL FLANGE AND RUNWAY BEAM FLANGE**

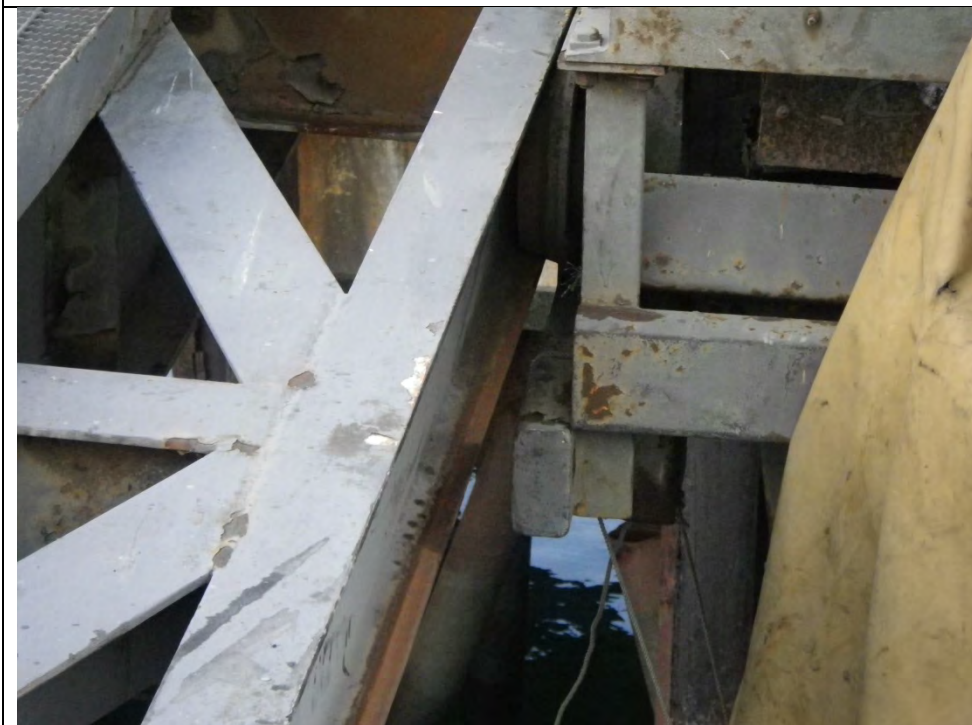
**DESCRIPTION: RIGHT SIDE SHUTTLE SUPPORT BEAM; RIGHT CARRIER WHEEL VISIBLE INSIDE CARRIER BEAM RUNWAY; NOTE WEAR ON BEAM FLANGE AND FLANGE BENT DOWNWARD TO SLOPE OF SHUTTLE WHEEL "TREAD"; FLANGE TO WHEEL FLANGE GAP EXCESSIVE.**

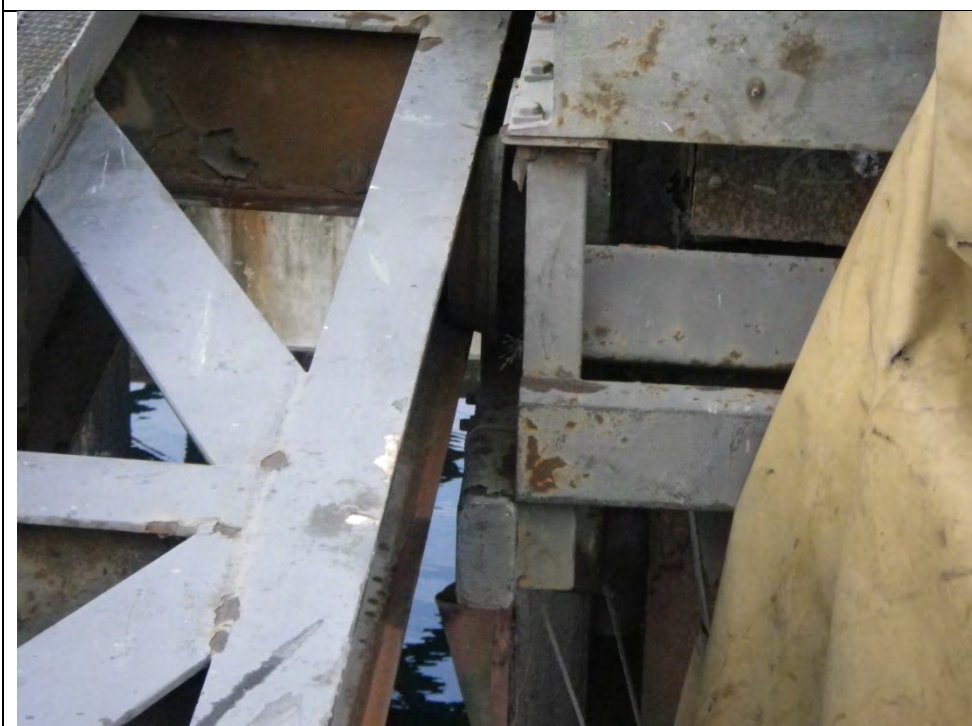
**DESCRIPTION: RIGHT SIDE SHUTTLE SUPPORT BEAM; RIGHT CARRIER WHEEL VISIBLE INSIDE CARRIER BEAM RUNWAY; NOTE WEAR ON BEAM FLANGE AND FLANGE BENT DOWNWARD TO SLOPE OF SHUTTLE WHEEL "TREAD"; FLANGE TO WHEEL FLANGE GAP EXCESSIVE.**

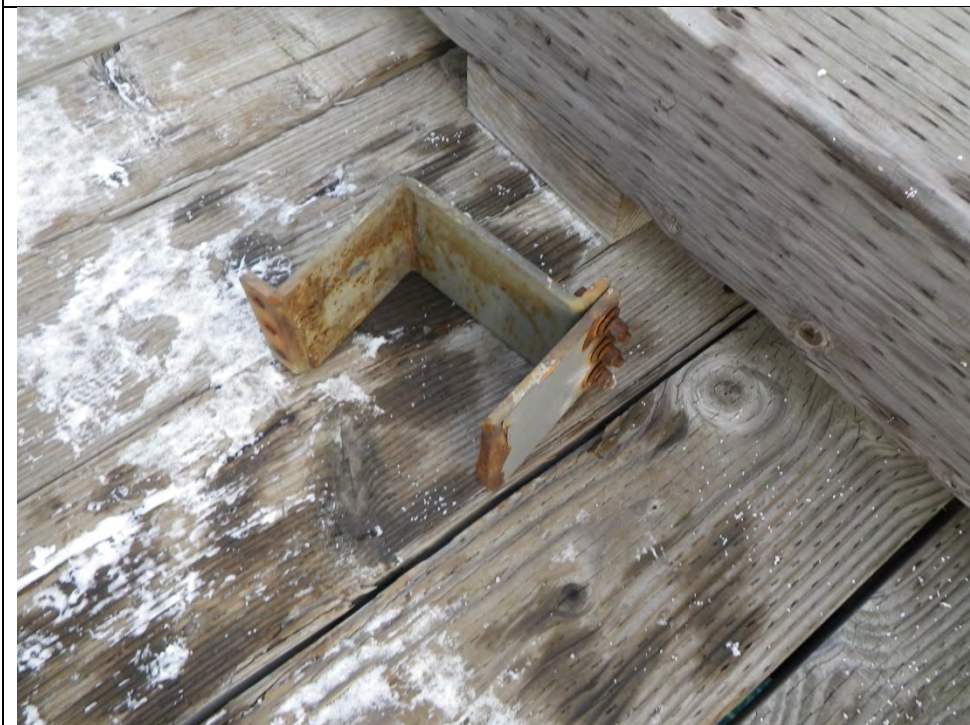
**LOCATION: SKAGWAY ORE TERMINAL SHIP LOADER**

**DESCRIPTION: GANGWAY HANDLING JIB CRANE FAILED BOOM BRACKET**

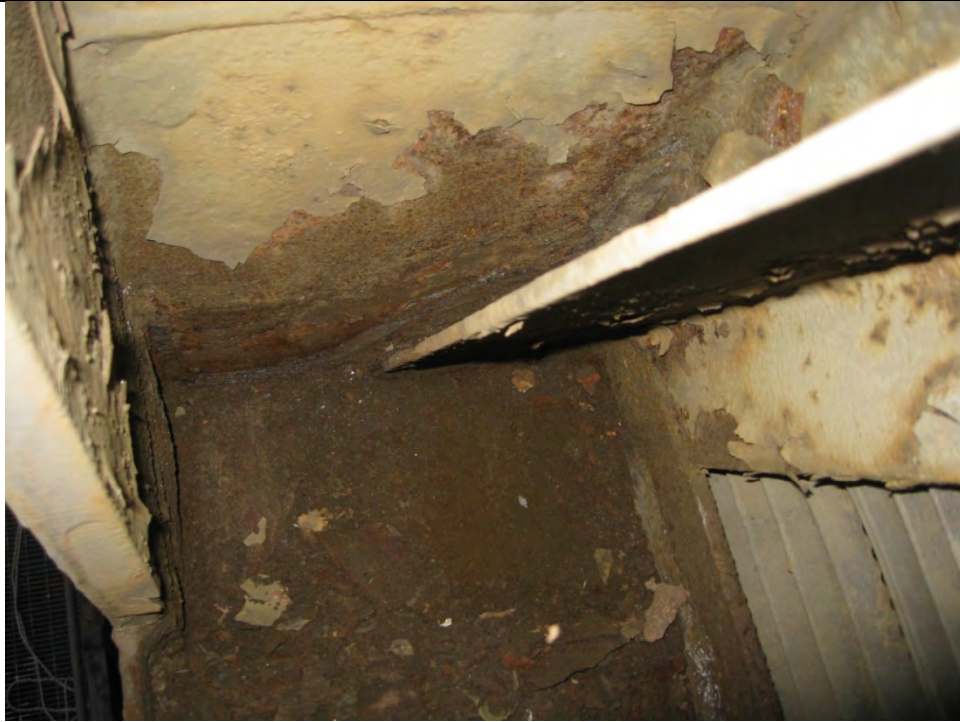
**SH-111213-29 SKAGWAY ORE TERMINAL SHIP LOADER**  
**LOCATION: SHIP LOADER BOOM 12 SOUTH**  
**DESCRIPTION: DIAGONAL DOWN TO 1/8-INCH THICK. 1/32-INCH SECTION LOSS TO MAIN WEB ALONG DIAGONAL WELD. SAME CONDITION AT 12 NORTH.**  
**CONDITION STATE CS5**

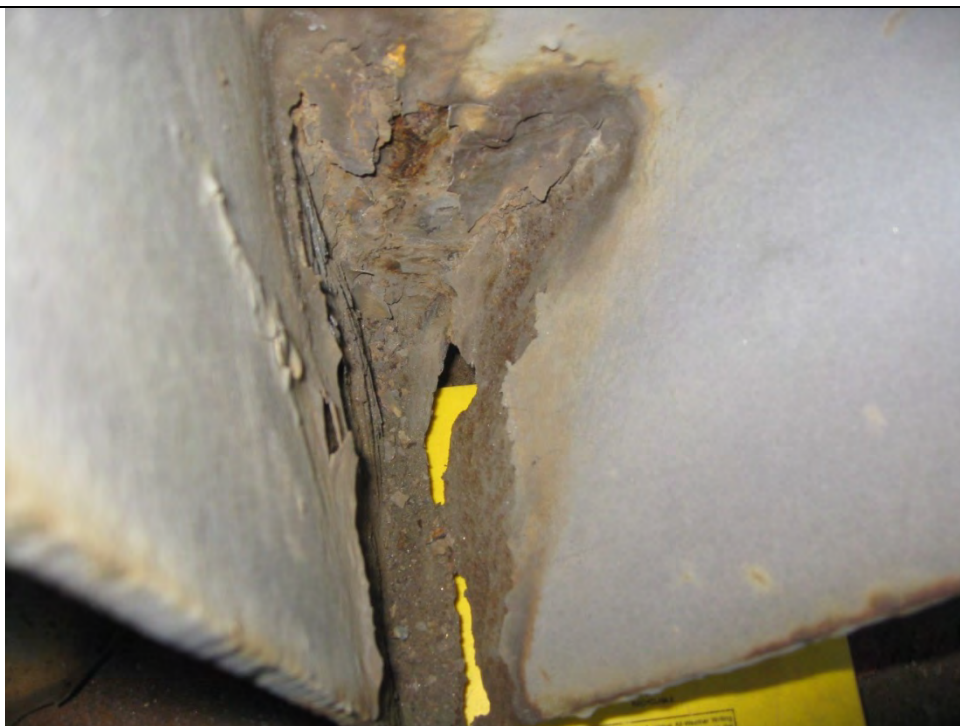
**SH-111213-28 SKAGWAY ORE TERMINAL SHIP LOADER**  
**LOCATION: SHIP LOADER BOOM 11 SOUTH V-BRACE**  
**DESCRIPTION: DIAGONAL RUSTED THROUGH. SAME ON NORTH V-BRACE.**  
**CONDITION STATE CS5**

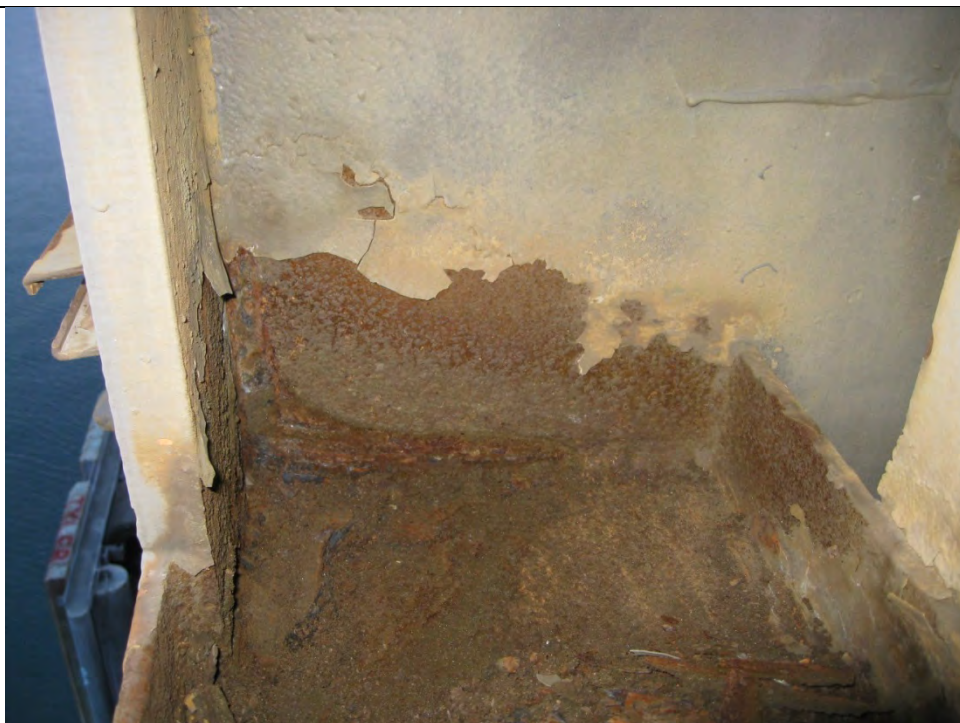
**SH-111213-27 SKAGWAY ORE TERMINAL SHIP LOADER**  
**LOCATION: SHIP LOADER BOOM 11 SOUTH INTERIOR**  
**DESCRIPTION: BOTH WEBS HAVE 1/16-INCH LOSS AREA 8"X2" EACH**  
**CONDITION STATE CS5**

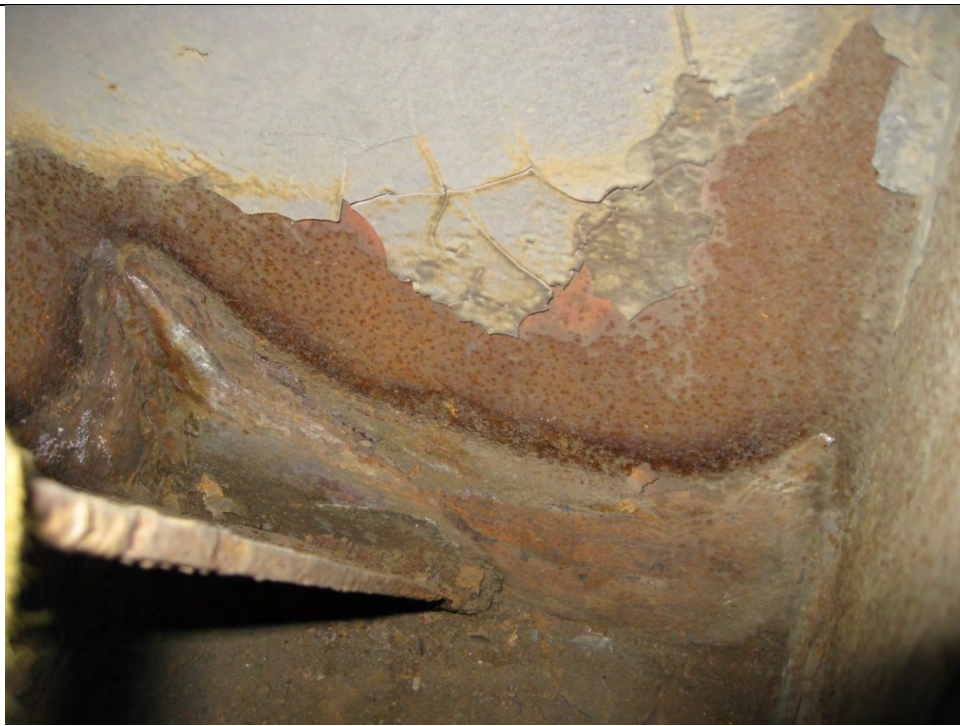
SH-111213-26 SKAGWAY ORE TERMINAL SHIP LOADER

LOCATION: SHIP LOADER BOOM 10 NORTH INTERIOR

DESCRIPTION: DIAGONAL WEB HAS 1/16-INCH REMAINING SECTION. MAIN GIRDER WEB HAS SECTION LOSS TO 1/8-INCH 10" TALL X 4" WIDE. TRANSVERSE WEB HAS SECTION LOSS TO 1/8-INCH 6"X6".

CONDITION STATE CS5

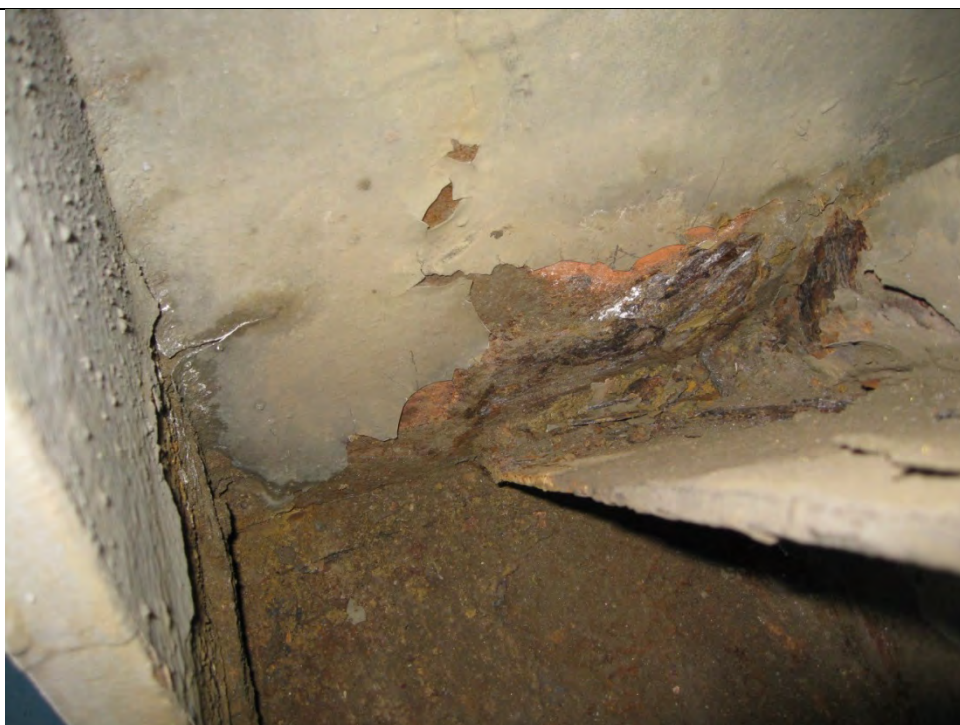
SH-111213-25 SKAGWAY ORE TERMINAL SHIP LOADER

LOCATION: SHIP LOADER BOOM 10 SOUTH INTERIOR

DESCRIPTION: DIAGONAL WEB HAS 3/16-INCH REMAINING SECTION. MAIN GIRDER WEB & TRANSVERSE WEB HAS 1/16-INCH SECTION LOSS 4"X4" EACH.

CONDITION STATE CS5

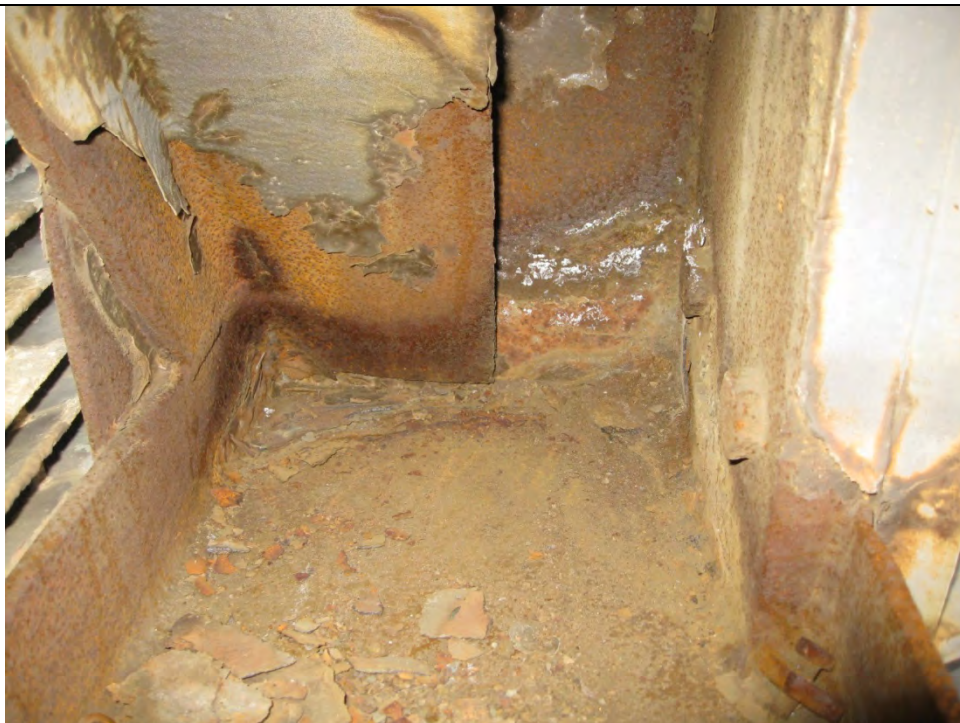
SH-111213-24 SKAGWAY ORE TERMINAL SHIP LOADER

LOCATION: SHIP LOADER BOOM 9 NORTH INTERIOR

DESCRIPTION: DIAGONAL SECTION LOSS TO 1/8-INCH 4"X4" AREA. MAIN WEB SECTION LOSS TO 1/8-INCH 5"X5" AREA.

CONDITION STATE CS5

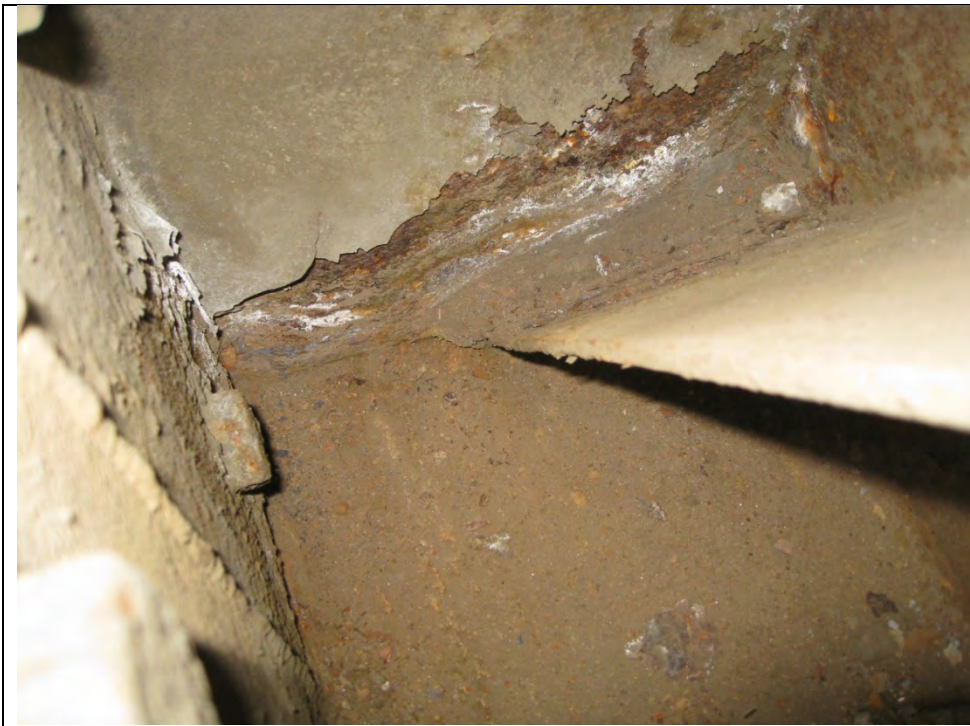
**SH-111213-23 SKAGWAY ORE TERMINAL SHIP LOADER**

**LOCATION: SHIP LOADER BOOM 9 SOUTH INTERIOR**

**DESCRIPTION: DIAGONAL & MAIN GIRDER WEBS WITH SECTION LOSS TO 1/16-INCH IN 2 AREAS EACH 1"X5".**

**CONDITION STATE CS5**

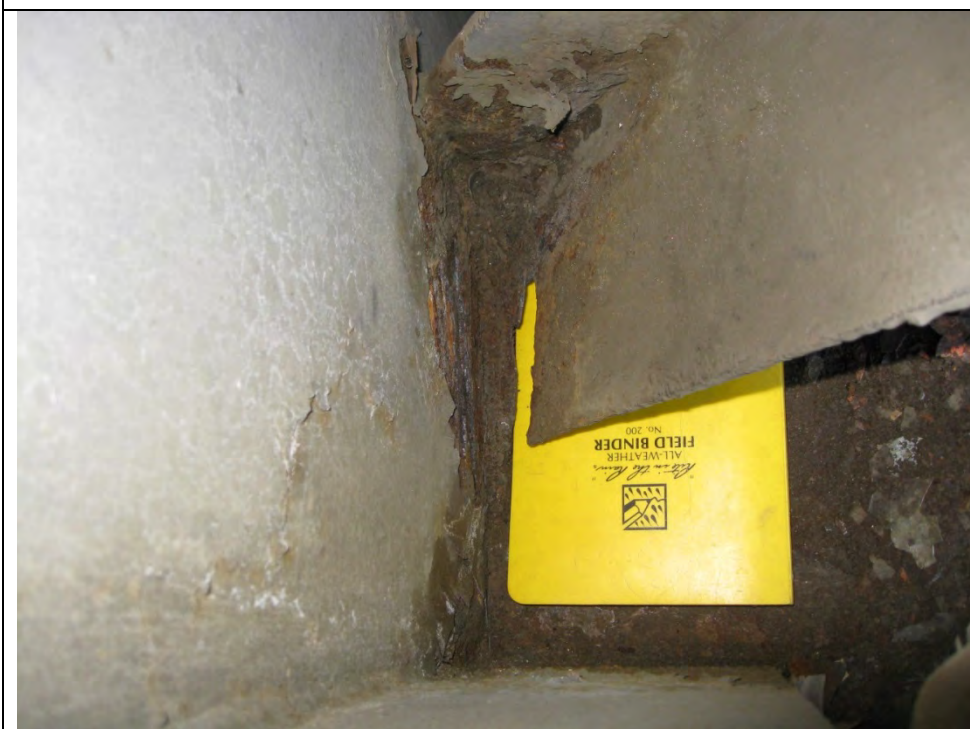
**SH-111213-22 SKAGWAY ORE TERMINAL SHIP LOADER**

**LOCATION: SHIP LOADER BOOM 8 SOUTH INTERIOR**

**DESCRIPTION: DIAGONAL RUSTED THROUGH. MAIN GIRDER WEB WITH SECTION LOSS TO 1/8-INCH | AREA 2"x6". REMAINING WEB SECTION ON THE NORTH SIDE DIAGONAL IS 1/16-INCH (NOT RUSTED ALL THE WAY THROUGH)**

**CONDITION STATE CS5**

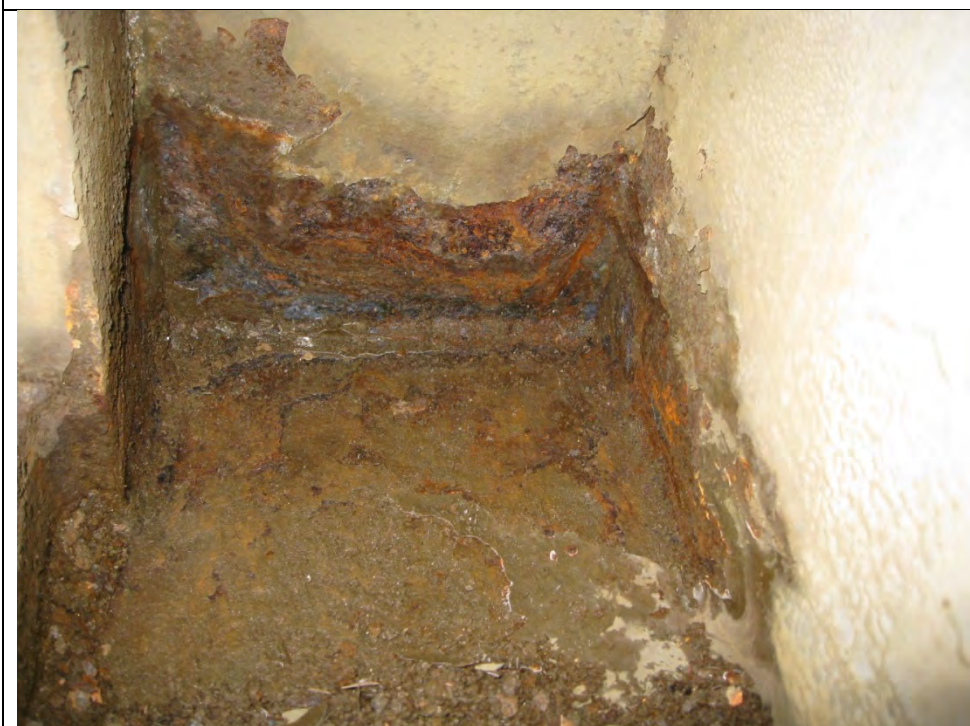
**SH-111213-21 SKAGWAY ORE TERMINAL SHIP LOADER**

**LOCATION: SHIP LOADER BOOM 7 SOUTH**

**DESCRIPTION: SECTION LOSS TO 1/16-INCH IN AREA 8"x8" IN WEB OF BOTH GIRDERS.**

**CONDITION STATE CS5**

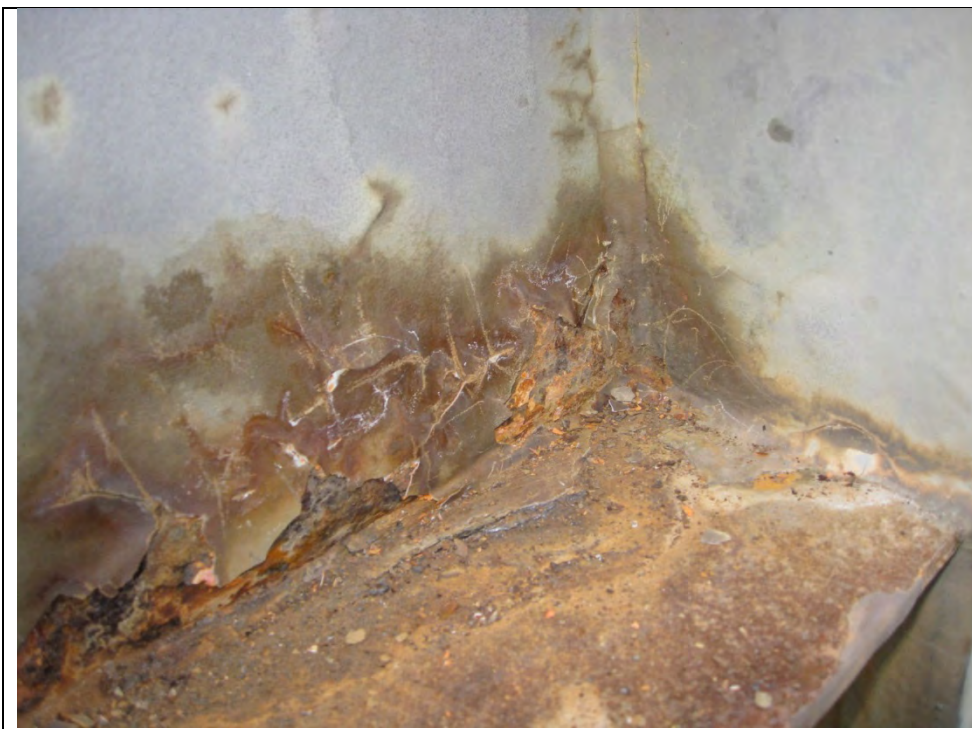
**SH-111213-20 SKAGWAY ORE TERMINAL SHIP LOADER**  
**LOCATION: SHIP LOADER BOOM STIFFENER 1-FOOT TOWARD WATER FROM SPLICE.**

**DESCRIPTION: HEAVY SECTION LOSS AT TRIAXIAL WELD TO 3/16-INCH IN AREA 2"X2".**

**CONDITION STATE CS5**

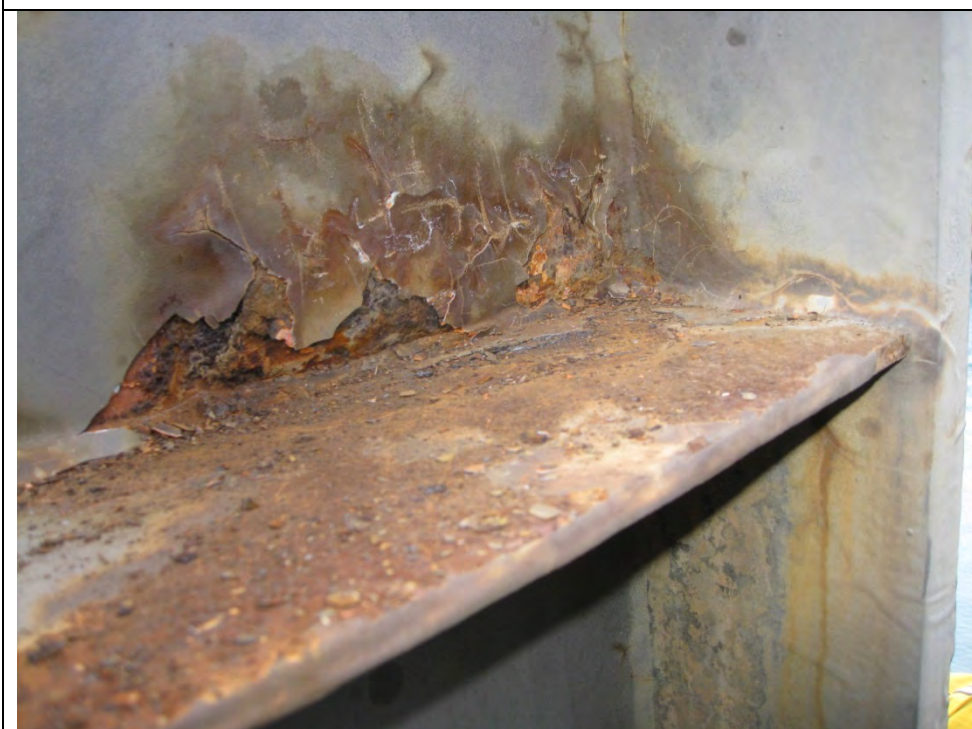
**SH-111213-19 SKAGWAY ORE TERMINAL SHIP LOADER**  
**LOCATION: SHIP LOADER BOOM STIFFENER 1-FOOT TOWARD WATER FROM SPLICE.**

**DESCRIPTION: HEAVY SECTION LOSS AT TRIAXIAL WELD TO 3/16-INCH IN AREA 2"X2".**

**CONDITION STATE CS5**

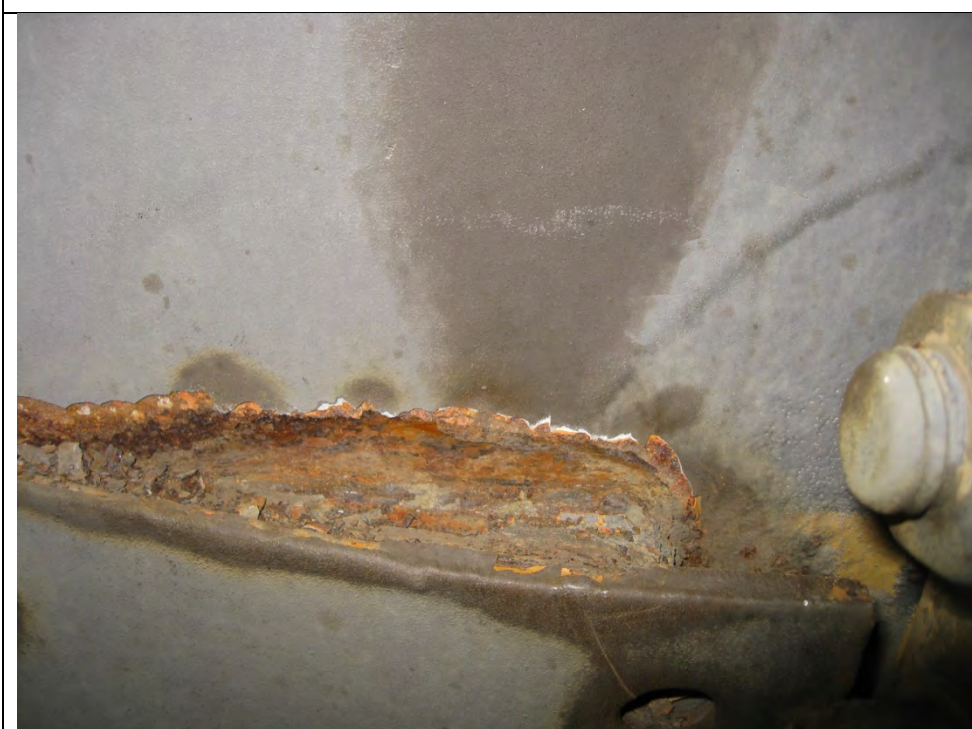
**SH-111213-18 SKAGWAY ORE TERMINAL SHIP LOADER**  
**LOCATION: SHIP LOADER BOOM SPLICE PLATE BETWEEN 6 & 7 NORTH EXTERIOR**

**DESCRIPTION: PACK RUST TO 7/8-INCH ON BOTTOM NEAR FLANGE ON WATER SIDE. MINIMAL ON DOCK/SHORE SIDE.**

**CONDITION STATE CS5**

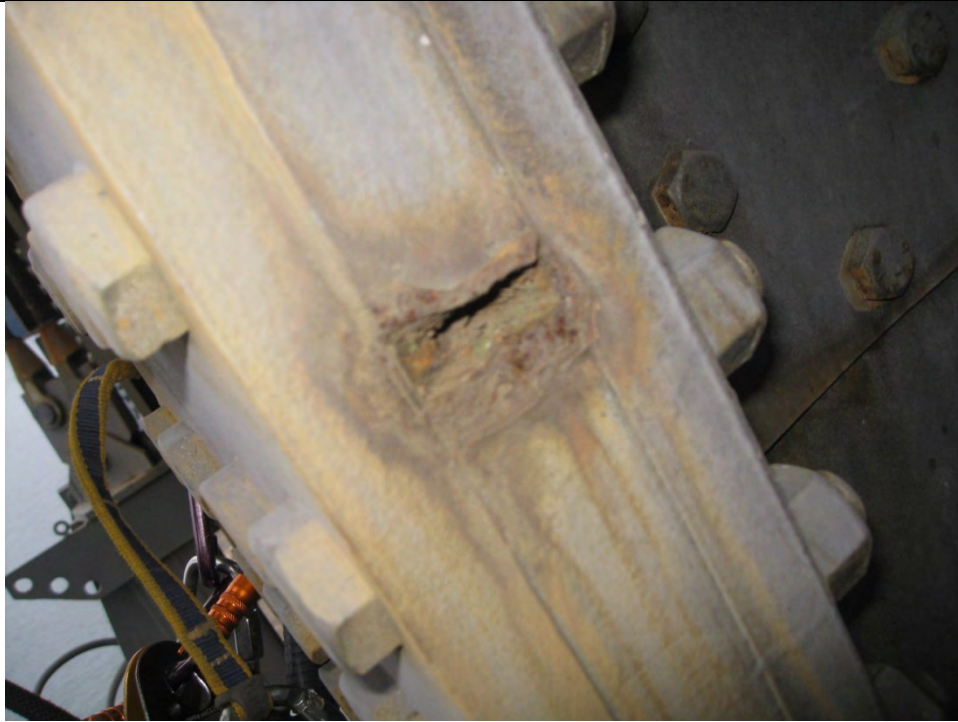
**SH-111213-14 SKAGWAY ORE TERMINAL SHIP LOADER**  
**LOCATION: SHIP LOADER BOOM SPLICE PLATE BETWEEN 6&7 NORTH**

**DESCRIPTION: EXTERIOR BOTTOM FLANGE HAS PACK RUST FORMING.**

**CONDITION STATE CS4**

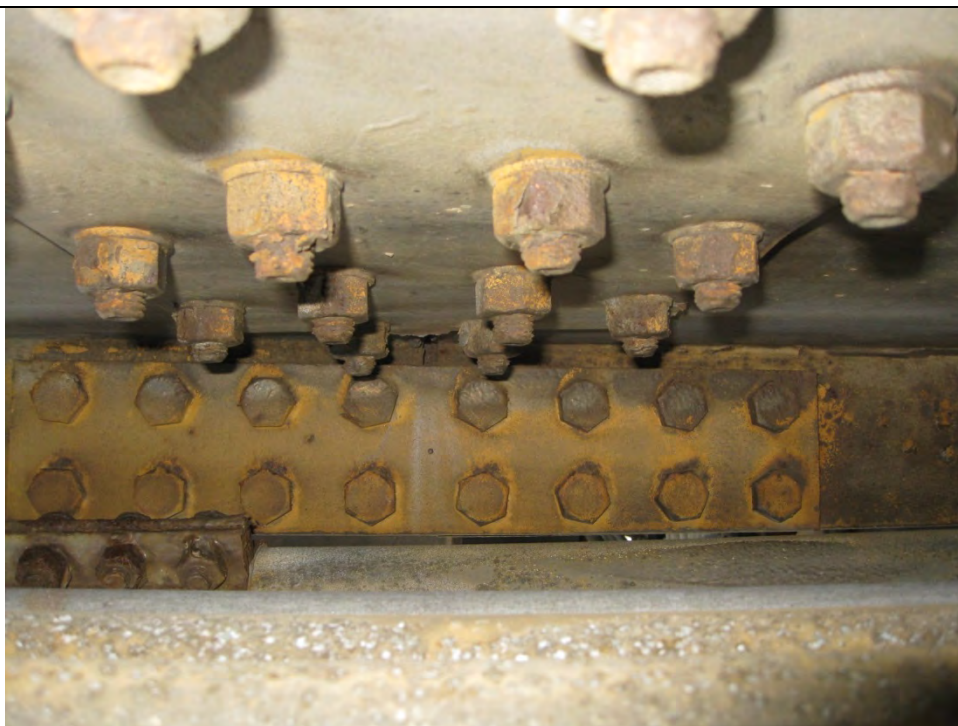
**SH-111213-13 SKAGWAY ORE TERMINAL SHIP LOADER**  
**LOCATION: SHIP LOADER BOOM SPLICE PLATE BETWEEN 6&7 NORTH**

**DESCRIPTION: INTERIOR NUTS RUSTED THROUGHOUT.**

**CONDITION STATE CS4**

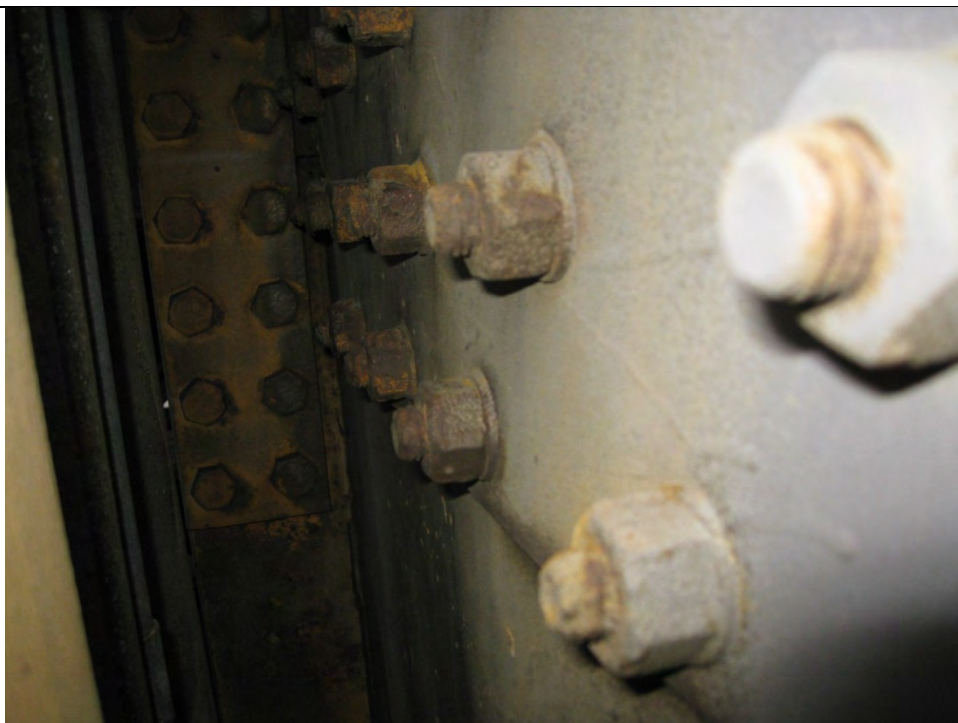
**SH-111213-12 SKAGWAY ORE TERMINAL SHIP LOADER**  
**LOCATION: SHIP LOADER BOOM SPLICE PLATE BETWEEN 6&7 NORTH**

**DESCRIPTION: INTERIOR NUTS RUSTED THROUGHOUT.**

**CONDITION STATE CS4**

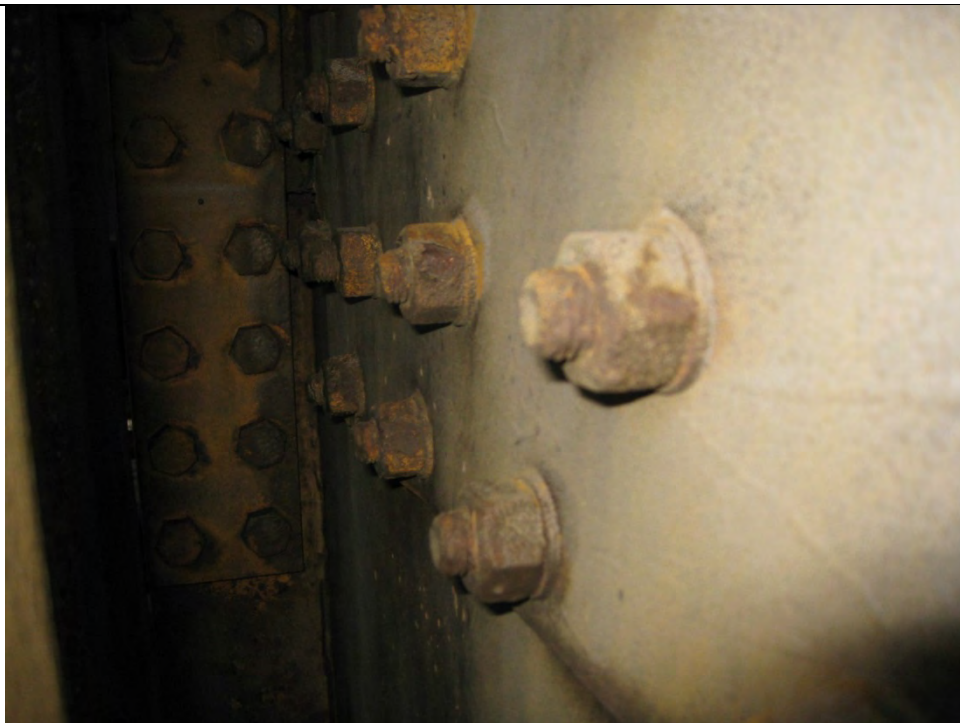
**SH-111213-11 SKAGWAY ORE TERMINAL SHIP LOADER**  
**LOCATION: SHIP LOADER BOOM SPLICE PLATE BETWEEN 6&7 NORTH**  
**DESCRIPTION: INTERIOR NUTS RUSTED THROUGHOUT.**  
**CONDITION STATE CS4**

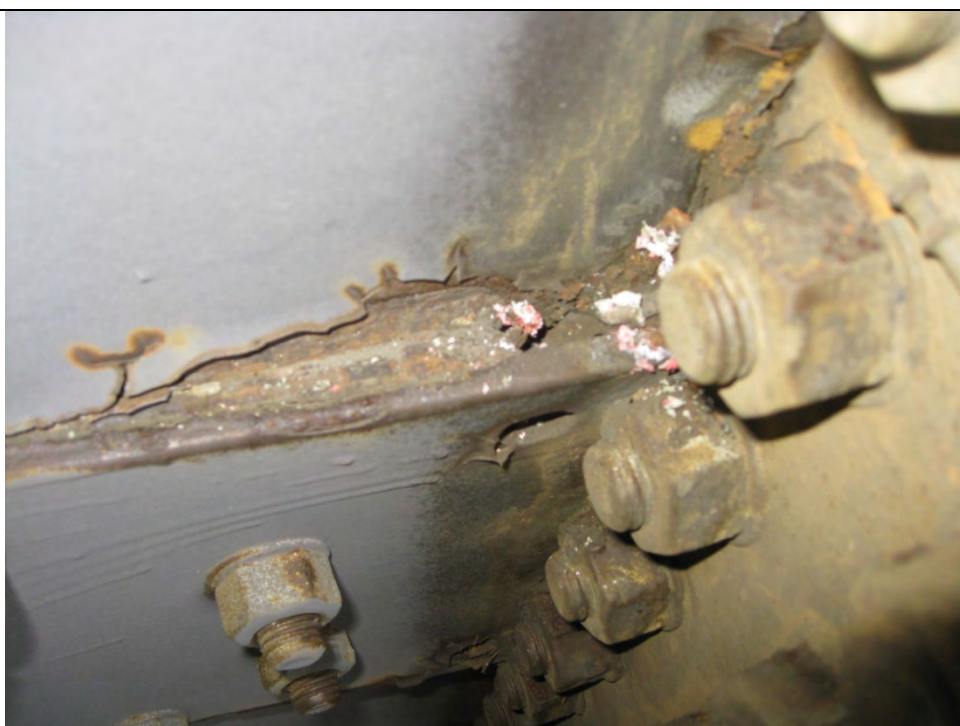
**SH-111213-10 SKAGWAY ORE TERMINAL SHIP LOADER**  
**LOCATION: SHIP LOADER BOOM SPLICE PLATE BETWEEN 6&7 NORTH**  
**DESCRIPTION: PACK RUST TO 1-INCH ON BOTTOM OF SPLICE PLATE BOTH SIDES (STORE WATER SIDE WHEN DOWN. CAN'T MEASURE SECTION LOSS BUT LIKELY TO BE 1/12<sup>TH</sup> OF PACK THICKNESS. SIMILAR PACK RUST OUTBOARD WEB BUT ONLY ON SHORE SIDE!**  
**CONDITION STATE CS4**

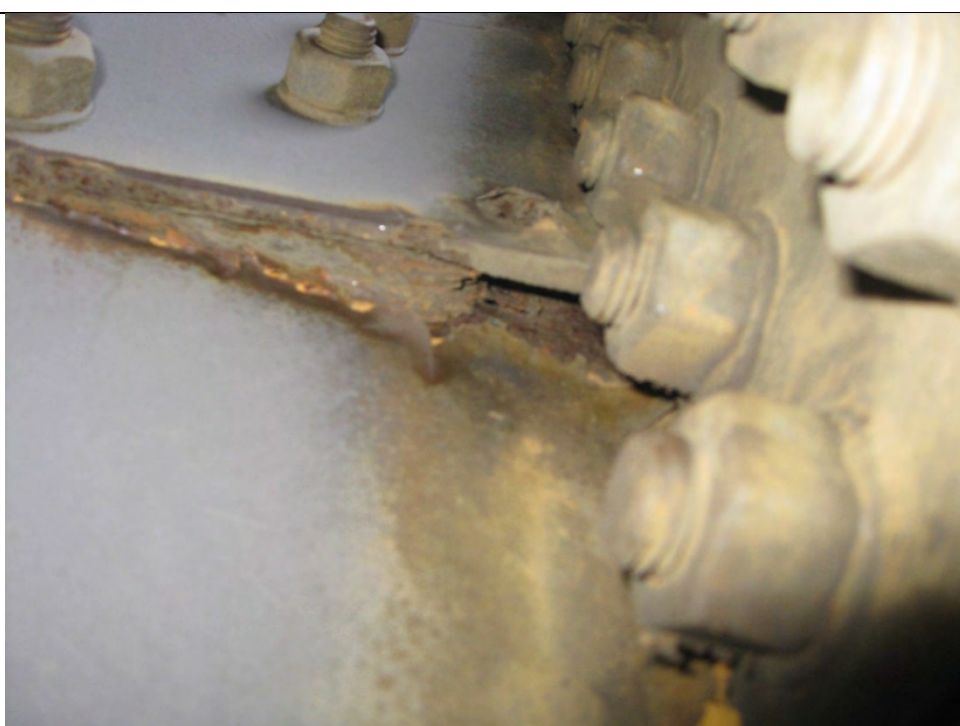
**SH-111213-09 SKAGWAY ORE TERMINAL SHIP LOADER**  
**LOCATION: SHIP LOADER BOOM SPLICE PLATE BETWEEN 6&7 NORTH**  
**DESCRIPTION: PACK RUST TO 1-INCH ON BOTTOM OF SPLICE PLATE BOTH SIDES (STORE WATER SIDE WHEN DOWN. CAN'T MEASURE SECTION LOSS BUT LIKELY TO BE 1/12<sup>TH</sup> OF PACK THICKNESS. SIMILAR PACK RUST OUTBOARD WEB BUT ONLY ON SHORE SIDE!**  
**CONDITION STATE CS4**
