**ALASKA INDUSTRIAL DEVELOPMENT AND EXPORT AUTHORITY**  
**SKAGWAY ORE TERMINAL**  
**SHIP LOADER STRUCTURAL INSPECTION**  
**November 11, 12 and 13, 2013**

**R&M Consultants, Inc.**

December 17, 2013

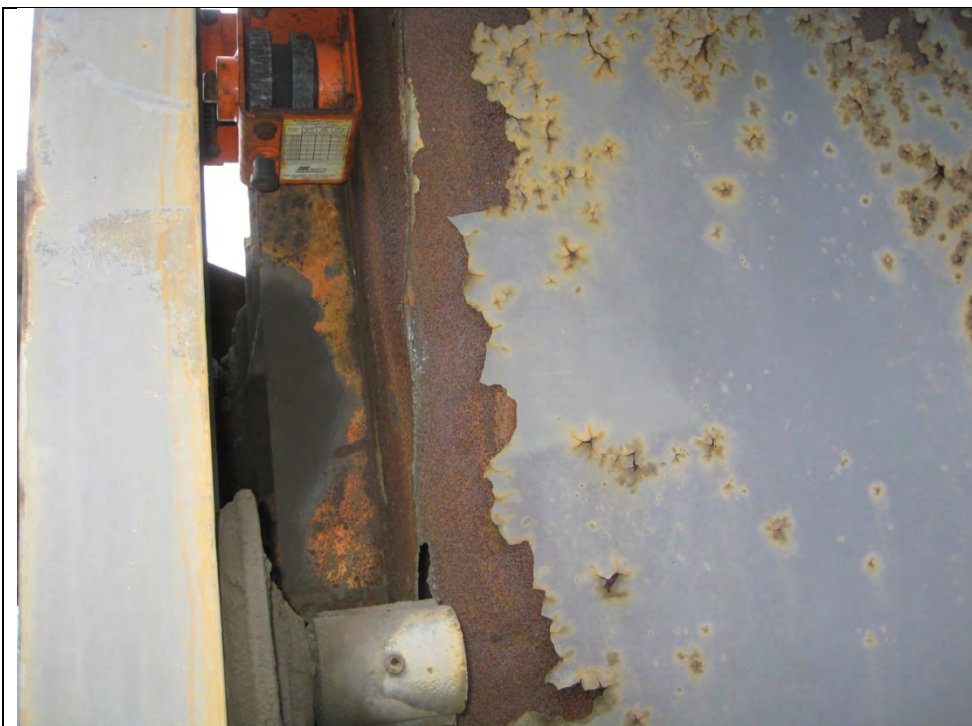
**SH-111213-05 SKAGWAY ORE TERMINAL SHIP LOADER**

**LOCATION: 5 SOUTH UNDERSIDE CHUTE**

**DESCRIPTION: CS4-5, HEAVY SECTION LOSS, HOLES THROUGHOUT.**

**CONDITION STATE CS4/5**

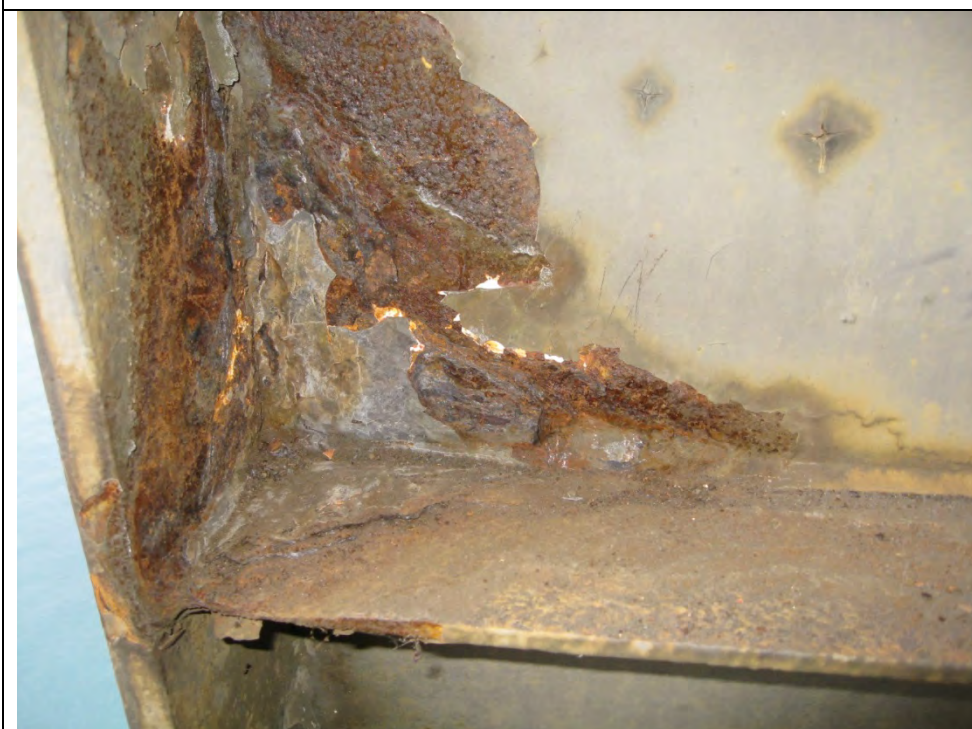
**SH-111213-04 SKAGWAY ORE TERMINAL SHIP LOADER**

**LOCATION: 5 SOUTH**

**DESCRIPTION: SECTION LOSS 3/16-INCH OVER AREA 8"X8". STIFFENER KNIFE EDGE NEAR FLANGE, SECTION LOSS TO STIFFENER, FLANGE & WEB. TYPICAL AT 3 & 4 & 5, NORTH SIDE AT 3, 4 & 5 SECTION LOSS ONLY 1/16-INCH TO 1/8-INCH**

**CONDITION STATE CS5**

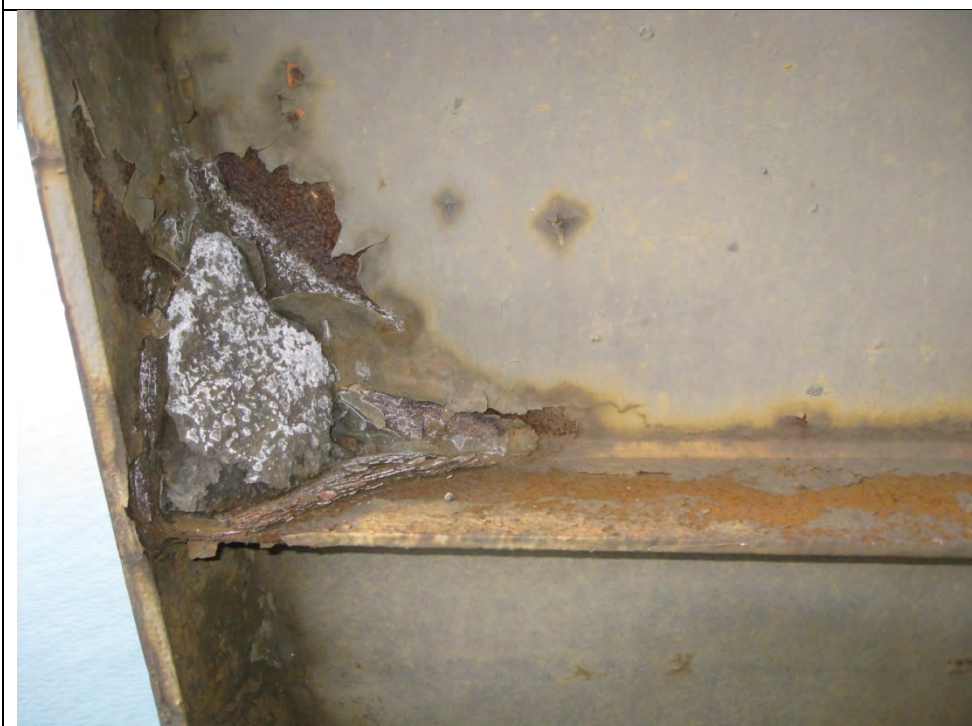
**SH-111213-03 SKAGWAY ORE TERMINAL SHIP LOADER**

**LOCATION: 5 SOUTH**

**DESCRIPTION: SECTION LOSS 3/16-INCH OVER AREA 8"X8". STIFFENER KNIFE EDGE NEAR FLANGE, SECTION LOSS TO STIFFENER, FLANGE & WEB. TYPICAL AT 3 & 4 & 5, NORTH SIDE AT 3, 4 & 5 SECTION LOSS ONLY 1/16-INCH TO 1/8-INCH**

**CONDITION STATE CS4/5**

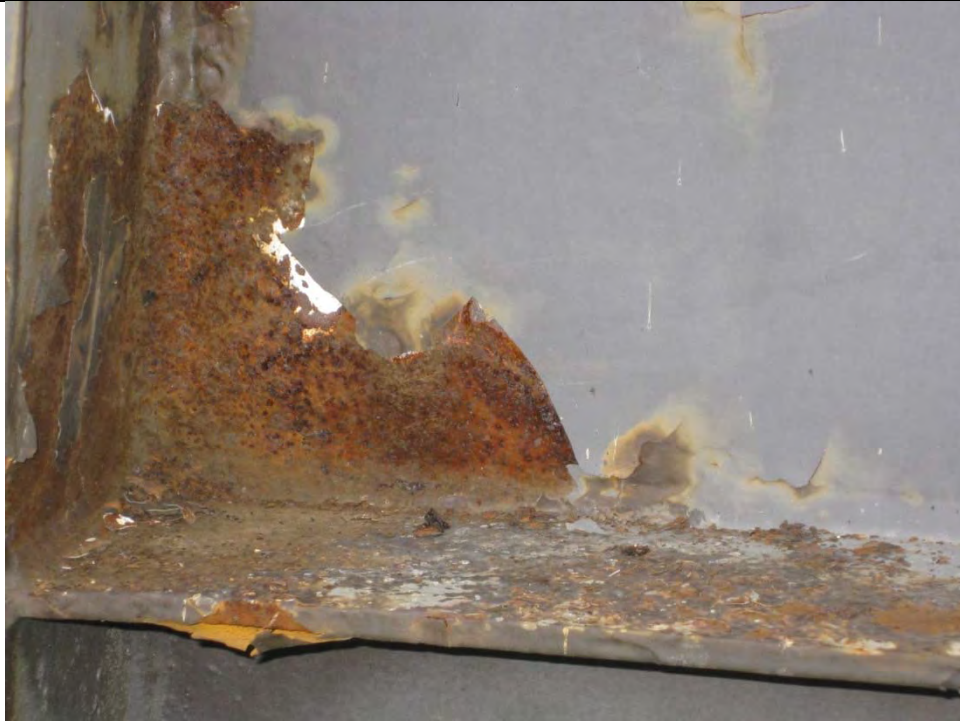
**SH-111213-02 SKAGWAY ORE TERMINAL SHIP LOADER**  
**LOCATION: 2 SOUTH**  
**DESCRIPTION: CS 4 OR 5. SECTION LOSS 1/16-INCH TO 1/8-INCH IN AREA 6'X6". TYPICAL OF ALL INTERSECTIONS NORTH AND SOUTH SIDES. LOADER STORED IN UPRIGHT POSITION RESULTS IN TRAPPED WATER AT JOINTS.**  
**CONDITION STATE CS3/4**

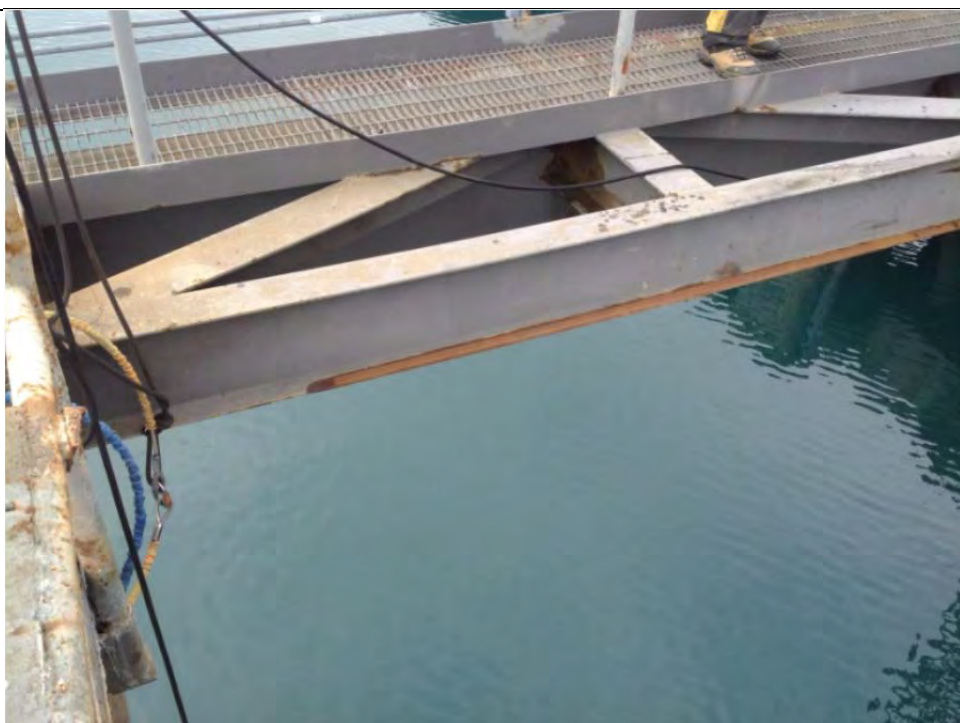
**LG-111213-01 SKAGWAY ORE TERMINAL SHIP LOADER**  
**LOCATION: SKAGWAY ORE TERMINAL SHIP LOADER BOOM**  
**DESCRIPTION: SHUTTLE DISCHARGE SPOUT CARRIER RUNWAY/TRACK. NOTE BENT FLANGE IN I-BEAM TRACK AND COATING LOSS UNDER WHEEL.**

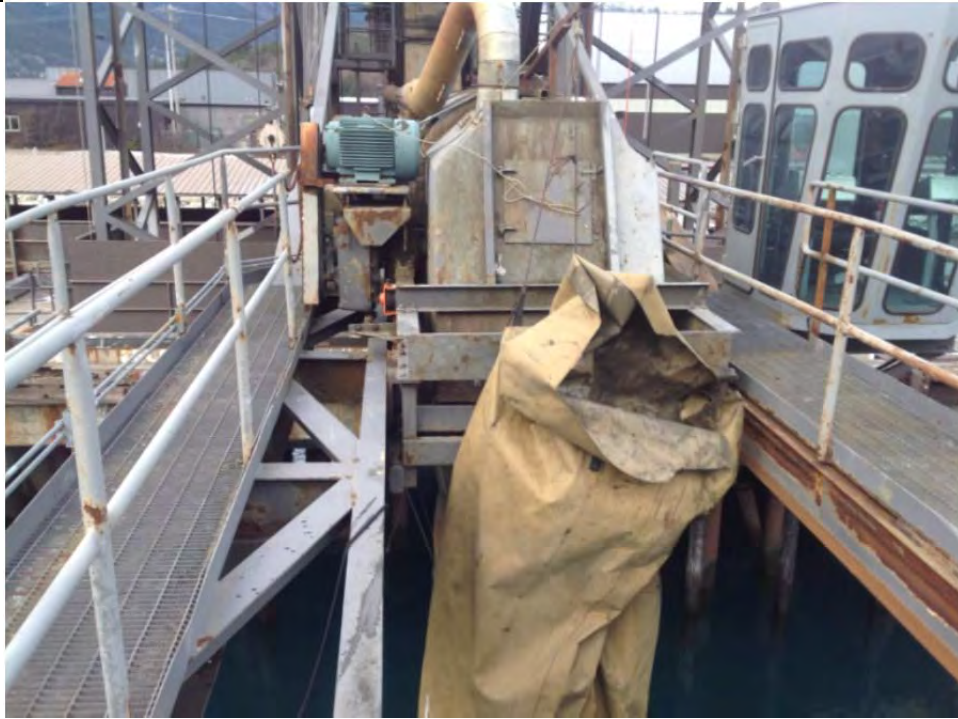
**LG-111213-02 SKAGWAY ORE TERMINAL SHIP LOADER**  
**LOCATION: SKAGWAY ORE TERMINAL SHIP LOADER BOOM**

**DESCRIPTION: SHUTTLE SLOT IN SHIP LOADER BOOM FOR DISCHARGE SPOUT. NOTE CARRIER RUNWAY/TRACK I-BEAM EACH SIDE OF SLOT. NOTE WEAR ON NORTH I- BEAM TRACK AND COATING LOSS UNDER WHEEL.**

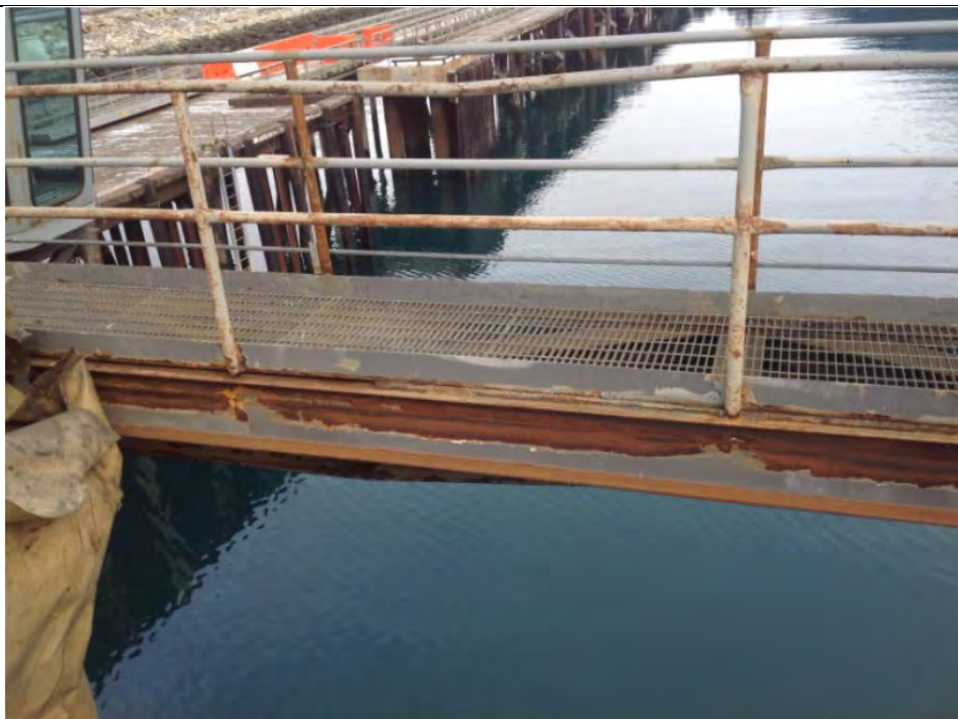
**LG-111213-03 SKAGWAY ORE TERMINAL SHIP LOADER**  
**LOCATION: SKAGWAY ORE TERMINAL SHIP LOADER BOOM**

**DESCRIPTION: SHUTTLE SLOT IN SHIP LOADER BOOM FOR DISCHARGE SPOUT. NORTH CARRIER RUNWAY/TRACK I-BEAM, NOTE WEAR OF I- BEAM FLANGE (TRACK) AND WEB AND COATING LOSS ON TOP FLANGE, INSIDE BOTTOM FLANGE AND WEB.**

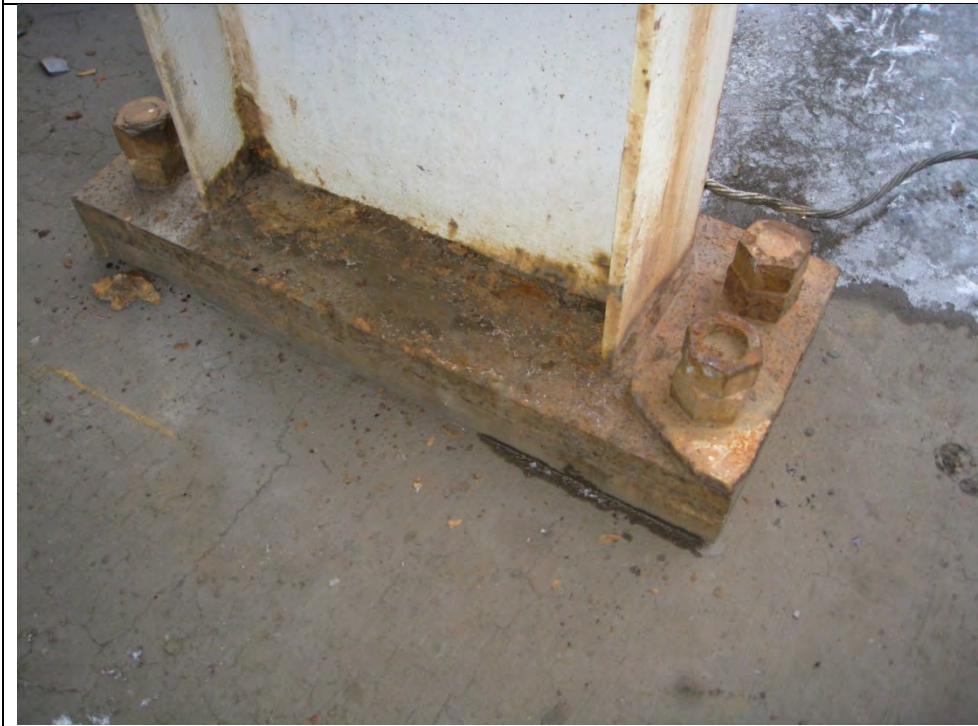
**SH-111313-17 SKAGWAY ORE TERMINAL SHIP LOADER**  
**LOCATION: SHIP LOADER TOWER S/NW FOOTING**

**DESCRIPTION: FOOTING PLATE & WEB & FLANGES CS3 UNDER FAILED PAINT. HOLD DOWN BOLTS TOO SHORT FOR LOCK NUT.**

**CONDITION STATE CS3**

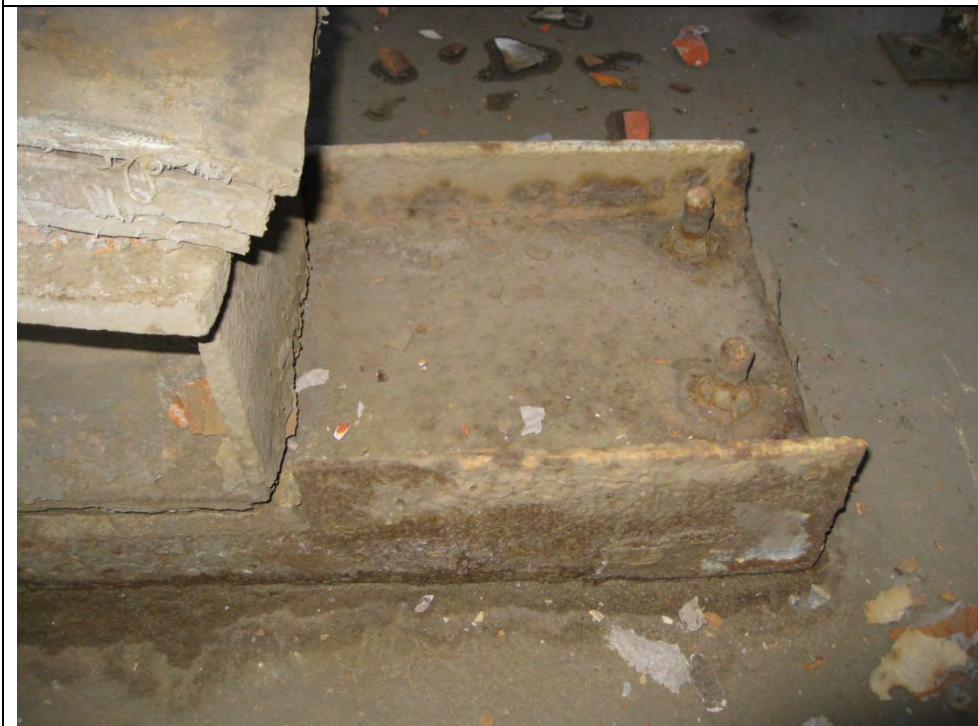
**SH-111313-16 SKAGWAY ORE TERMINAL SHIP LOADER**  
**LOCATION: SHIP LOADER TOWER N BOOM STOP/PARKING STOOL**

**DESCRIPTION: HOLD DOWN NUTS WITH 95% SECTION LOSS! SOUTH BOOM STOP/PARKING STOOL IN SIMILAR CONDITION WITH 75% SECTION LOSS.**

**CONDITION STATE CS4/5**

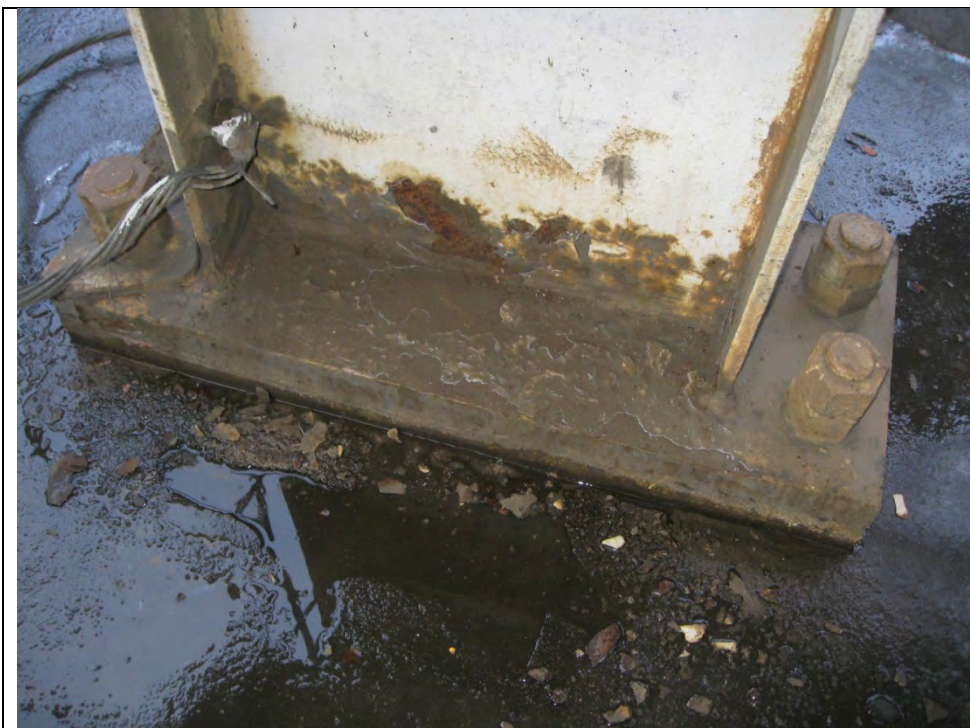
SH-111313-15 SKAGWAY ORE TERMINAL SHIP LOADER

LOCATION: SHIP LOADER TOWER N/SW FOOTING

DESCRIPTION: WEB CS4 IN 4"X4" AREA

CONDITION STATE CS4

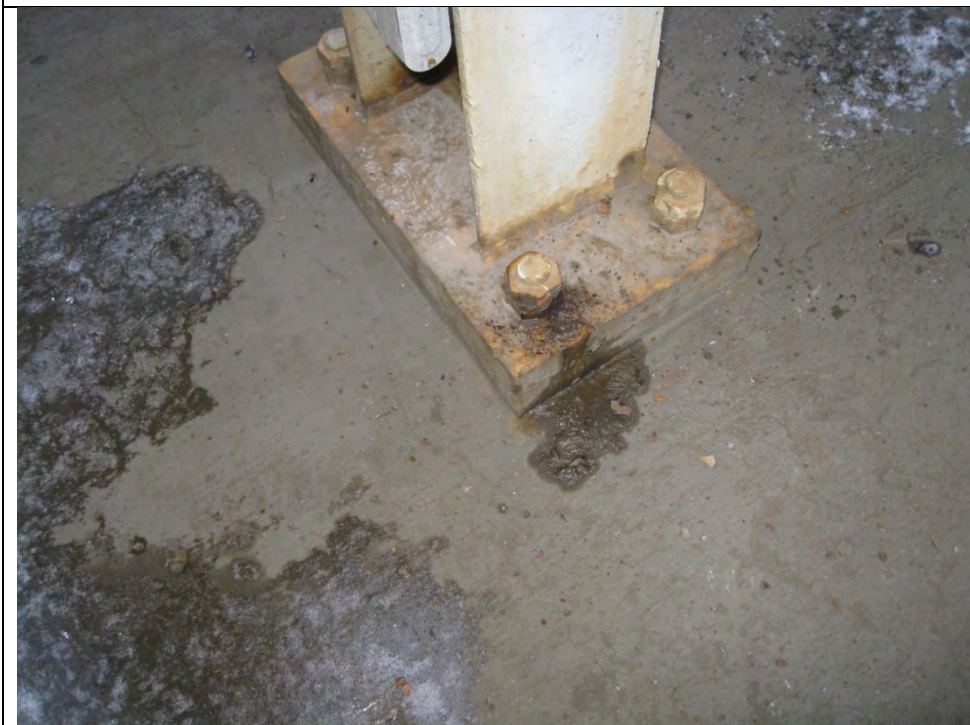
SH-111313-14 SKAGWAY ORE TERMINAL SHIP LOADER

LOCATION: SHIP LOADER TOWER N/NE FOOTING

DESCRIPTION: HOLDOWN NUT NW IS CS4. PLATE IS CS3. N/NW HOLD DOWN (BASE) PLATE IS IN CS4 WITH FAILED JOINT AND SECTION LOSS 1/16-INCH.

CONDITION STATE CS3/4

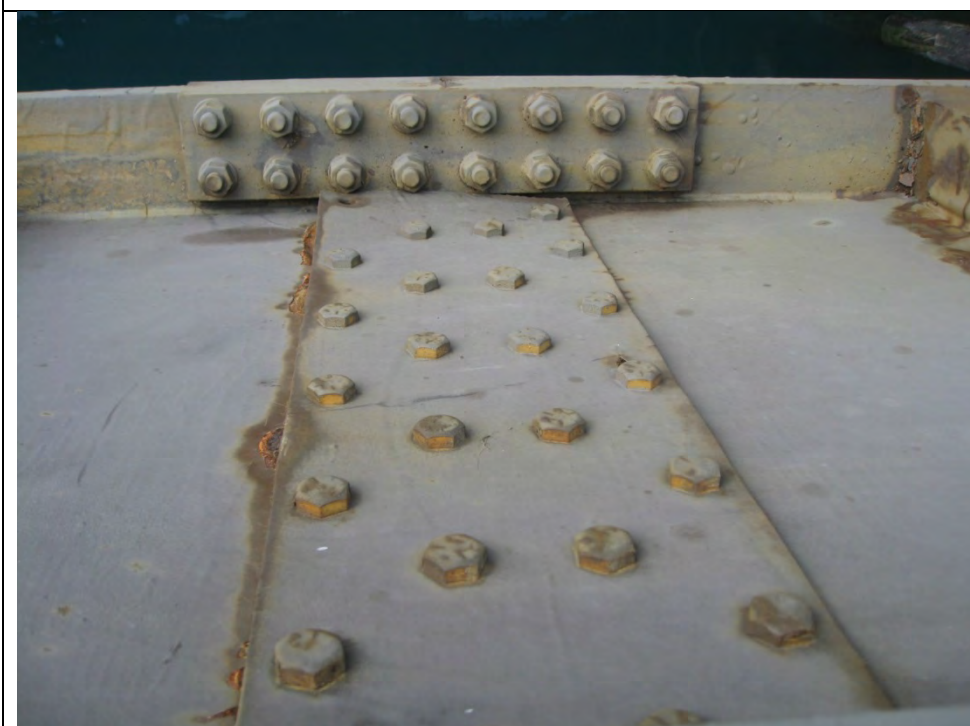
SH-111313-13 SKAGWAY ORE TERMINAL SHIP LOADER

LOCATION: SHIP LOADER BOOM SPLICE SOUTH EXTERIOR & TOP OF BOTTOM FLANGE,

DESCRIPTION: VIEW OF SPLICE PLATE CS2 SAVE FOR PACK RUST NEAR BOTTOM FLANGE NOTED IN PHOTOS 11/12/13,

CONDITION STATE CS2

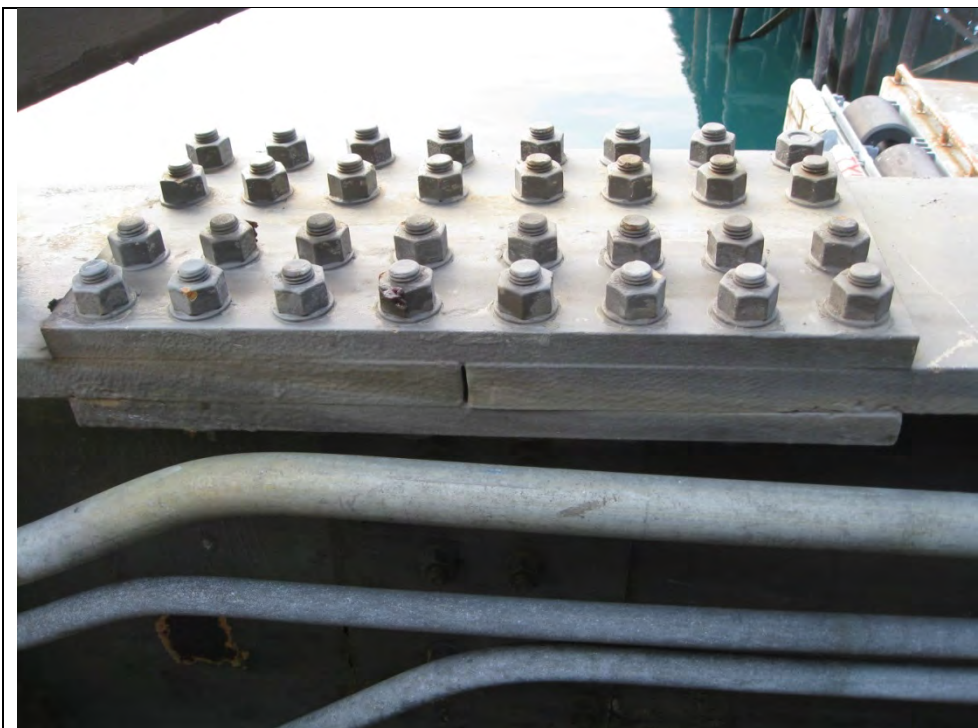
**SH-111313-12 SKAGWAY ORE TERMINAL SHIP LOADER**  
**LOCATION: SHIP LOADER BOOM GIRDER SPLICE TOP OF TOP FLANGE**  
**DESCRIPTION: VIEW OF SPLICE PLATE CS2**  
**CONDITION STATE CS2**

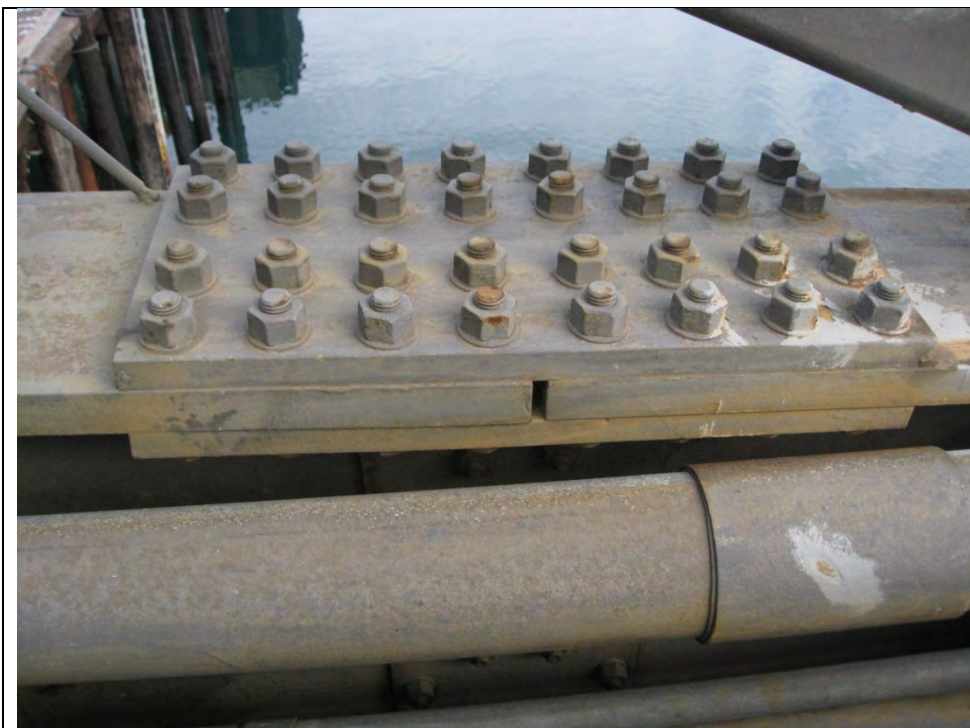
SH-111313-09 SKAGWAY ORE TERMINAL SHIP LOADER

LOCATION: SHIP LOADER BOOM SPLICE NORTH TOP

DESCRIPTION:VIEW OF GIRDER FLANGE SPLICE PLATE. CS2.

CONDITION STATE CS2

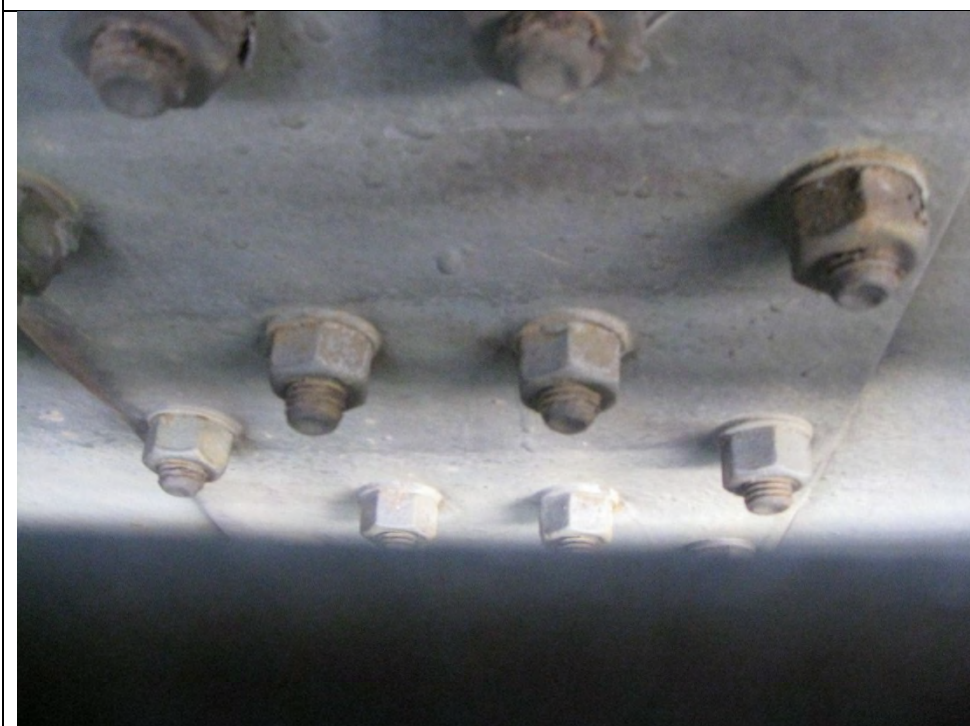
SH-111313-08 SKAGWAY ORE TERMINAL SHIP LOADER

LOCATION: SHIP LOADER BOOM SPLICE NORTH INTERIOR

DESCRIPTION:VIEW OF SPLICE PLATE , CS2 EXCEPT FOR PACK RUST NEAR LOWER FLANGE, SEE PHOTOS FROM 11/12/13.

CONDITION STATE CS2/3

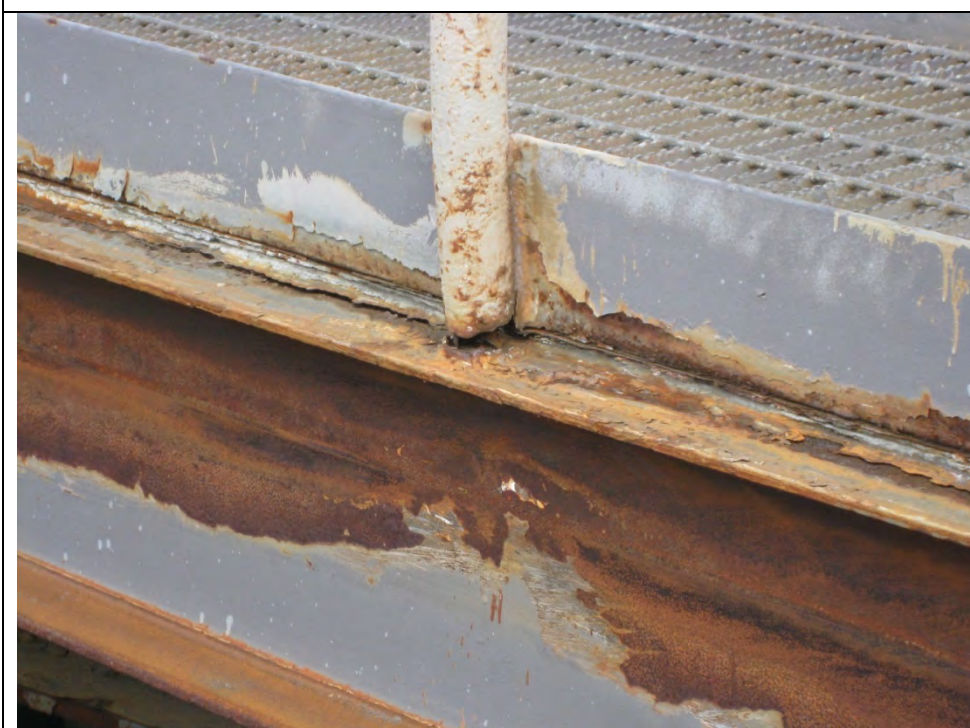
SH-111313-07 SKAGWAY ORE TERMINAL SHIP LOADER

LOCATION: SHIP LOADER BOOM 2 NORTH INTERIOR

DESCRIPTION: HAND RAIL BASE HAS RUSTED THROUGH. VERY COMMON, 25% OF BASES ON BOOM HANDRAILS HAVE SIMILAR FAILURES. RUSTED FLANGE AT BOTTOM OF BEAM IS SHUTTLE RUNWAY AND RUSTED WEB IS WHERE SHUTTLE CARRIER WHEEL RUBS ON WEB.

CONDITION STATE CS3 SHUTTLE WHEEL RUNWAY

CONDITION STATE CS5 HANDRAIL

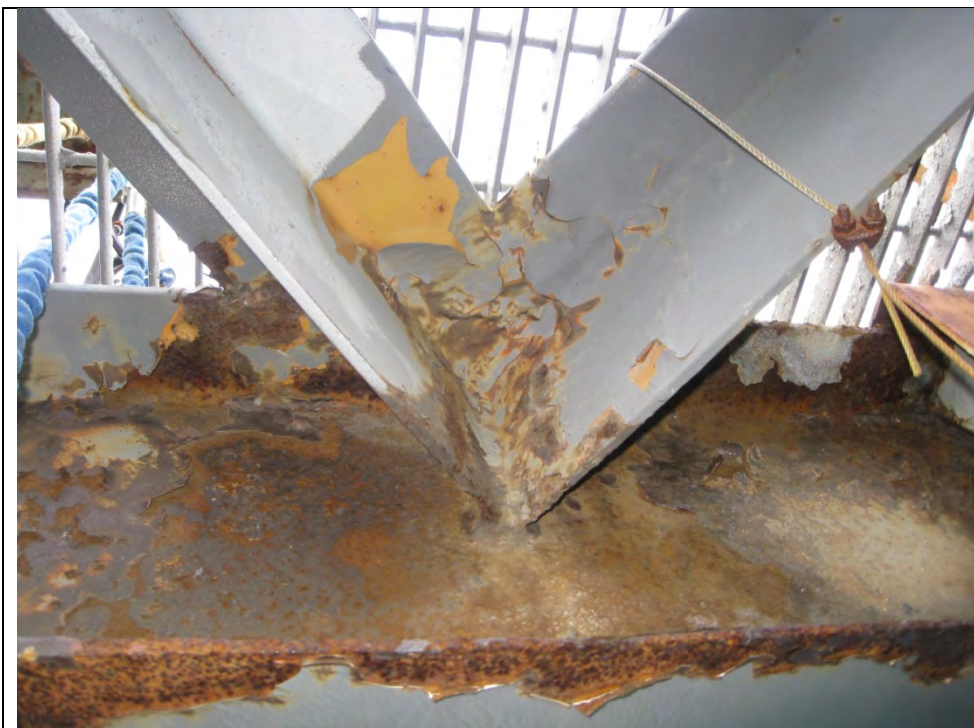
**SH-111313-06 SKAGWAY ORE TERMINAL SHIP LOADER**  
**LOCATION: SHIP LOADER 1 NORTH INTERIOR**

**DESCRIPTION: V-BRACE WEBS WITH REMAINING SECTION = 1/8-INCH AT WELD LINE**

**CONDITION STATE CS2/3**

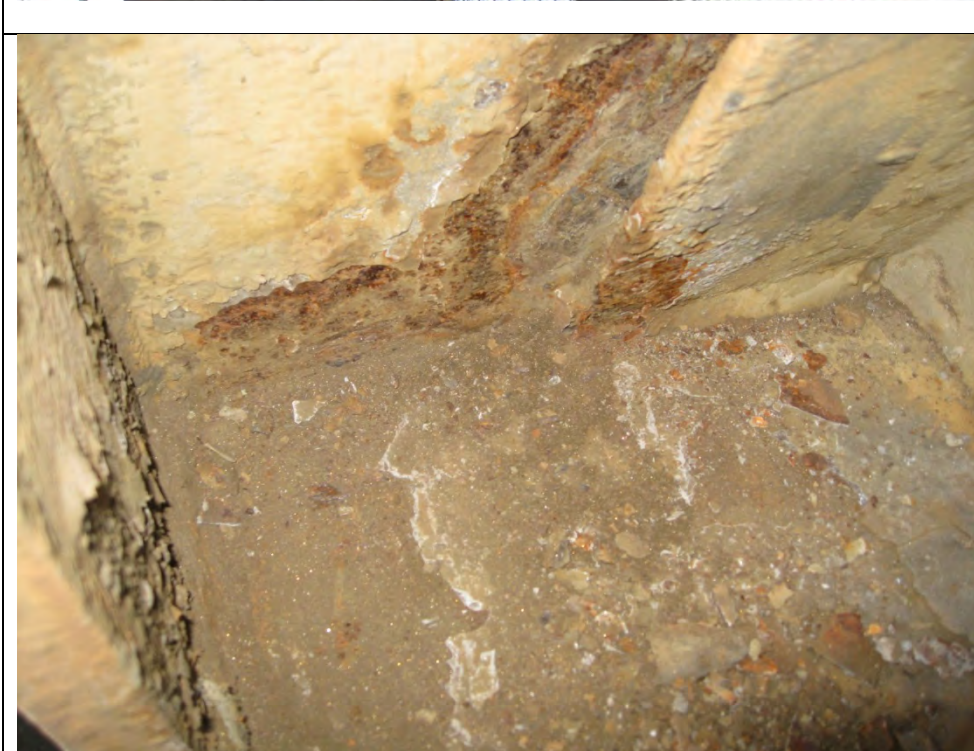
**SH-111313-03 SKAGWAY ORE TERMINAL SHIP LOADER**  
**LOCATION: SHIP LOADER BOOM 14 SOUTH OUTBOARD**

**DESCRIPTION: WEB OF DIAGONAL (CS5) IS 1/16-INCH REAR TOE OR BOTTOM OF WEB. 14 NORTH IS 3/16-INCH IN SAME LOCATION. MAIN GIRDER WEB & TRANSVERSE WEB BOTH HAVE SECTION LOSS TO 1/32-INCH GENERALLY (CS4)**

**CONDITION STATE CS 5**

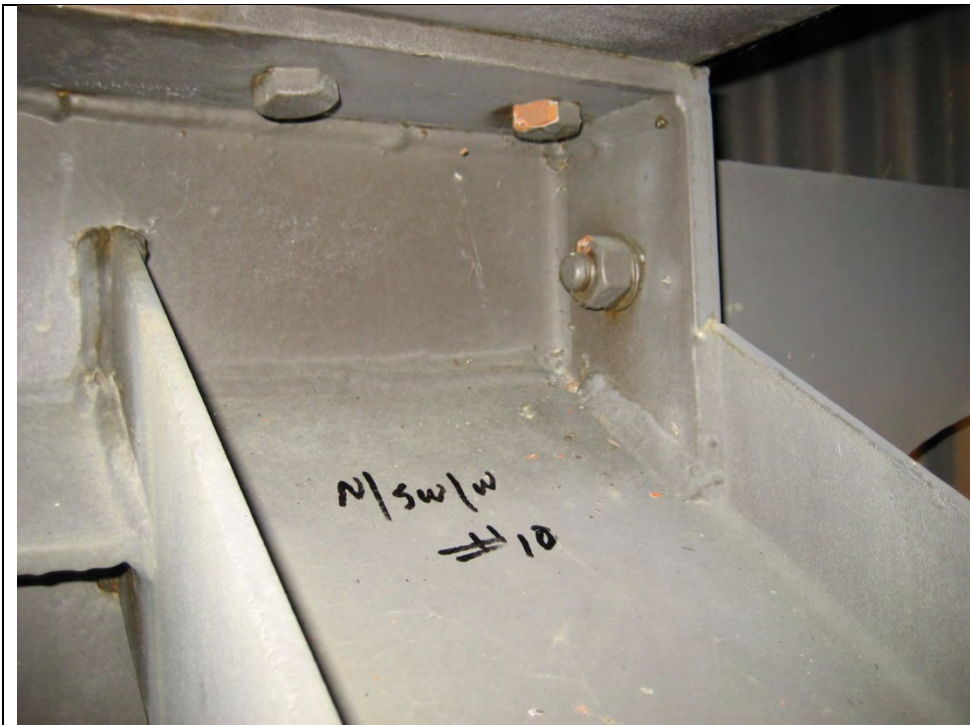
PF-111213-35 SKAGWAY ORE TERMINAL SHIP LOADER  
LOCATION: NORTH SHIP LOADER TOWER SW LEG WEST FACE  
#10 N/SW/W #10

DESCRIPTION: NSD

CONDITION STATE CS2

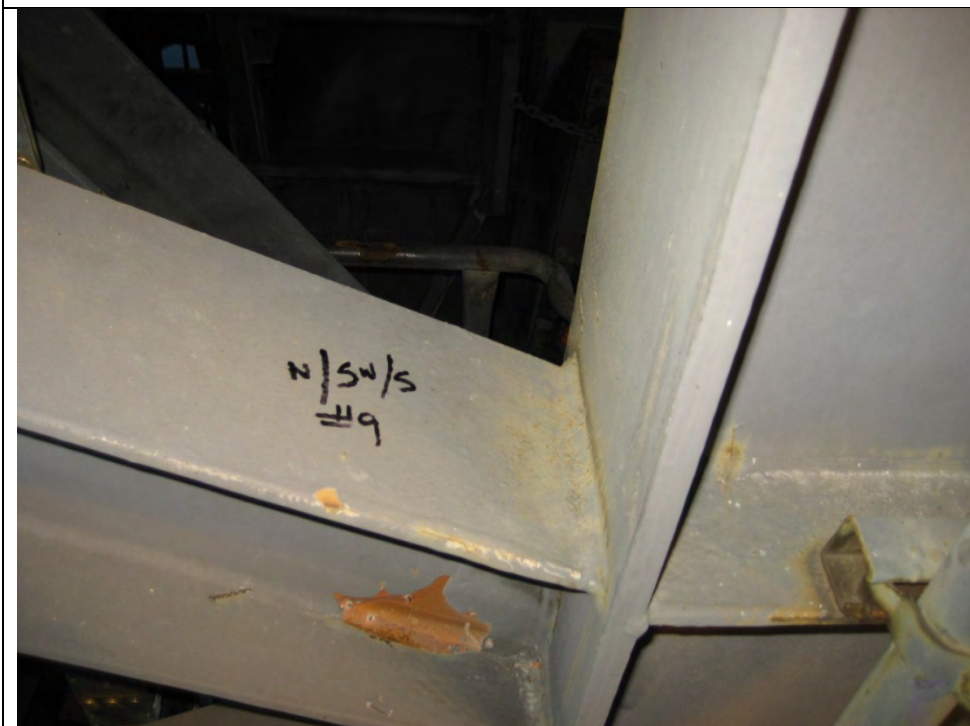
PF-111213-34 SKAGWAY ORE TERMINAL SHIP LOADER  
LOCATION: NORTH SHIP LOADER TOWER SW LEG SOUTH FACE  
#9 N/SW/S #9

DESCRIPTION: LIGHT PAINT FAILURE, LIGHT SURFACE RUST,  
NSD

CONDITION STATE CS2

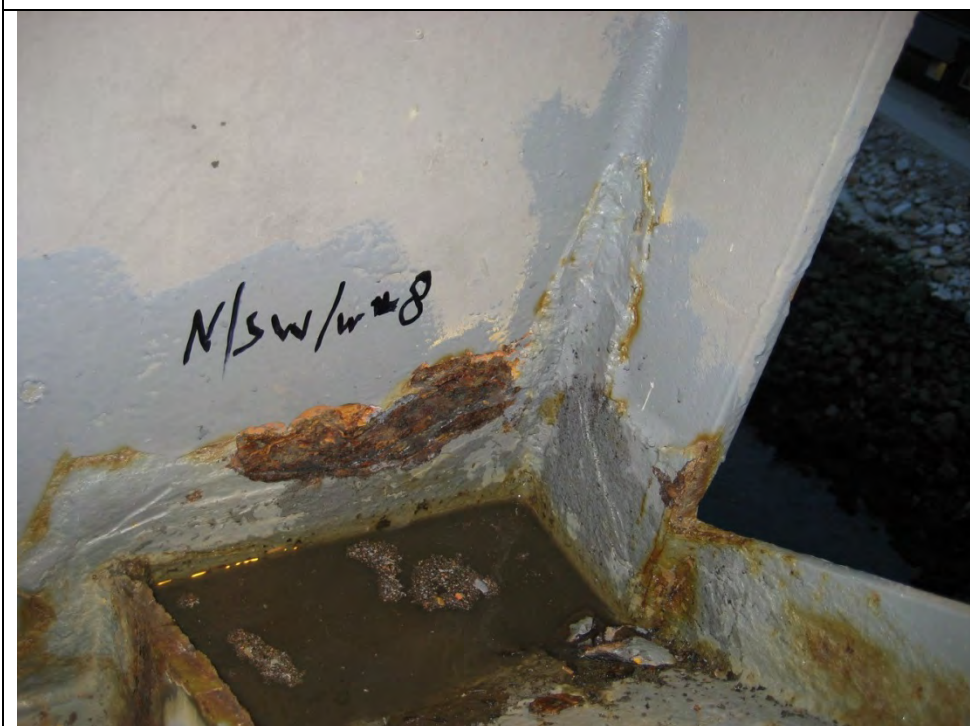
PF-111213-33 SKAGWAY ORE TERMINAL SHIP LOADER  
LOCATION: NORTH SHIP LOADER TOWER SW LEG WEST FACE  
#8 N/SW/W #8

DESCRIPTION: POOLING WATER, LAMINAR RUST ABOUT 2/4-  
INCH, MINOR SECTION LOSS VISABLE ALONG EDGES ABOUT  
1/8-INCH.

CONDITION STATE CS4/5

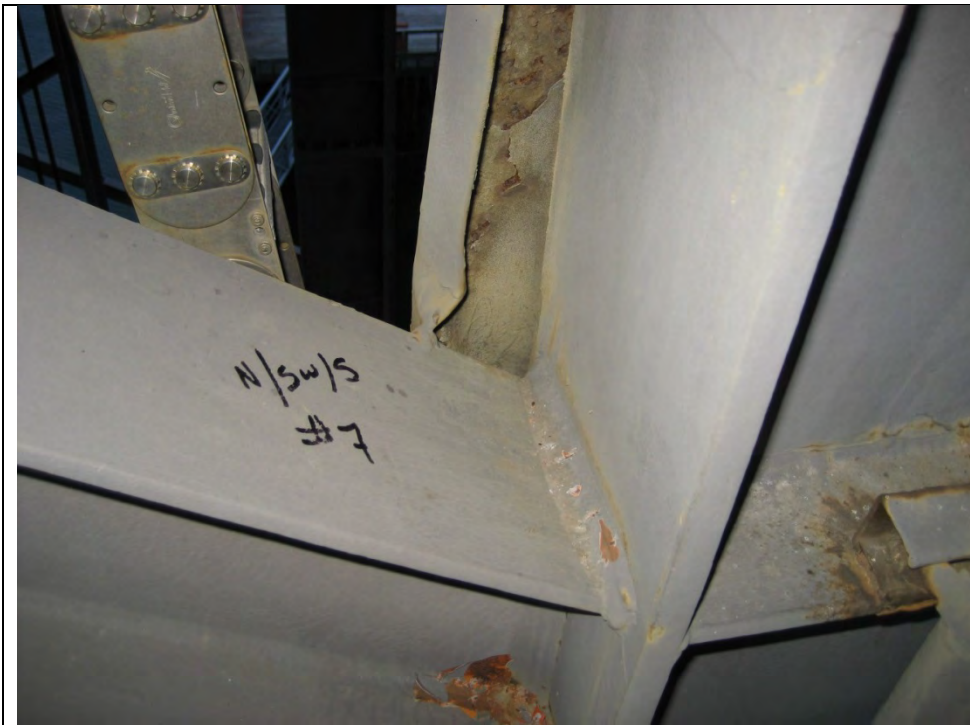
PF-111213-32 SKAGWAY ORE TERMINAL SHIP LOADER  
LOCATION: NORTH SHIP LOADER TOWER SW LEG SOUTH FACE #7 N/SW/S #7  
DESCRIPTION: NSD  
CONDITION STATE CS2

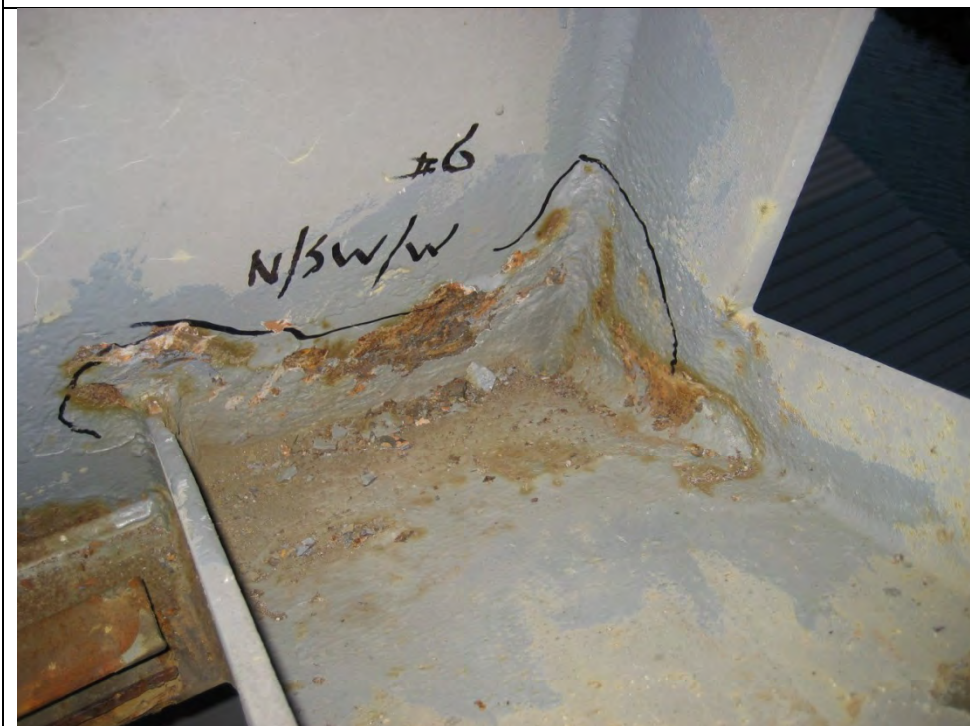
PF-111213-31 SKAGWAY ORE TERMINAL SHIP LOADER  
LOCATION: NORTH SHIP LOADER TOWER SW LEG WEST FACE #6 N/SW/W #6  
DESCRIPTION: PSC 4 SMALL AREA RUST SCALE ABOUT 1/4-INCH AREAS ( MARKED IN PHOTO) WITH SECTION LOSS TO LEG WEB + FLANGE ABOUT 1/8-INCH 4"X8"  
CONDITION STATE CS4

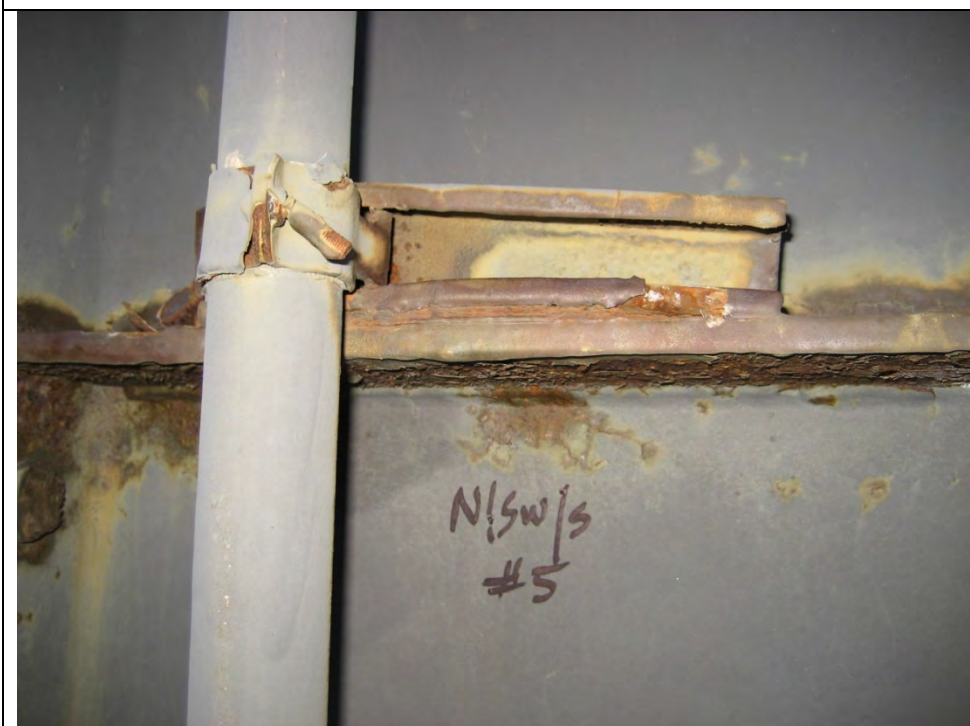
PF-111213-30 SKAGWAY ORE TERMINAL SHIP LOADER  
LOCATION: NORTH SHIP LOADER TOWER SW LEG WEST FACE #5 WEB STIFFENER N/SW/S #5  
DESCRIPTION: PACK RUST ABOUT 3/8 INCH BETWEEN STIFFENER AND UNISTRUT  
CONDITION STATE CS4

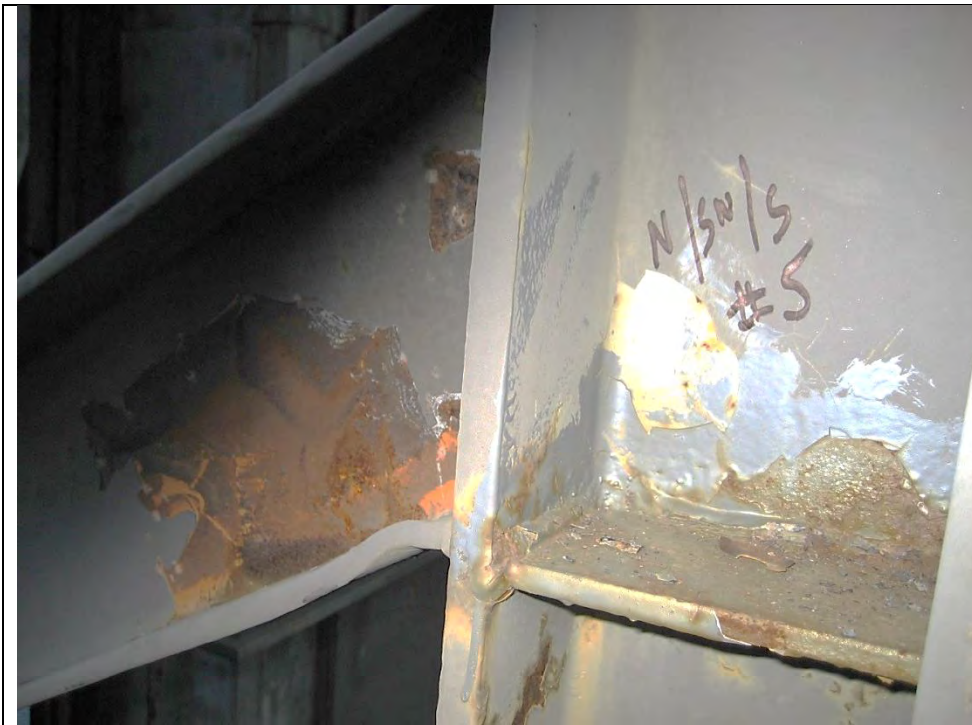
**PF-111213-29 SKAGWAY ORE TERMINAL SHIP LOADER**  
**LOCATION: NORTH SHIP LOADER TOWER SW LEG SOUTH FACE #5 N/SW/S #5**  
**DESCRIPTION: LOWER DIAGONAL HAS OUT OF PLANE BOND AT LEG CONNECTION ABOUT ½-INCH**  
**CONDITION STATE CS4**

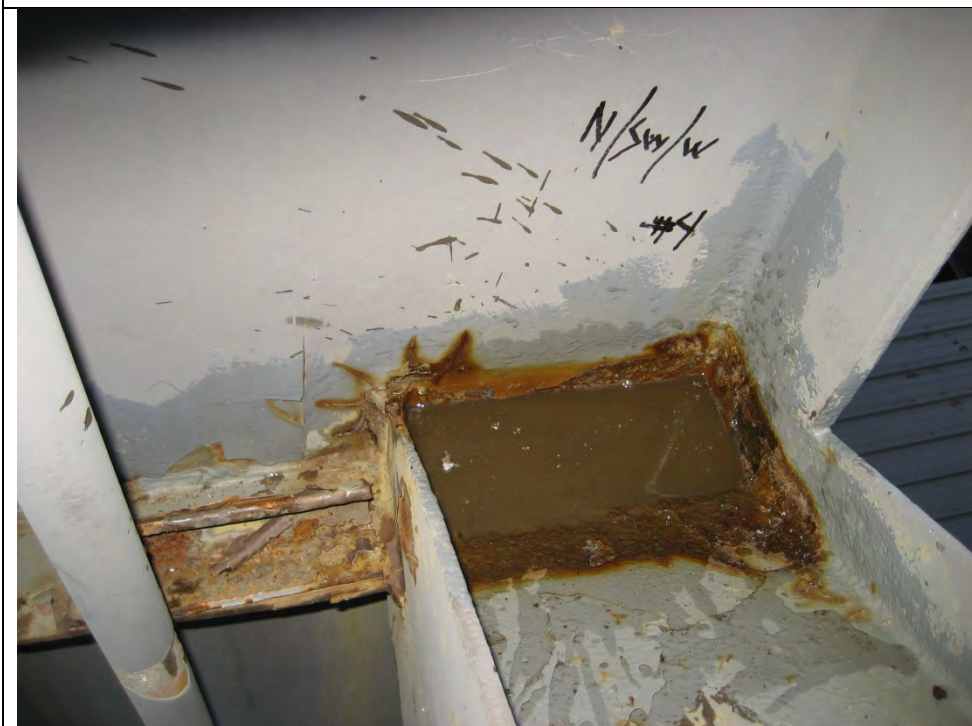
**PF-111213-28 SKAGWAY ORE TERMINAL SHIP LOADER**  
**LOCATION: NORTH SHIP LOADER TOWER SW LEG WEST FACE #4 N/SW/W/#4**  
**DESCRIPTION: POOLING WATER – PCS 4 MODERATE RUST SCALE ABOUT 1/8-INCH IN AREA OF POOLING WATER. UNISTRUT FOR ELECTRICAL CONDUIT RUSTING OFF.**  
**CONDITION STATE CS4/5**

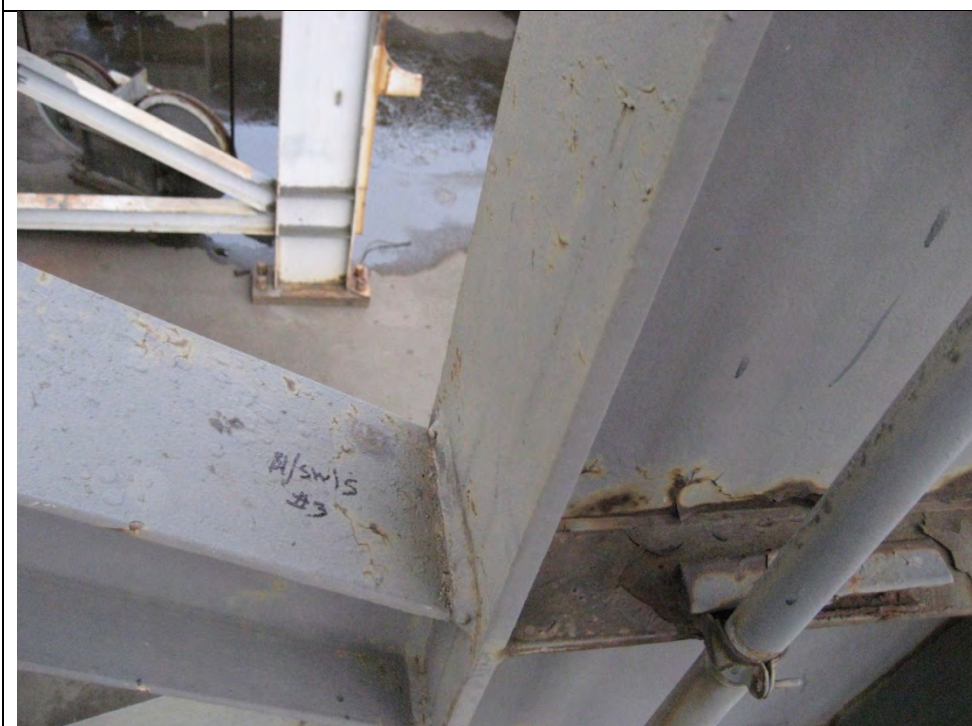
**PF-111213-27 SKAGWAY ORE TERMINAL SHIP LOADER**  
**LOCATION: NORTH SHIP LOADER TOWER SW LEG SOUTH FACE #3 N/SW/S #3**  
**DESCRIPTION: NSD AT DIAGONALS WEB STIFFENER ON LEG HAS PAINT FAILURE LIGHT SURFACE RUST.**  
**CONDITION STATE CS3**

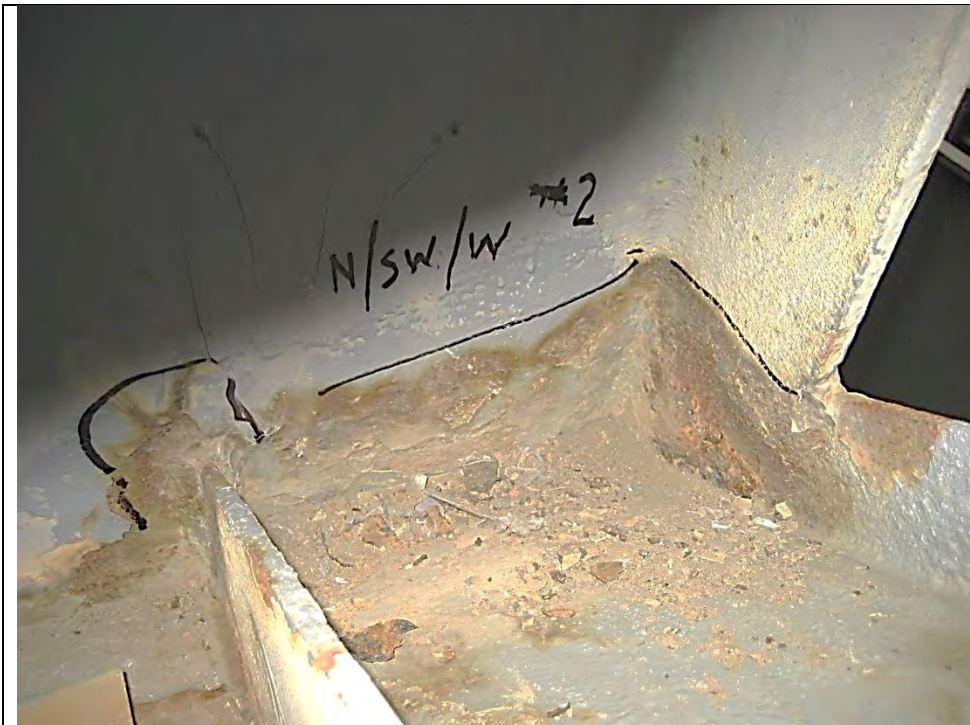
PF-111213-26 SKAGWAY ORE TERMINAL SHIP LOADER  
LOCATION: NORTH SHIP LOADER TOWER SW LEG WEST FACE #2 N/SW/W #2  
DESCRIPTION: PCS 4 LOCALIZED TO WHERE WATER POOLS, MODERATE RUST SCALE ABOUT 1/8 INCH 2" TO 4" TALL 10" TO 12" LONG

CONDITION STATE CS4/5

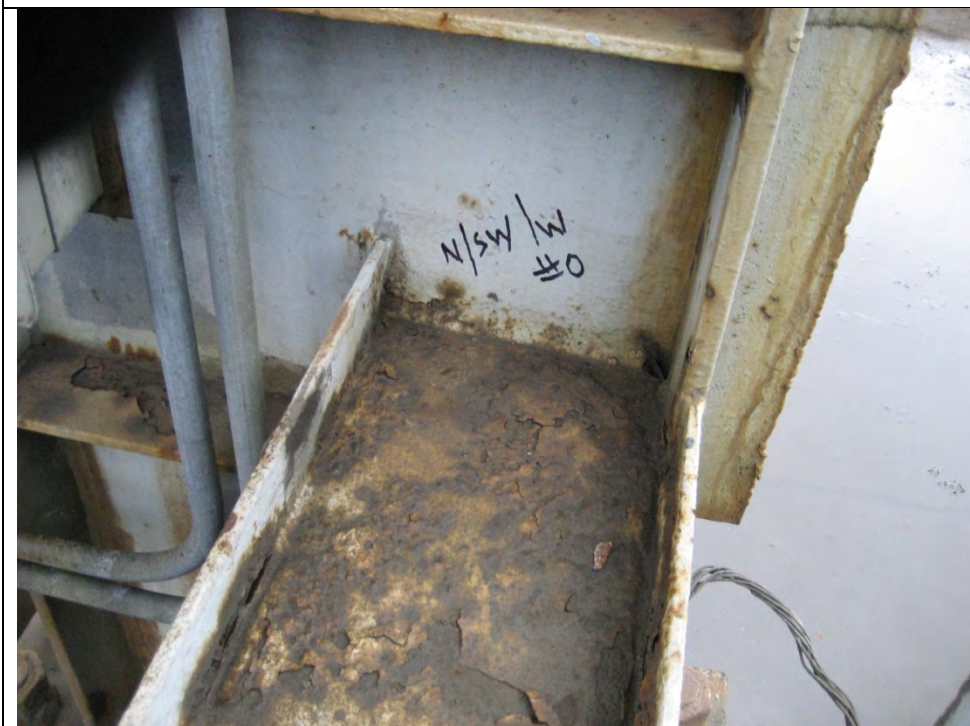
PF-111213-25 SKAGWAY ORE TERMINAL SHIP LOADER  
LOCATION: NORTH SHIP LOADER TOWER SW LEG WEST FACE #0 N/SW/W #0  
DESCRIPTION: PCS 3 ON HORIZONTAL RUST STAINING THROUGHOUT.

CONDITION STATE CS3

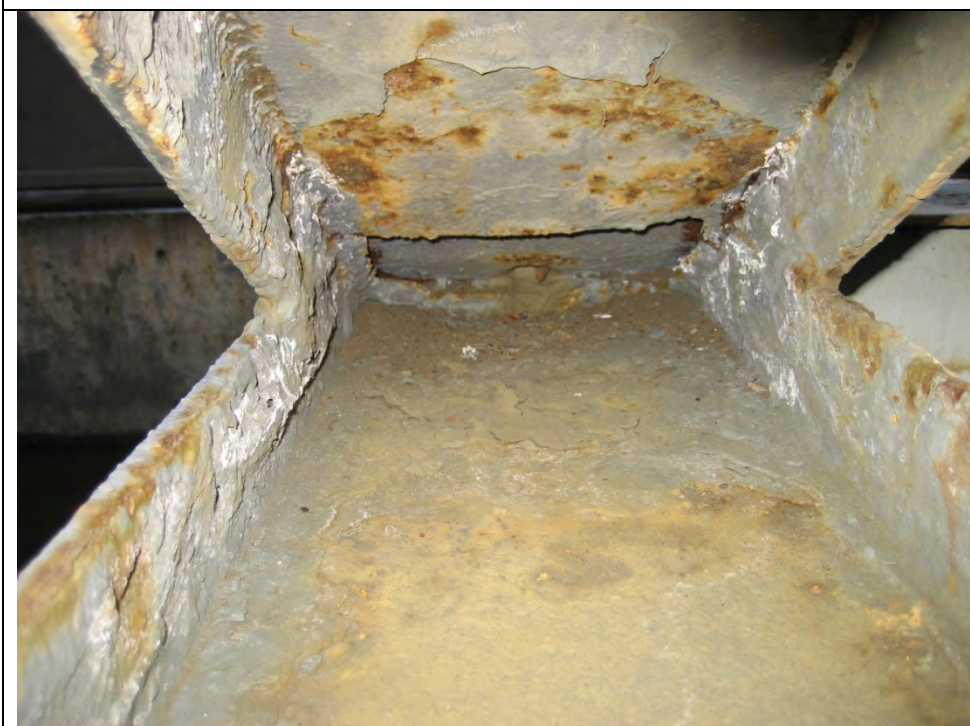
PF-111213-24 SKAGWAY ORE TERMINAL SHIP LOADER  
LOCATION: NORTH SHIP LOADER TOWER NW LEG WEST FACE #1  
DESCRIPTION: VIEW BETWEEN DIAGONAL AND HORIZONTAL PCS 4 MODERATE RUST SCALE FLANGE + WEB

CONDITION STATE CS4/5
