**ALASKA INDUSTRIAL DEVELOPMENT AND EXPORT AUTHORITY**  
**SKAGWAY ORE TERMINAL**  
**SHIP LOADER STRUCTURAL INSPECTION**  
**November 11, 12 and 13, 2013**

**R&M Consultants, Inc.**

December 17, 2013

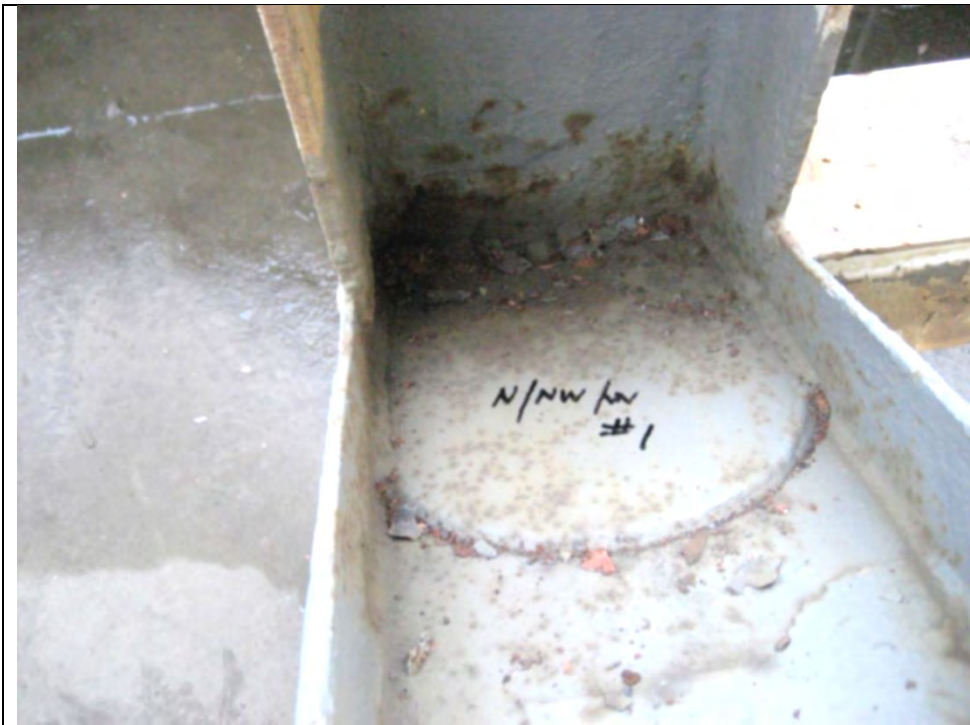
PF-111213-23 SKAGWAY ORE TERMINAL SHIP LOADER  
LOCATION: NORTH SHIP LOADER TOWER NW LEG WEST FACE #1 N/NW/W #1  
DESCRIPTION: TOP SURFACE OF DIAGONAL WITH ADDED "FISH PLATE" VISIBLE PCS 3  
CONDITION STATE CS3/4

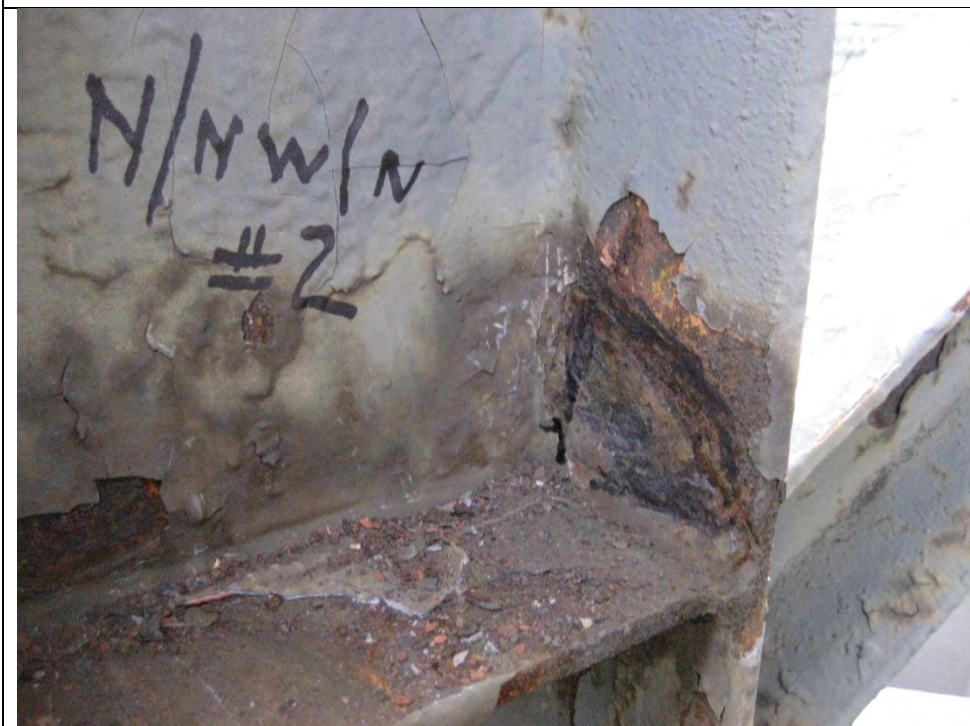
PF-111213-22 SKAGWAY ORE TERMINAL SHIP LOADER  
LOCATION: NORTH SHIP LOADER TOWER NW LEG N FACE #2 INBOARD N/NW/W #2  
DESCRIPTION: VIEW OF AREA OF SECTION LOSS TO FLANGE OF LEG ABOUT 2"X3"X1/8-INCH WITH RUST SCALE ABOUT 1/8-INCH.  
CONDITION STATE CS4

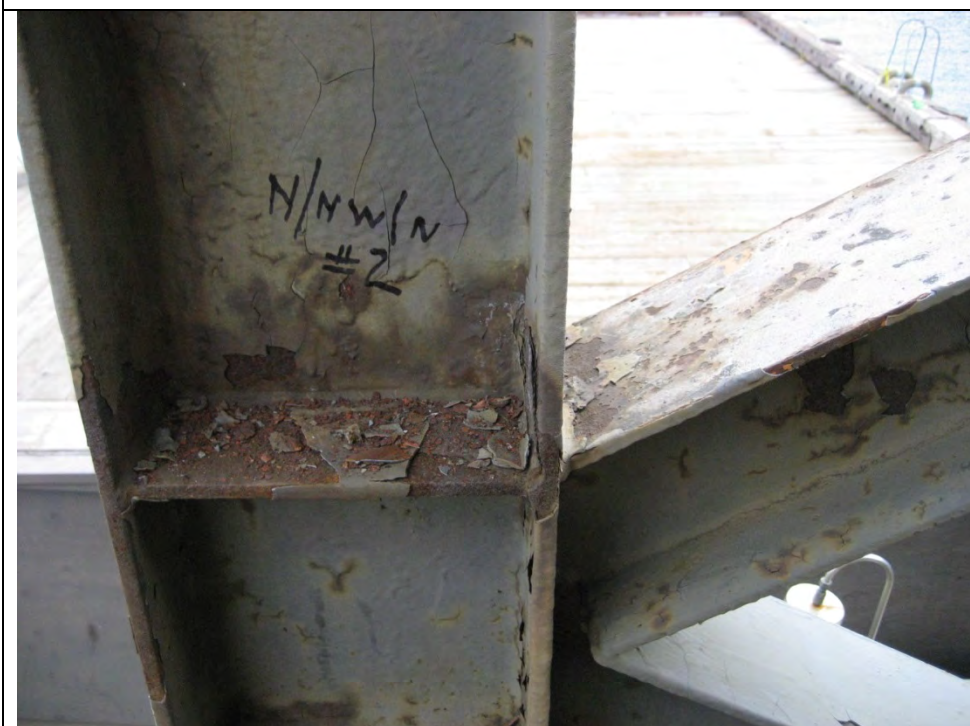
PF-111213-21 SKAGWAY ORE TERMINAL SHIP LOADER  
LOCATION: NORTH SHIP LOADER TOWER NW LEG N FACE #2 INBOARD N/NW/W #2  
DESCRIPTION: VIEW OF INBOARD SIDE #2 SMALL AREAS OF PCS 4 GENERAL PAINT FAILURE.  
CONDITION STATE CS4

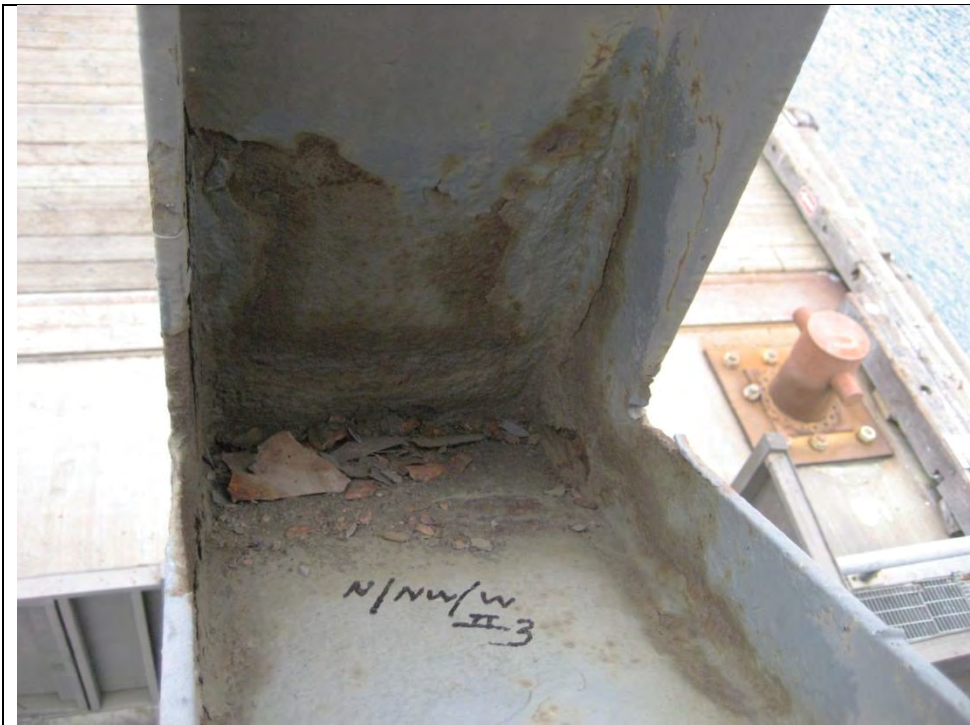
**PF-111213-20 SKAGWAY ORE TERMINAL SHIP LOADER**  
**LOCATION: NORTH SHIP LOADER TOWER NW LEG WEST FACE #3 FROM ABOVE N/NW/W #3**  
**DESCRIPTION: DRAIN HOLE PLUGGED WITH RUST AND PAINT DEBRIS, RUST SCALE ABOUT 1/8-INCH WEB AND FLANGES OF LEG AND DING 2" TO 5" HIGH.**  
**CONDITION STATE CS4/5**

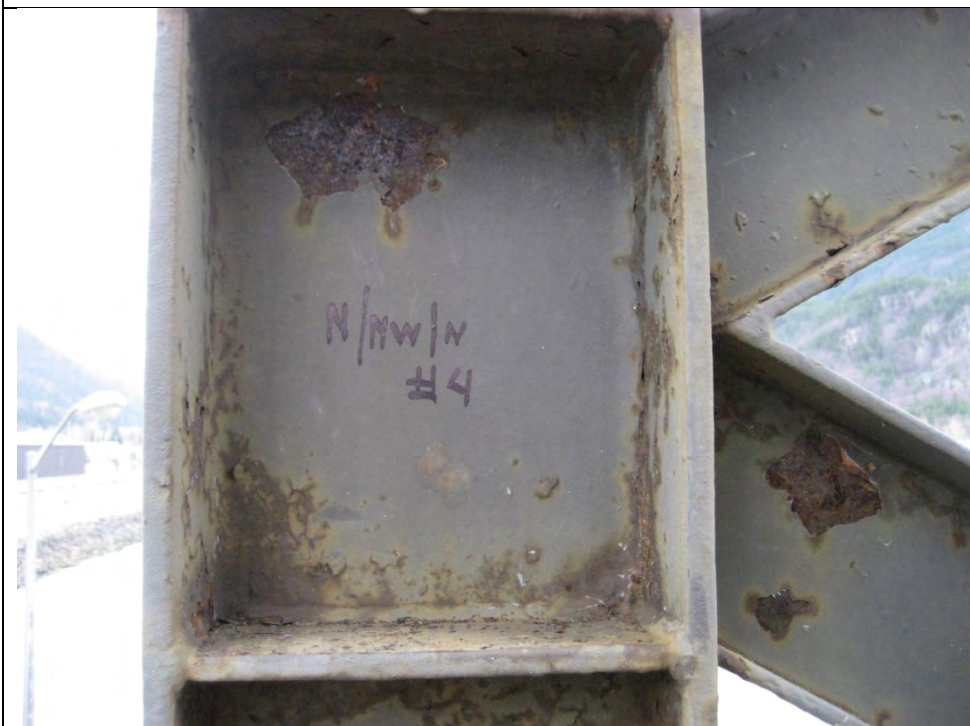
**PF-111213-19 SKAGWAY ORE TERMINAL SHIP LOADER**  
**LOCATION: NORTH SHIP LOADER TOWER NW LEG NORTH FACE #4 INBOARD N/NW/N #4**  
**DESCRIPTION: VIEW OF LEG INBOARD AT LOWER WEB STIFFENER PCS4, SOME RUST SCALE**  
**CONDITION STATE CS4**

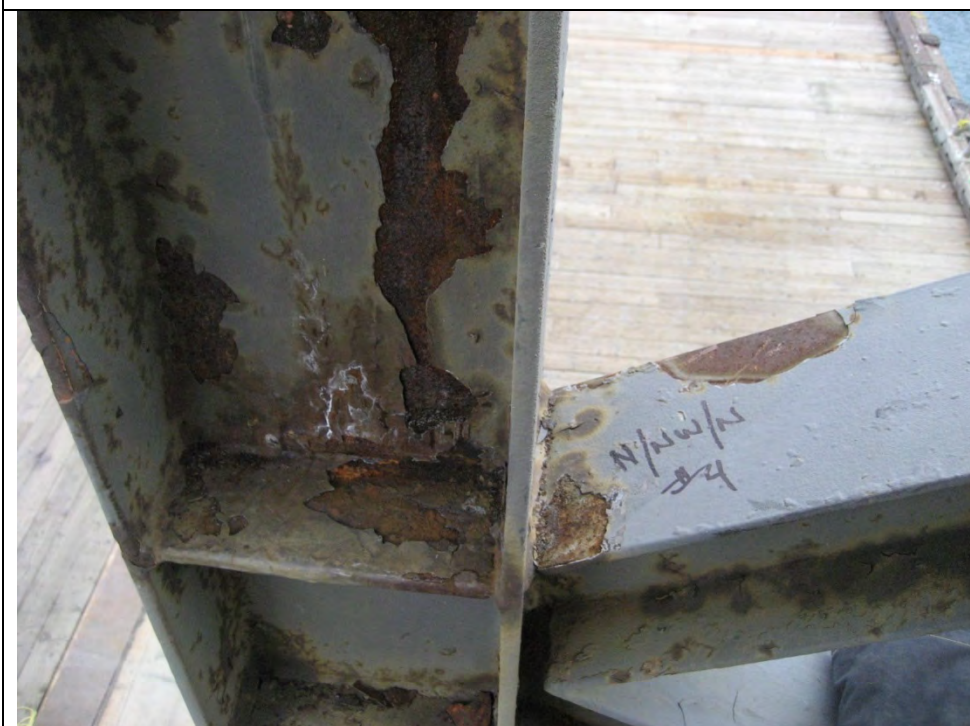
**PF-111213-18 SKAGWAY ORE TERMINAL SHIP LOADER**  
**LOCATION: NORTH SHIP LOADER TOWER NW LEG NORTH FACE #4 INBOARD N/NW/N #4**  
**DESCRIPTION: PCS 4 TO WEB + WEB STIFFENER. EXPOSED BASE METAL, SMALL AREAS OF MODERATE RUST SCALE ON INSIDE OF LEG ABOUT 3/16-INCH.**  
**CONDITION STATE CS4**

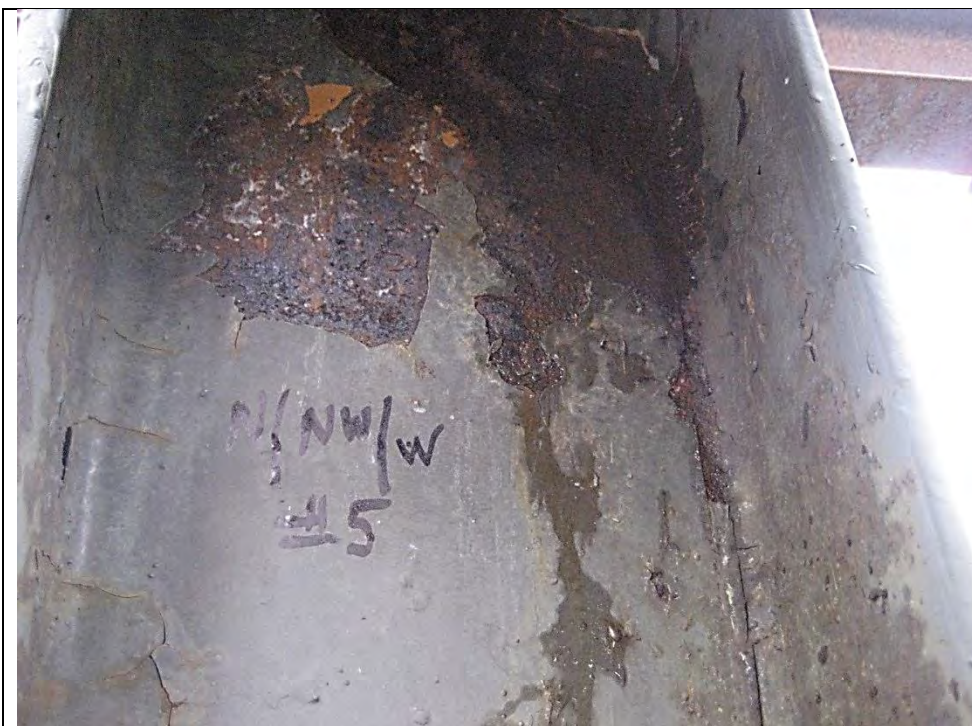
**PF-111213-17 SKAGWAY ORE TERMINAL SHIP LOADER**  
**LOCATION: NORTH SHIP LOADER TOWER NW LEG WEST FACE #5 FROM BELOW DIAGONAL ON LEG N/NW/W #5**  
**DESCRIPTION: PCS 4 EXPOSED BASE METAL ON WEB OF LEG, MODERATE SURFACE RUST**  
**CONDITION STATE CS4**

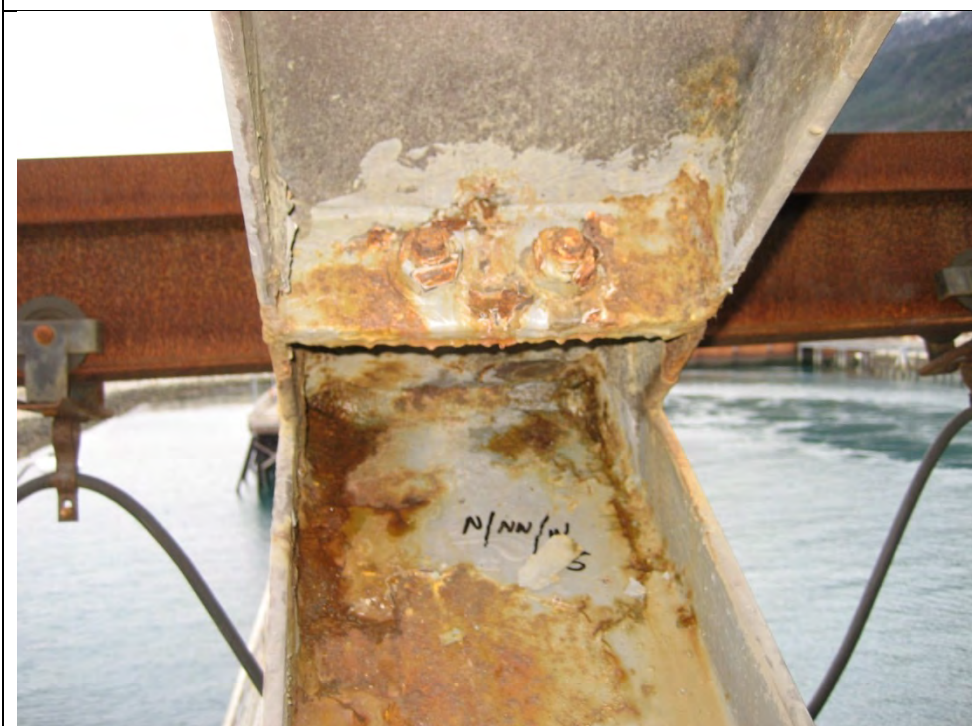
**PF-111213-16 SKAGWAY ORE TERMINAL SHIP LOADER**  
**LOCATION: NORTH SHIP LOADER TOWER NW LEG WEST FACE #5 LOWER DIAGONAL**  
**DESCRIPTION: VIEW OF SPLICE FROM BELOW PCS 4 SECTION LOSS TO BOLTS + NUTS AT SPLICE, LOCALIZED MODERATE SURFACE RUST ON WEB OF LOWER DIAGONAL.**  
**CONDITION STATE CS4**

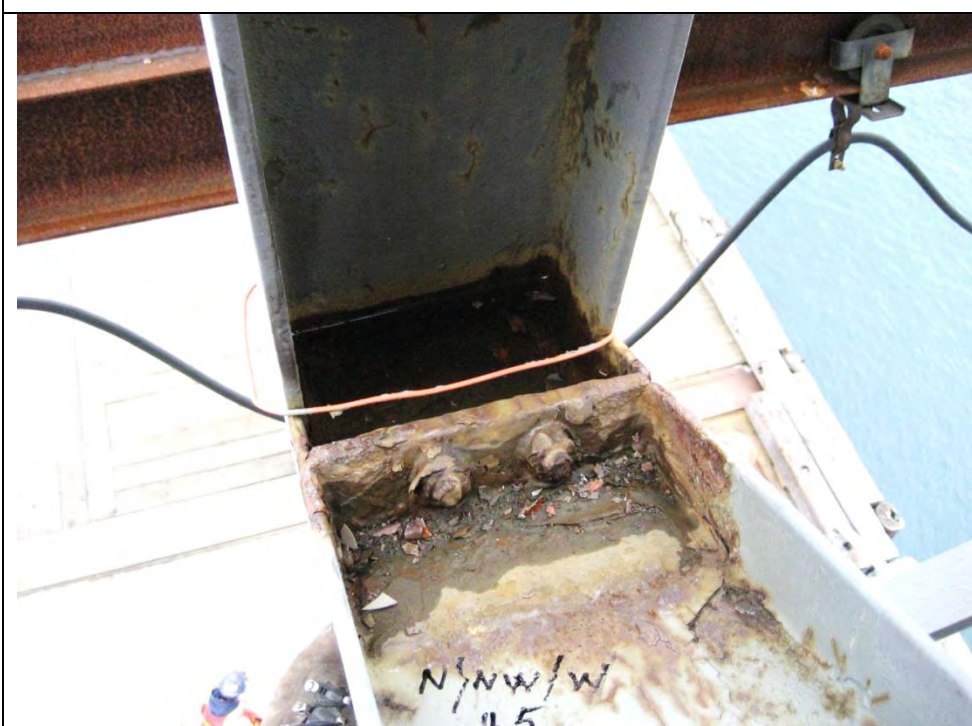
**PF-111213-15 SKAGWAY ORE TERMINAL SHIP LOADER**  
**LOCATION: NORTH SHIP LOADER TOWER NW LEG WEST FACE #5 N/NW/W #5**  
**DESCRIPTION: POOLONG WATER BELOW SPLICE ON BASE OF DIAGONAL, RUST SCALE ABOUT ¼-INCH TO AREAS ON DIAGONAL WEB + FLANGE, NUTS +BOLT ENDS AT SPLICE, FLANGE AT SPLICE ON OUTBOARD SIDES APPEARS TO BE WIDER.**  
**CONDITION STATE CS4/5**

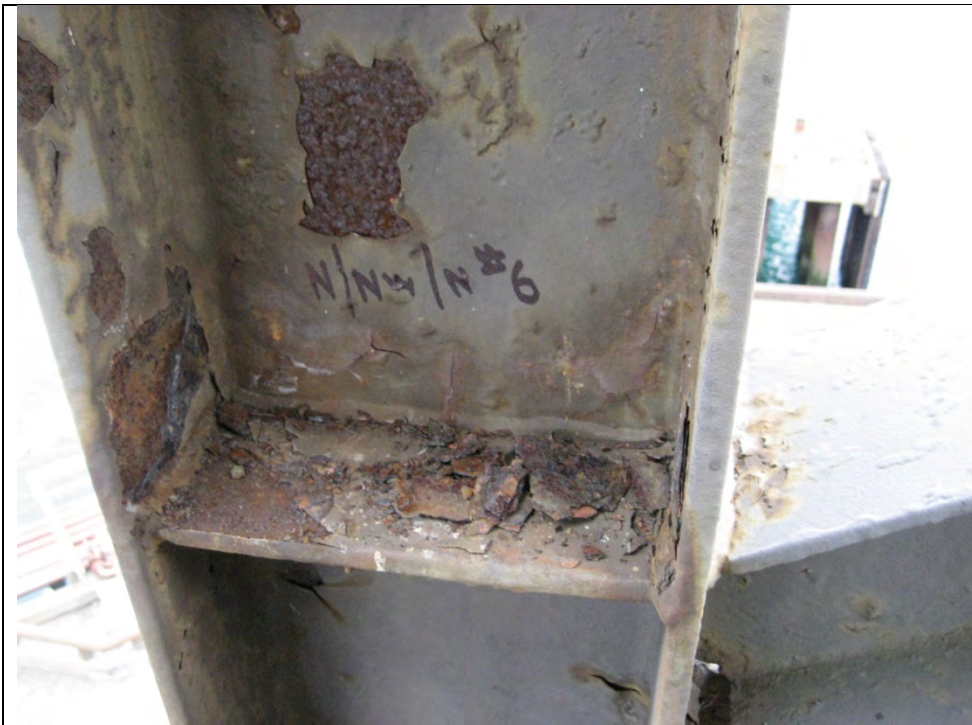
**PF-111213-11 SKAGWAY ORE TERMINAL SHIP LOADER**  
**LOCATION: NORTH SHIP LOADER TOWER NW LEG NORTH FACE #6 N/NW/N #6**  
**DESCRIPTION: VIEW OF INBOARD SIDE OF LEG. MODERATE RUST SCALE ABOUT 3/16 INCH ON LEG FLANGES + WEB STIFFENER. LEG SPLICE JUST BELOW THIS LOCATION, UPPER DIAGONAL WELDED ON WEB AND TOP FLANGE ONLY, LOWER DIAGONAL HAS 2 BOLTS FOR CONNECTION.**  
**CONDITION STATE CS4**

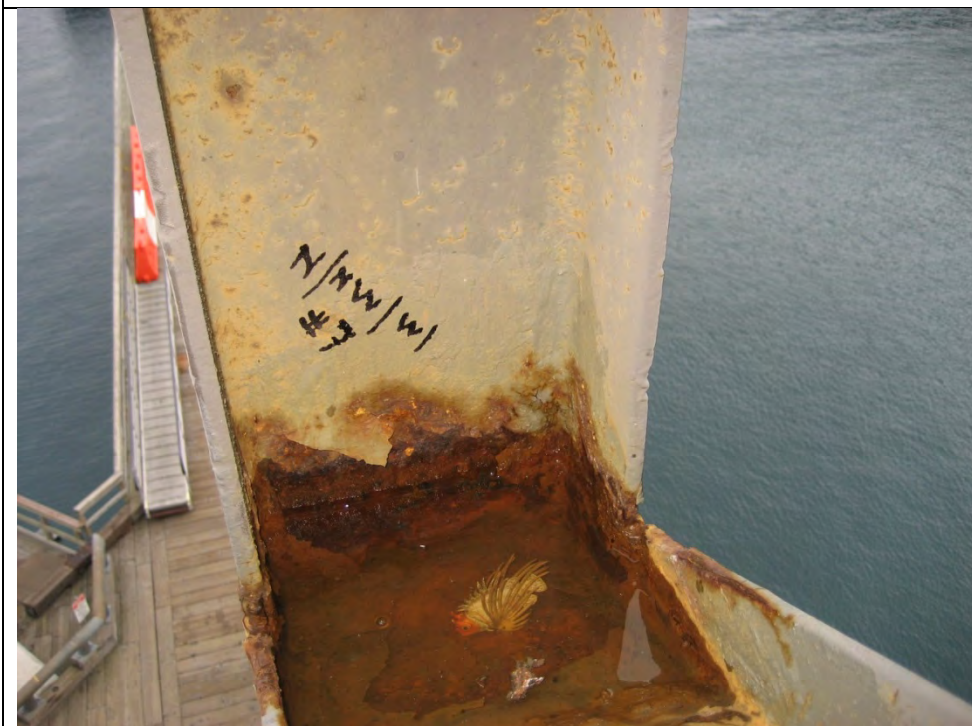
**PF-111213-10 SKAGWAY ORE TERMINAL SHIP LOADER**  
**LOCATION: NORTH SHIP LOADER TOWER NW LEG WEST FACE #7**  
**DESCRIPTION: POOLING WATER (DRASIN HOLES IN WEBS CLOSED FROM BELOW) PCS 4 MODERATE SURFACE RUST AT WATER CONTACTING RUST SCALE ABOUT 3/16 INCH THICK.**  
**CONDITION STATE CS4/5**

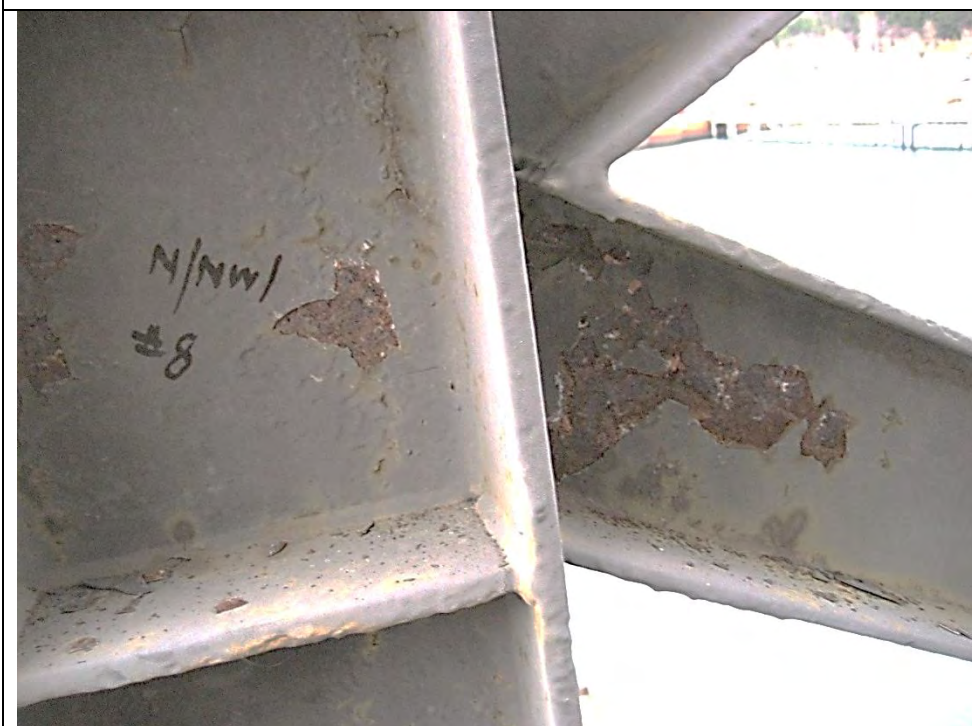
**PF-111213-09 SKAGWAY ORE TERMINAL SHIP LOADER**  
**LOCATION: NORTH SHIP LOADER TOWER NW LEG SOUTH FACE INBOARD #8 N/NW #8**  
**DESCRIPTION: LOCAL AREAS OF EXPOSED BASE METAL, LIGHT SURFACE RUST, PCS 4 AREA ABOUT 6-INCHES x 10 INCHES.**  
**CONDITION STATE CS4**

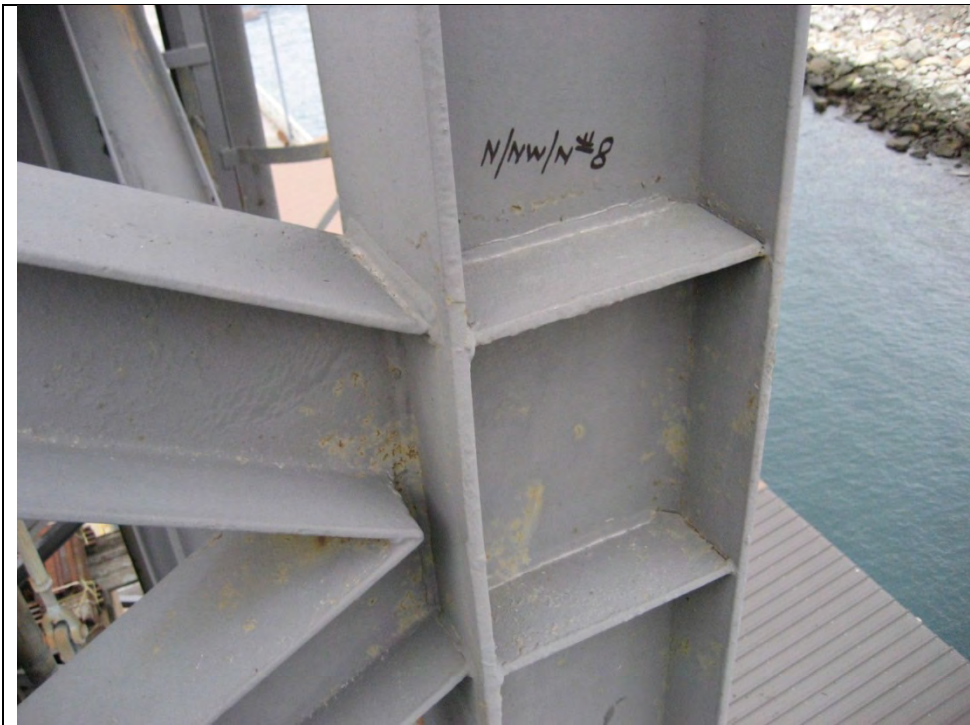
**PF-111213-08 SKAGWAY ORE TERMINAL SHIP LOADER**  
**LOCATION: NORTH SHIP LOADER TOWER NW LEG NORTH FACE #8 N/NW/N #8**  
**DESCRIPTION: SMALL AREA OF PAINT FAILURE ON TOP SURFACE OF LOWER DIAGONAL, NOTE THAT OUTBOARD WEB STIFFENER ONLY WELDED ON TWO EDGES (INBOARD WELDED ON ALL THREE EDGES!)**  
**CONDITION STATE CS2**

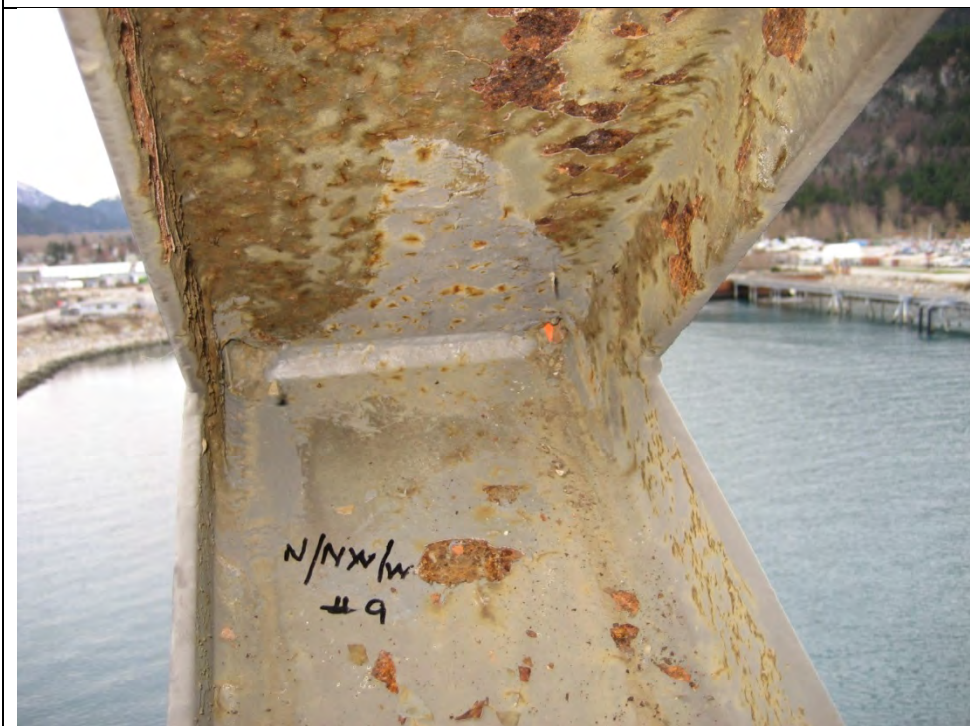
**PF-111213-07 SKAGWAY ORE TERMINAL SHIP LOADER**  
**LOCATION: NORTH SHIP LOADER TOWER NW LEG WEST FACE #9 N/NW/W #9**  
**DESCRIPTION:VIEW OF INTERSECTING DIAGONALS, UPPER HAS LOCALIZED DCS 3 9"X24", LIGHT SURFACE RUST.**  
**CONDITION STATE CS3**

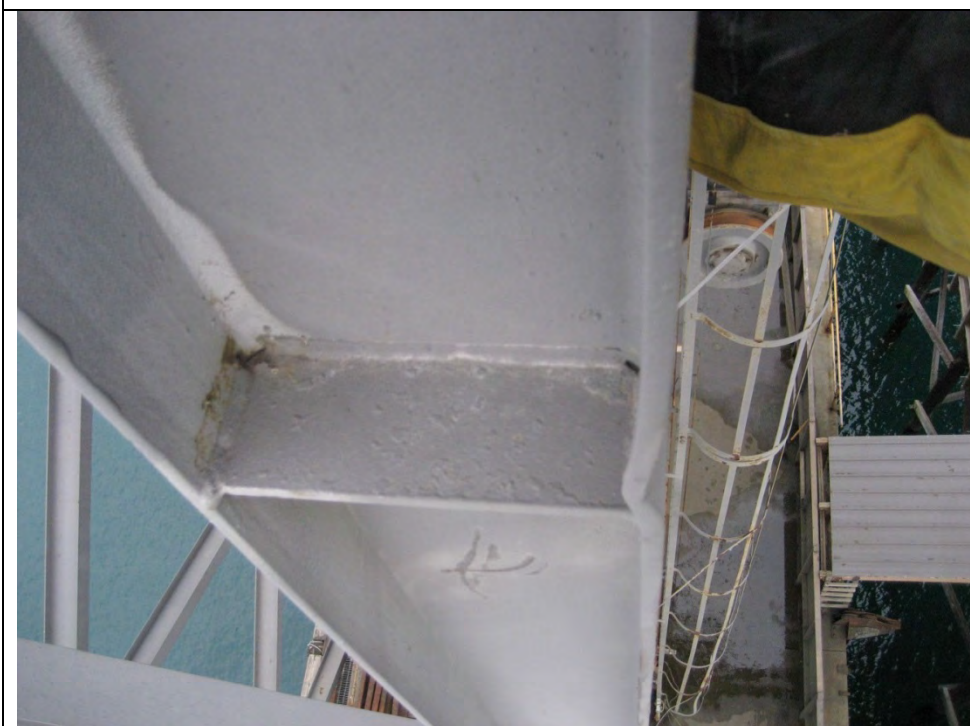
**PF-111213-06 SKAGWAY ORE TERMINAL SHIP LOADER**  
**LOCATION: NORTH SHIP LOADER TOWER NW LEG NORTH FACE #9**  
**DESCRIPTION: VIEW OF IMPACT DAMAGE TO FLANGE OF LEG AT WEB STIFFENER,OUT OF PLAIN ABOUT 5/8-INCH X 2 INCHES.**  
**CONDITION STATE CS1**

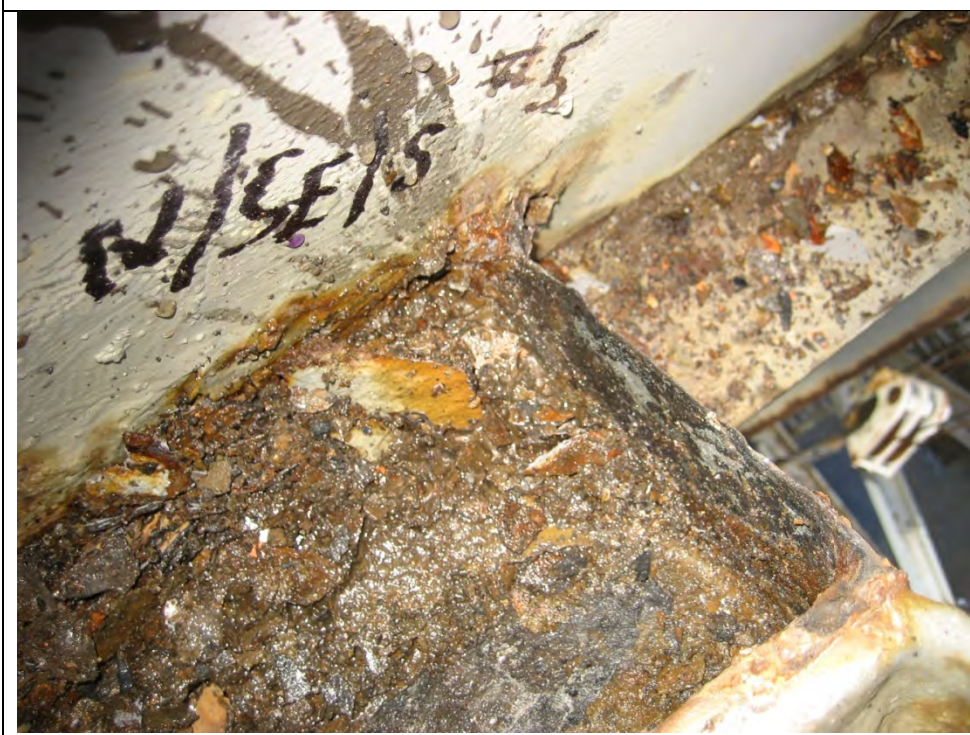
PF-111313-21 SKAGWAY ORE TERMINAL SHIP LOADER  
LOCATION: NORTH SHIP LOADER TOWER SE LEG EAST SIDE #5  
N/SE/S #5

DESCRIPTION: POOLING WATE, LAMINAR RUST ABOUT 3/8 =-  
INCH THICK ON FLANGE OF DIAGONAL

CONDITION STATE CS4/5

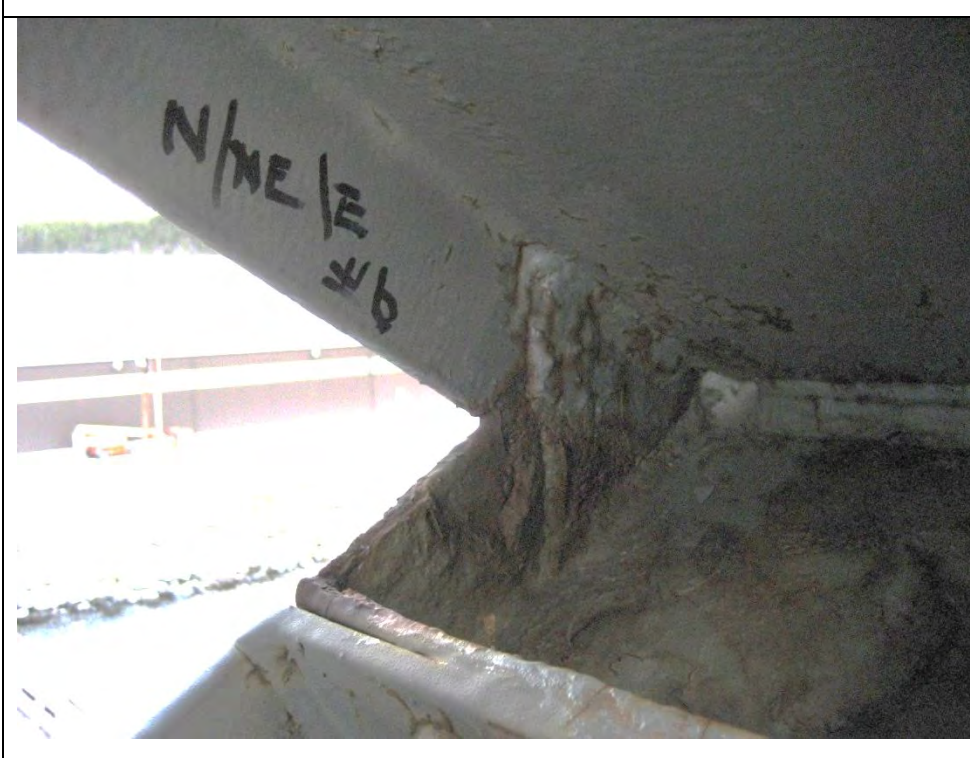
**PF-111313-09 SKAGWAY ORE TERMINAL SHIP LOADER**  
**LOCATION: NORTH SHIP LOADER TOWER NE LEG EAST FACE #6 N/NE/N #6**

**DESCRIPTION: DRAIN HOLES CLEAR, MINOR PAINT FAILURE, SOME RUST STAINING.**

**CONDITION STATE CS2**

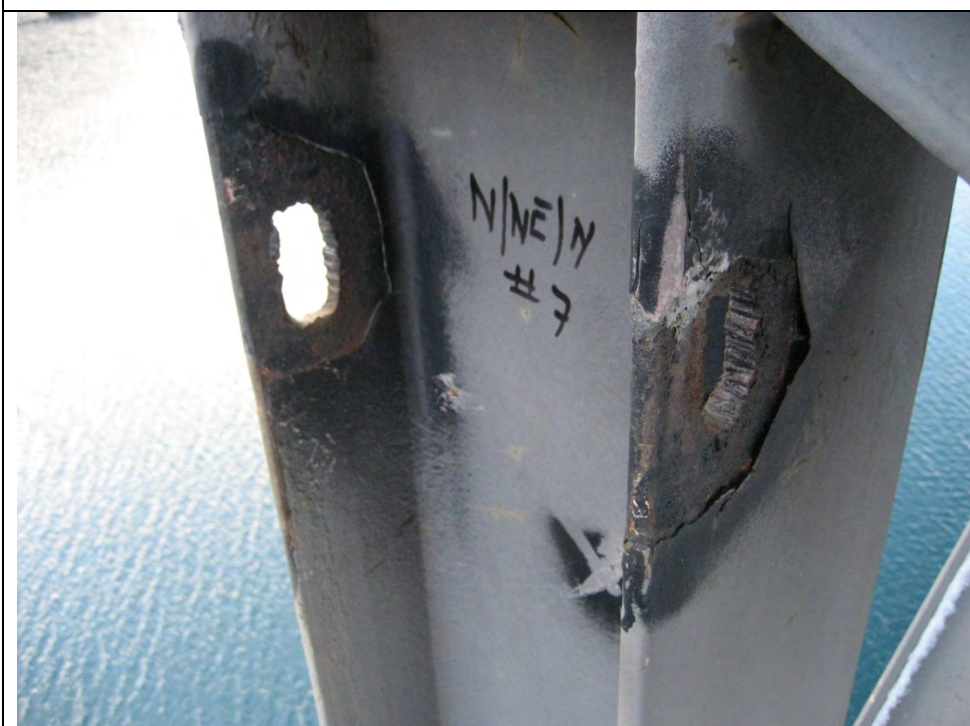
**PF-111313-07 SKAGWAY ORE TERMINAL SHIP LOADER**  
**LOCATION: NORTH SHIP LOADER TOWER NE LEG NORTH FACE #7**

**DESCRIPTION: MINOR PAINT FAILURE, SOME RUST BLEED THROUGH**

**CONDITION STATE CS2.**

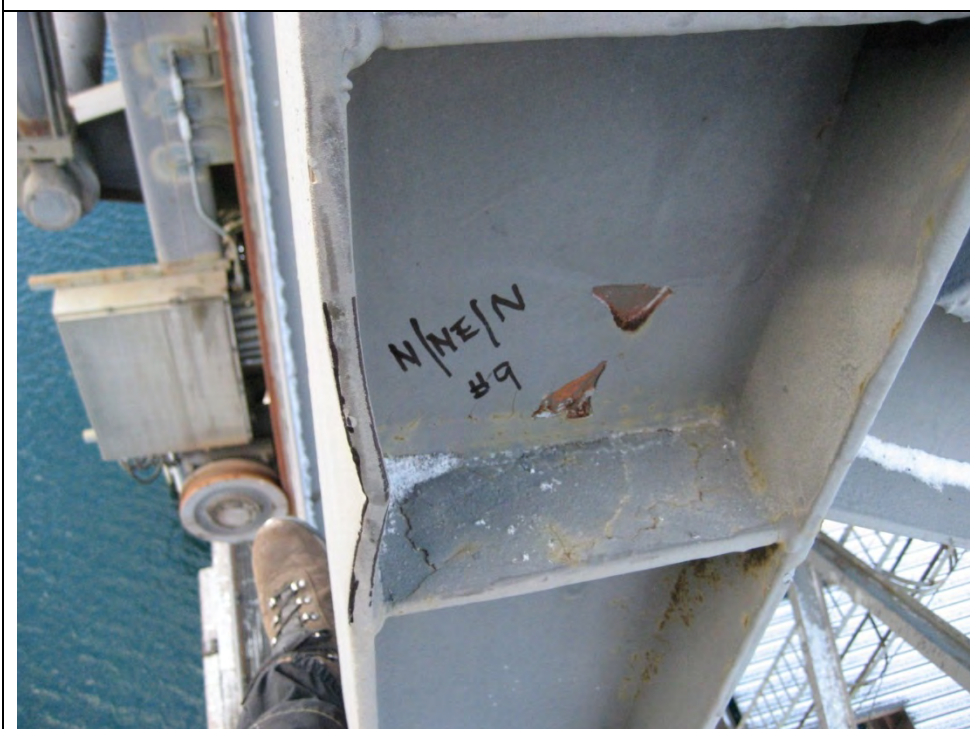
PF-111313-04 SKAGWAY ORE TERMINAL SHIP LOADER  
LOCATION: NORTH SHIP LOADER TOWER NE LEG NORTH FACE  
#9

DESCRIPTION: FLAKING PAINT PCS3 EXPOSES BASE METAL  
LIGHT SURFACE RUST (ON INBOARD SURFACES)

CONDITION STATE CS2

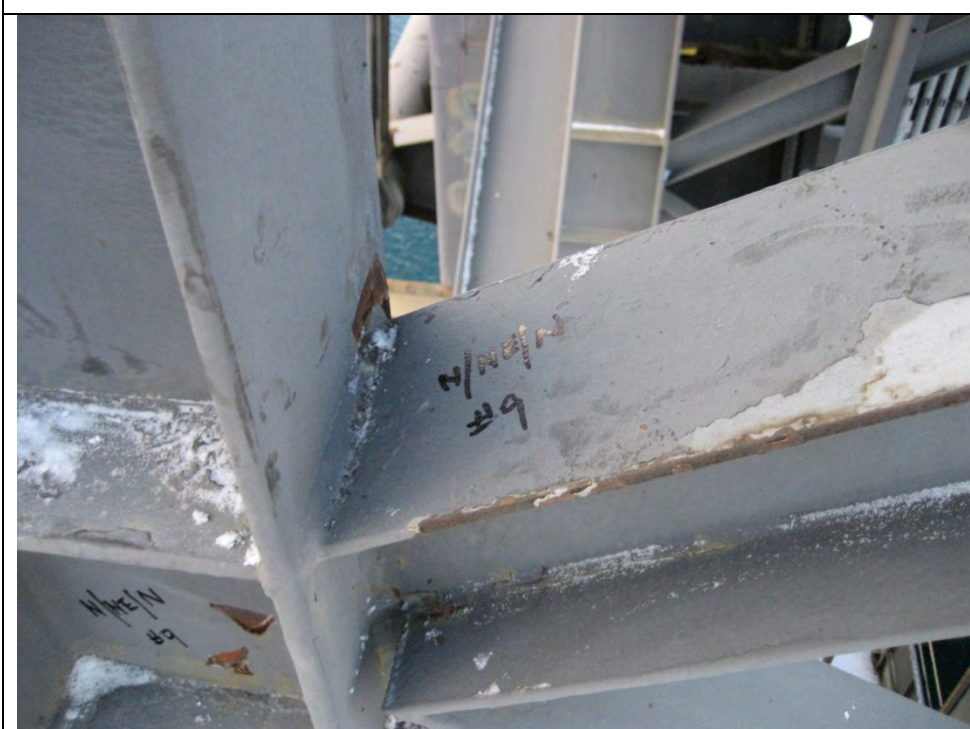
**PF-111313-03 SKAGWAY ORE TERMINAL SHIP LOADER**  
**LOCATION: NORTH SHIP LOADER TOWER NE LEG EAST FACE TOP OF LEG**

**DESCRIPTION: PACK RUST ABOUT ¼-INCH BETWEEN TOP OF LEG AND FLOOR BEAM OF WORK DECK.**

**CONDITION STATE CS2**

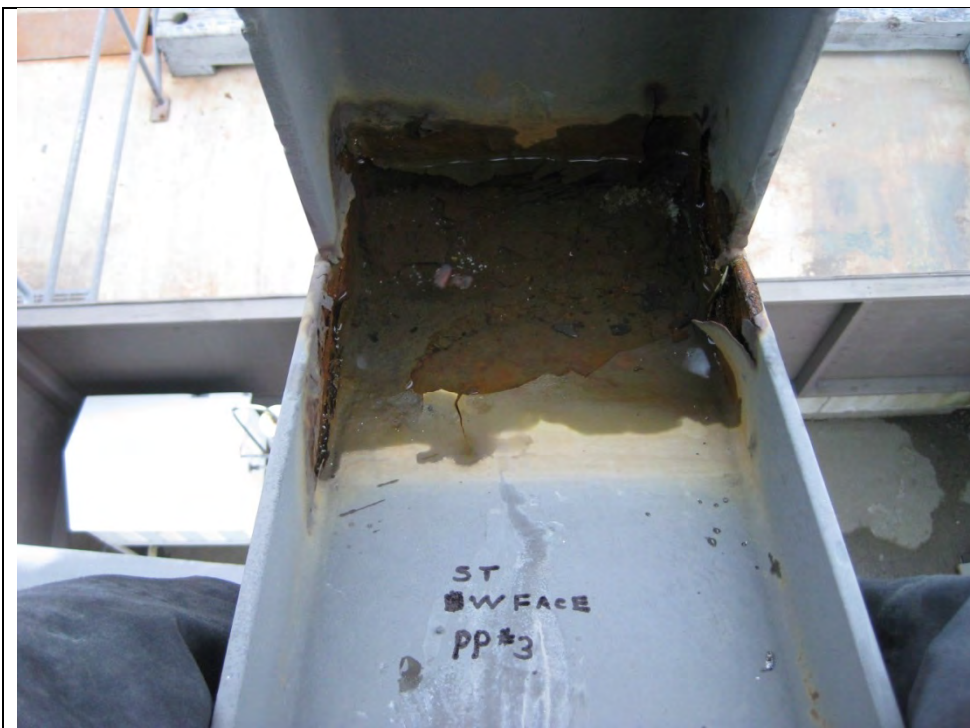
**JG-111213-25 SKAGWAY ORE TERMINAL SHIP LOADER**  
**LOCATION: SOUTH SHIP LOADER TOWER W FACE AT SW CORNER PP# 3**  
**DESCRIPTION: 2-INCHES WATER POOLING MODERATE TO HEAVY LSMINSR RUST FORMING UNDER FLAKING/PEELING PAINT. WAS ABLE TO CLEAN CEBRIS AND UNCLOG DRAIN.**  
**CONDITION STATE CS4/5**

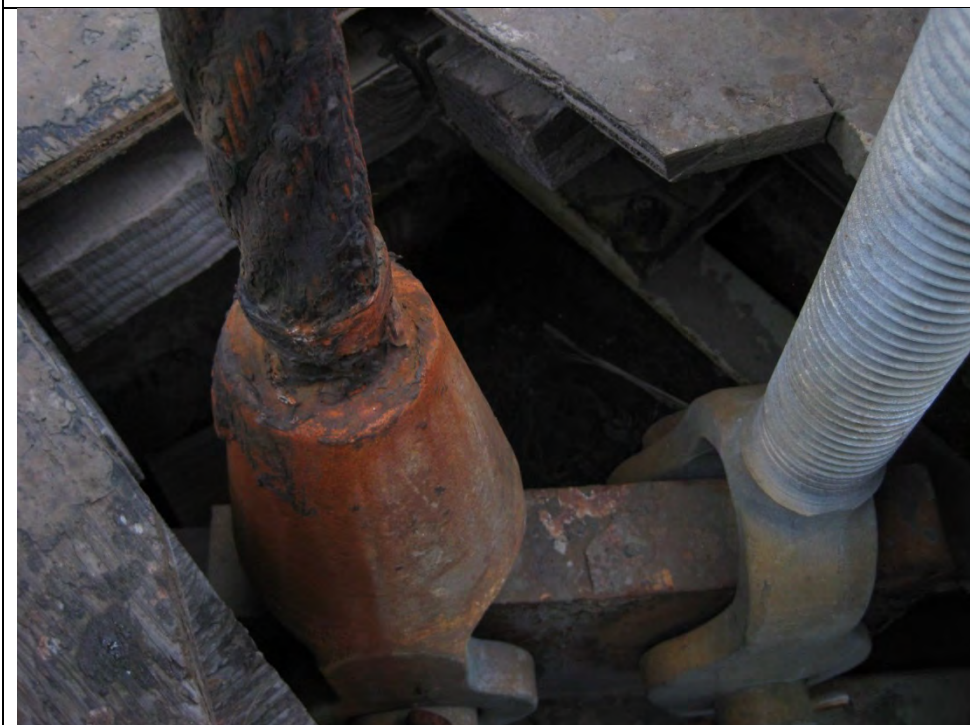
**JG-111213-24 SKAGWAY ORE TERMINAL SHIP LOADER**  
**LOCATION: SOUTH SHIP LOADER TOWER COUNTER WEIGHT CABLE**  
**DESCRIPTION: CABLE AT TURNBUCKLE, RUST BLEED OCCURING UNDER CABLE GREASE.**  
**CONDITION STATE CS5**

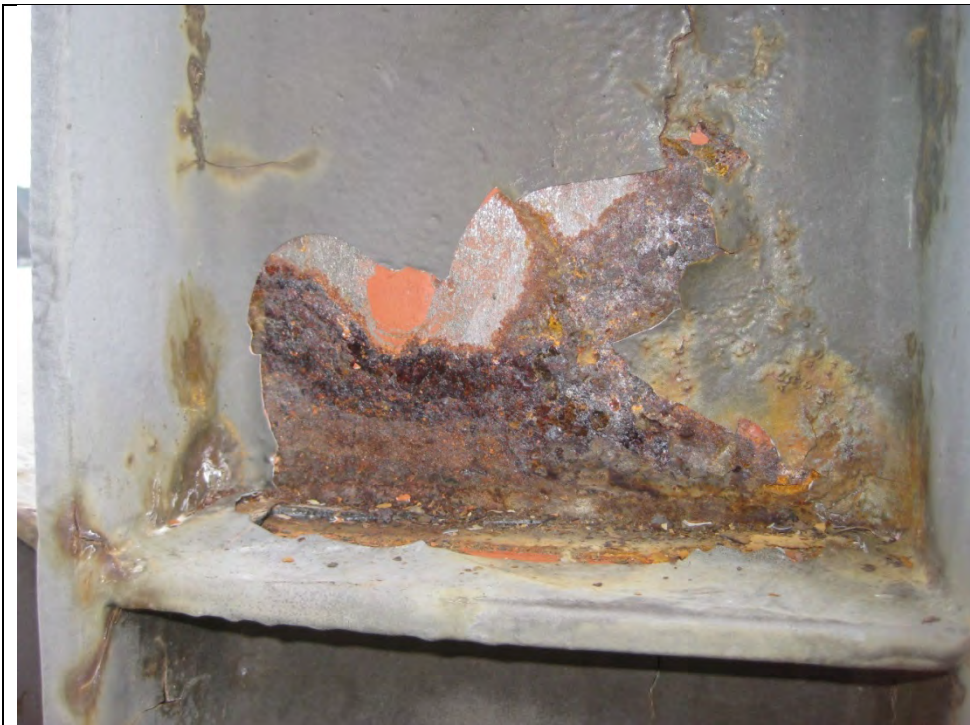
**JG-111213-17 SKAGWAY ORE TERMINAL SHIP LOADER**  
**LOCATION: SOUTH SHIP LOADER TOWER SW FACE PP#7**  
**DESCRIPTION: DEBRIS BUILT UP, PAINT IS CRACKING AND PEELING AWAY FROM STEEL WITH MODERATE RUST FORMING UNDER (TYPICAL)**  
**CONDITION STATE CS3/4**

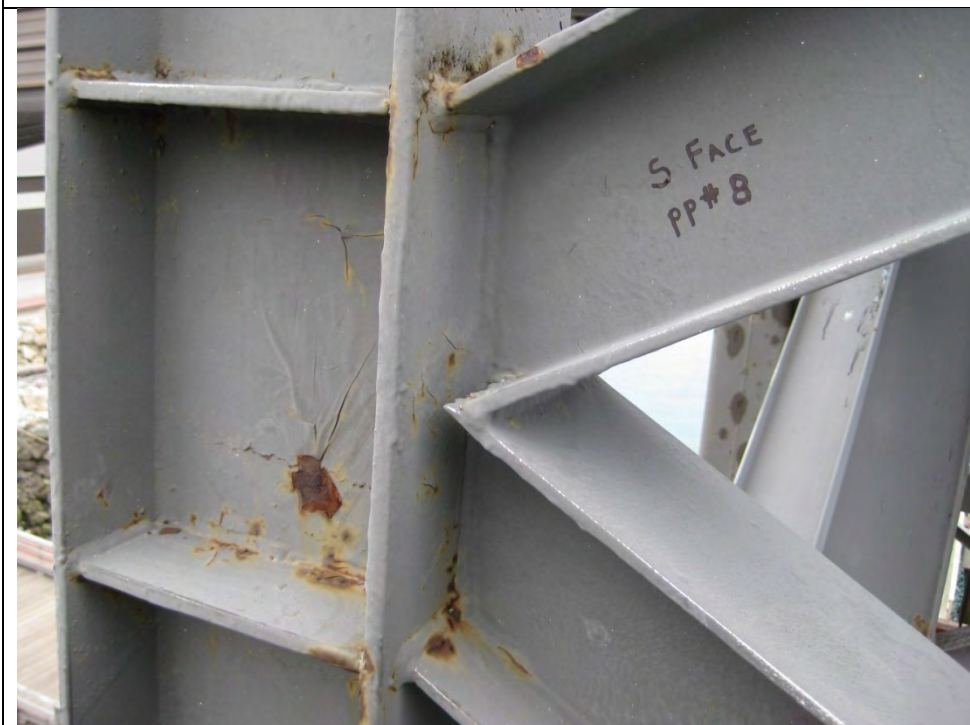
**JG-111213-16 SKAGWAY ORE TERMINAL SHIP LOADER**  
**LOCATION: SOUTH SHIP LOADER TOWER SW CORNER LEG**  
**DESCRIPTION: INBOARD JUST ABOVE S PANEL POINT #8**  
**PAINT IS BUBBLED WITH HEAVY LAMINAR RUST FORMING UNDER.**  
**CONDITION STATE CS4**

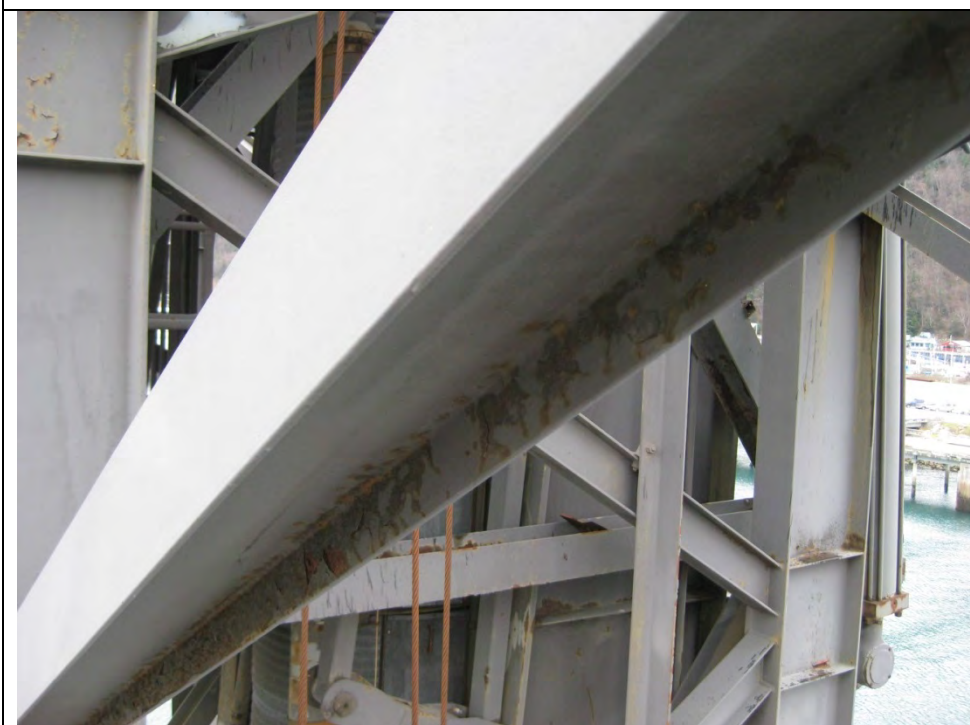
**JG-111213-15 SKAGWAY ORE TERMINAL SHIP LOADER**  
**LOCATION: SOUTH SHIP LOADER TOWER S FACE PANEL POINT #8**  
**DESCRIPTION: MODERATE RUST FORMED ON WELDS, NSD**  
**CONDITION STATE CS2**

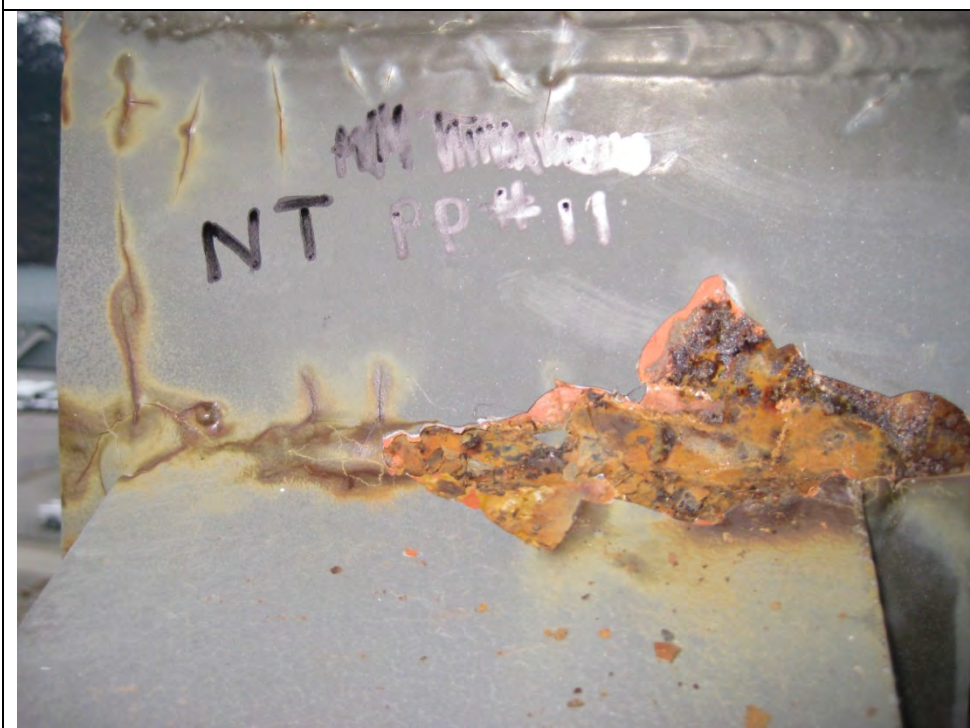
**JG-111213-09** SKAGWAY ORE TERMINAL SHIP LOADER  
**LOCATION:** SOUTH SHIP LOADER TOWER S PANEL POINT #11  
**DESCRIPTION:** 1-INCH LONG AREA ALONG TOP WELD HAS MODERATE LAMINAR RUST FORMING UNDER PAINT AND LIGHT PITTING STARTING TO FORM. ELEMENT MISMARKED AS NT)  
**CONDITION STATE CS4**

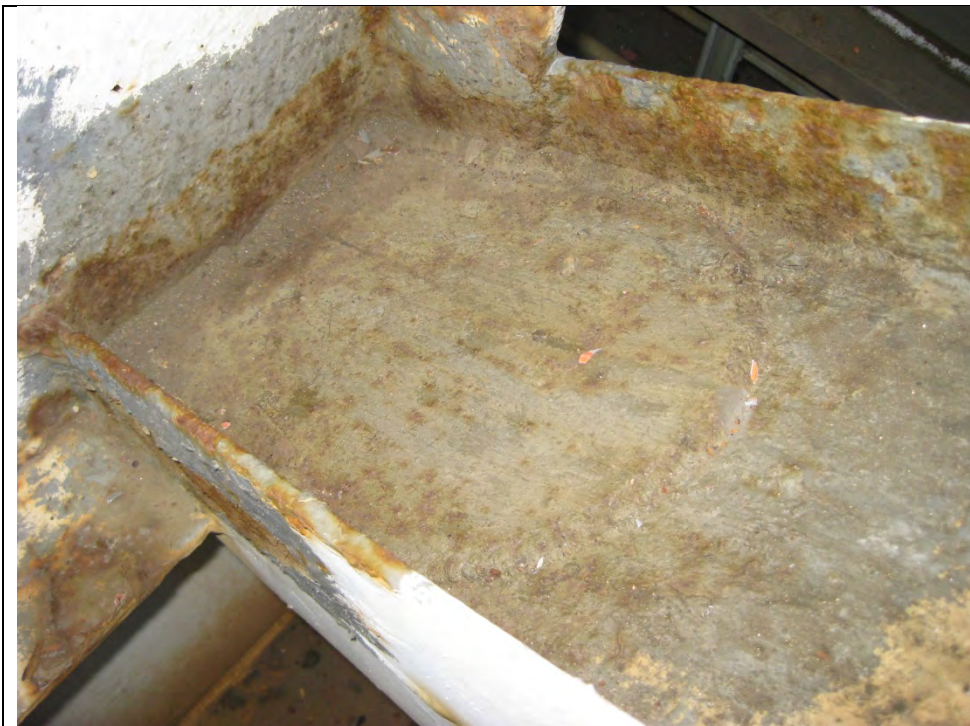
**JG-111313-19 SKAGWAY ORE TERMINAL SHIP LOADER**  
**LOCATION: SOUTH SHIP LOADER TOWER EAST FACE AT PP#1**

**DESCRIPTION: FISH PLATE IN DIAGONAL TO STRENGTHEN WEB (HEAVY SECTION LOSS) DRAIN HOLE IS CLEAR, PAINT CS 4 WITH 1/64-INCH SECTION LOSS TO WEB AND FLANGES.**

**CONDITION STATE CS4**

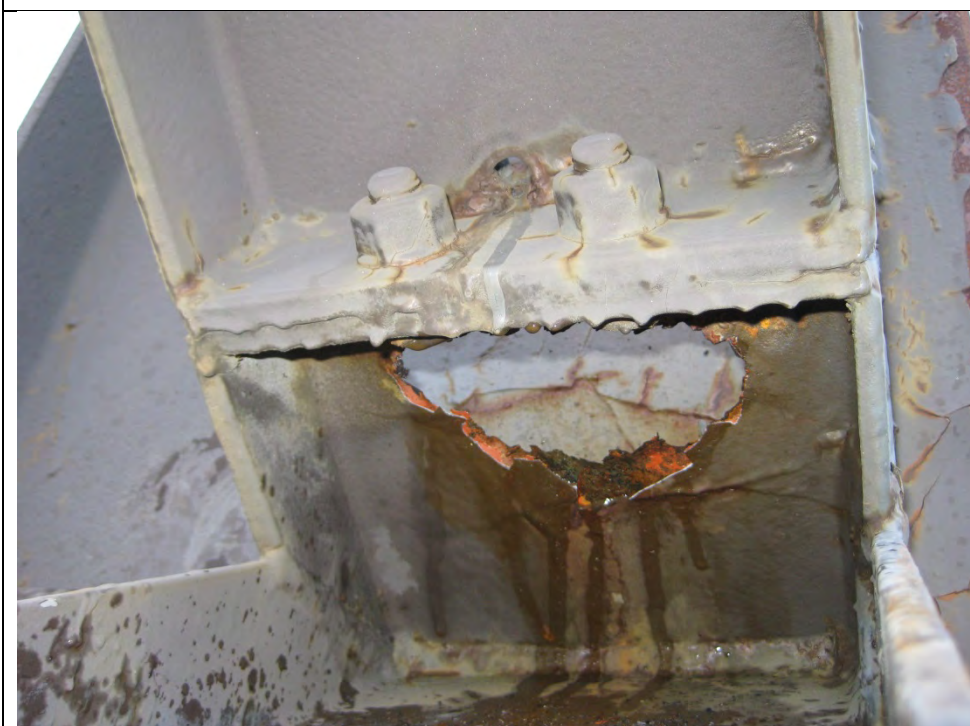
**JG-111313-18 SKAGWAY ORE TERMINAL SHIP LOADER**  
**LOCATION: SOUTH SHIP LOADER TOWER EAST FACE AT PP#5**

**DESCRIPTION: VIEW OF UNDERSIDE OF WEB. 6"X3" HOLE.**

**CONDITION STATE CS5**

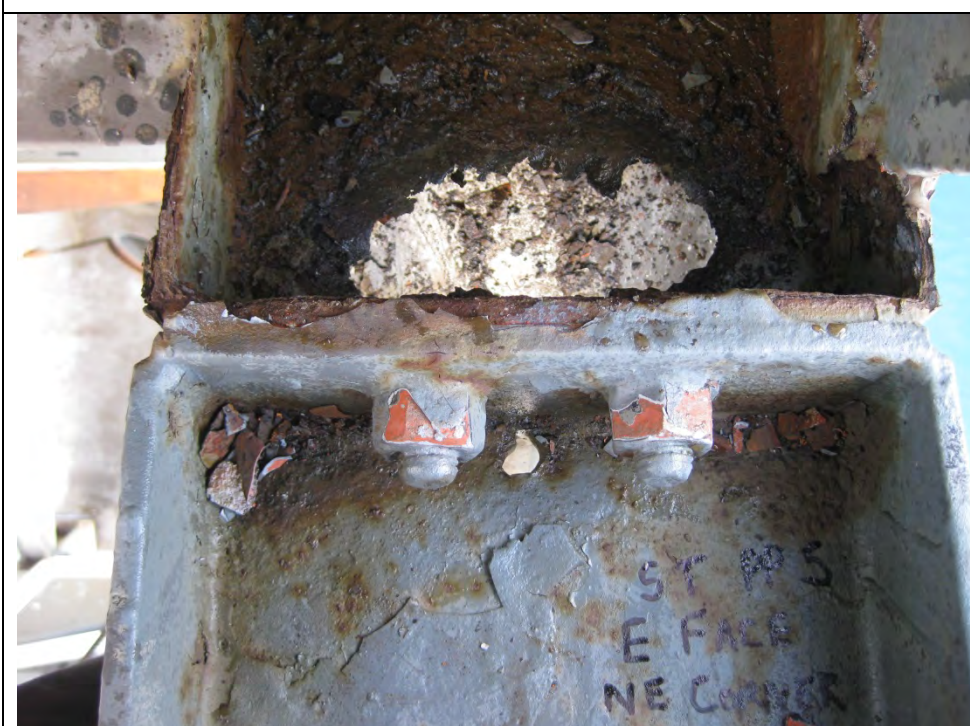
**JG-111313-17 SKAGWAY ORE TERMINAL SHIP LOADER**  
**LOCATION: SOUTH SHIP LOADER TOWER EAST FACE AT PP# 5**

**DESCRIPTION: DIAGONAL BRACE AT SPLICE 3-INCHES OFF WATER POOLED ON TOP SIDE IN BOARD FLANGE HAS HEAVY LAMINAR RUST WITH SECTION LOSS UP TO 1/8-INCH. WEB BETWEEN TOWER AND SPLICE HAS 6"X3" AREA WITH 100% SECTION LOSS.**

**CONDITION STATE CS5**
