**ALASKA INDUSTRIAL DEVELOPMENT AND EXPORT AUTHORITY**  
**SKAGWAY ORE TERMINAL**  
**SHIP LOADER STRUCTURAL INSPECTION**  
**November 11, 12 and 13, 2013**

**R&M Consultants, Inc.**

December 17, 2013

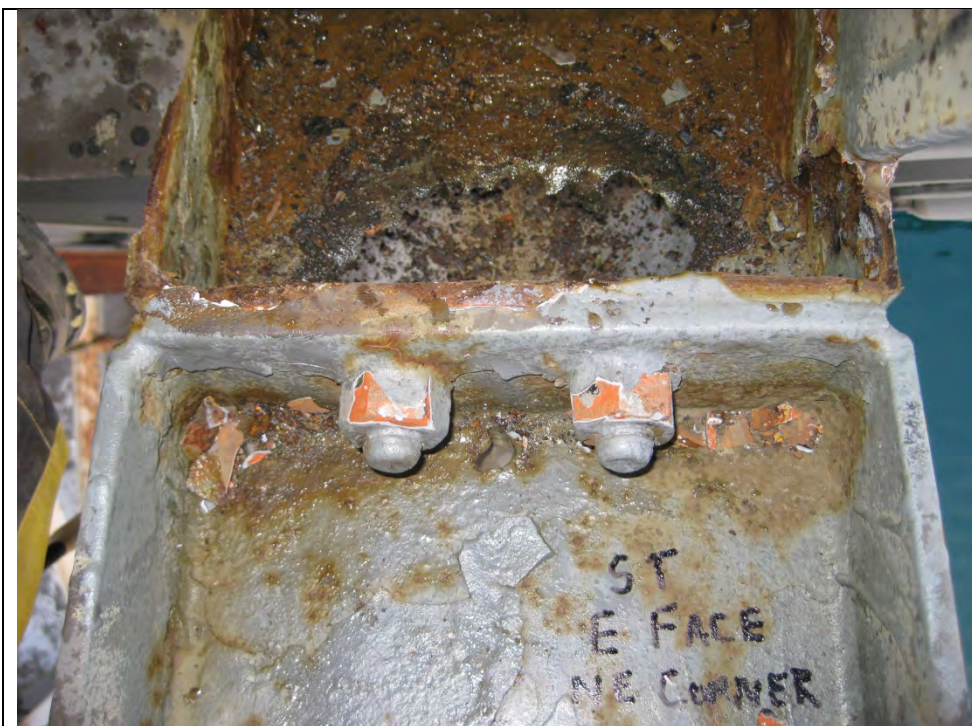
**JG-111313-16 SKAGWAY ORE TERMINAL SHIP LOADER**  
**LOCATION: SOUTH SHIP LOADER TOWER EAST FACE AT PP# 5**

**DESCRIPTION: DIAGONAL BRACE AT SPLICE 3-INCHES OFF WATER POOLED ON TOP SIDE INBOARD FLANGE HAS HEAVY LAMINAR RUST WITH SECTION LOSS UP TO 1/8-INCH. WEB BETWEEN TOWER AND SPLICE HAS 6"X3" AREA WITH 100% SECTION LOSS.**

**CONDITION STATE CS5**

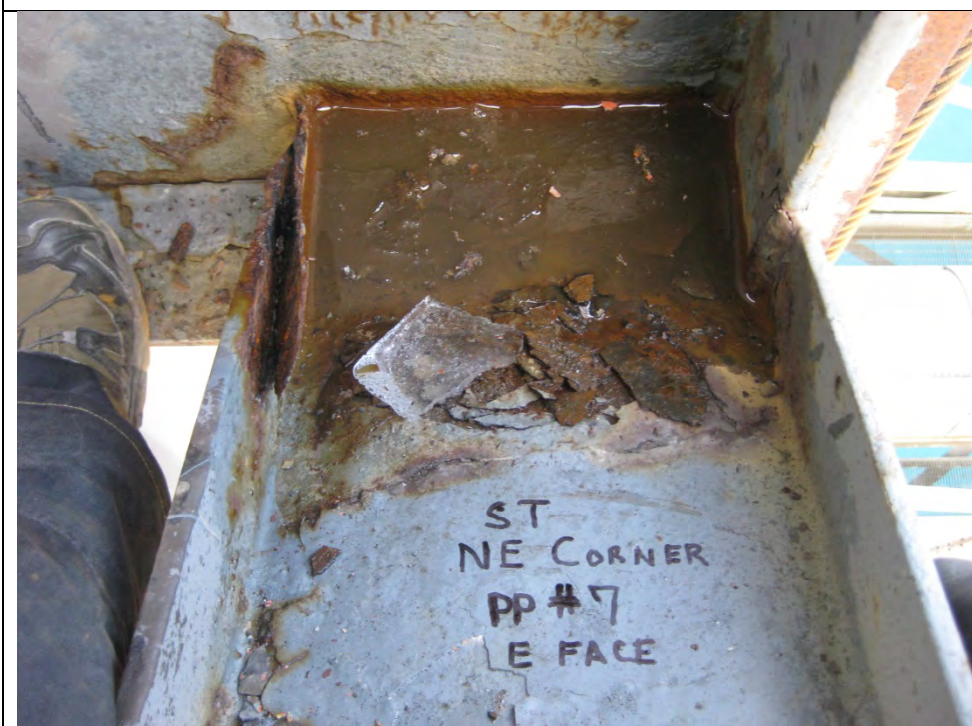
**JG-111313-15 SKAGWAY ORE TERMINAL SHIP LOADER**  
**LOCATION: SOUTH SHIP LOADER TOWER EAST FACE AT PP# 7**

**DESCRIPTION: WATER POOLING ON TOP SIDE OF DIAGONAL, HEAVY SECTION LOSS TO FLANGE ON INBOARD UP TO 1/8-INCH (COMMON TO FIND THIS TYPE CORROSION AT THESE LOCATIONS)**

**CONDITION STATE CS4/5**

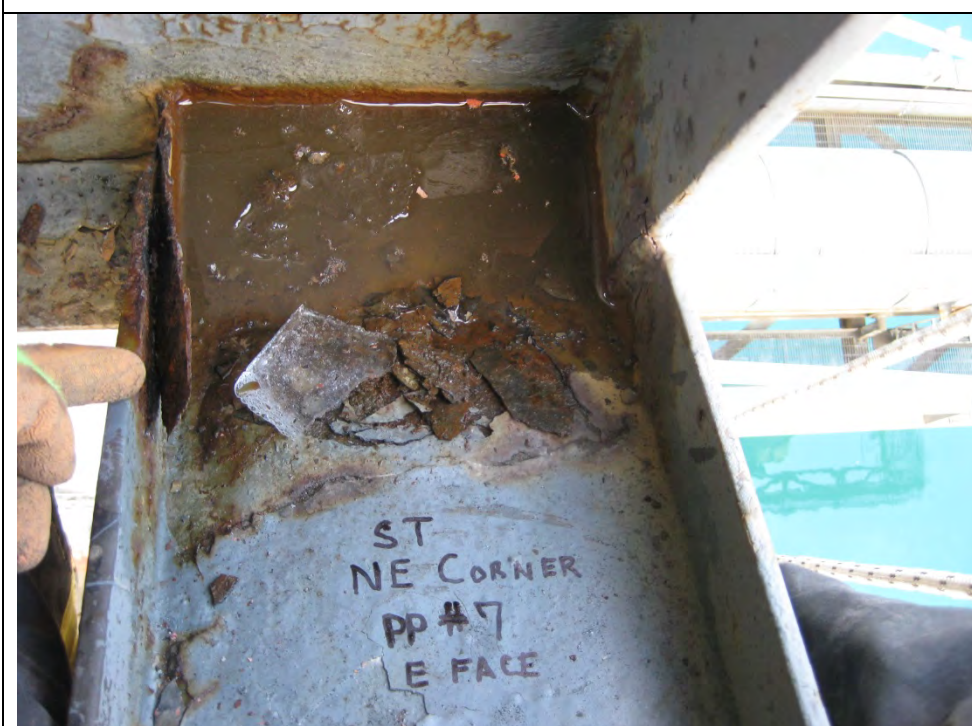
**JG-111313-14 SKAGWAY ORE TERMINAL SHIP LOADER**  
**LOCATION: SOUTH SHIP LOADER TOWER EAST FACE AT PP# 7**

**DESCRIPTION: WATER POOLING ON TOP SIDE OF DIAGONAL, HEAVY SECTION LOSS TO FLANGE ON INBOARD UP TO 1/8-INCH (COMMON TO FIND THIS TYPE CORROSION AT THESE LOCATIONS)**

**CONDITION STATE CS4/5**

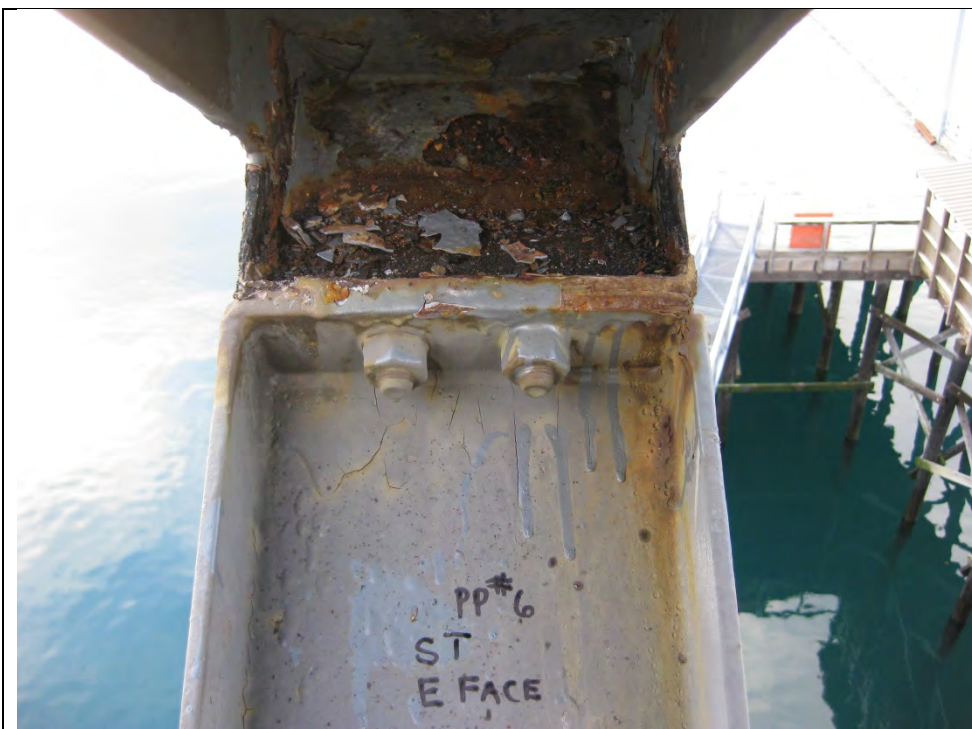
**JG-111313-13 SKAGWAY ORE TERMINAL SHIP LOADER**  
**LOCATION: SOUTH SHIP LOADER TOWER EAST FACE AT PP#6**

**DESCRIPTION: PACK RUST FORMING BETWEEN SEAM AT BOLTED CONNECTION. WATER POOLING ABOVE JOINT DUE TO NO DRAIN HOLE. HEAVY SECTION LOSS TO DIAGONAL FLANGES, UP TO 1/8 INCH.**

**CONDITION STATE CS4/5**

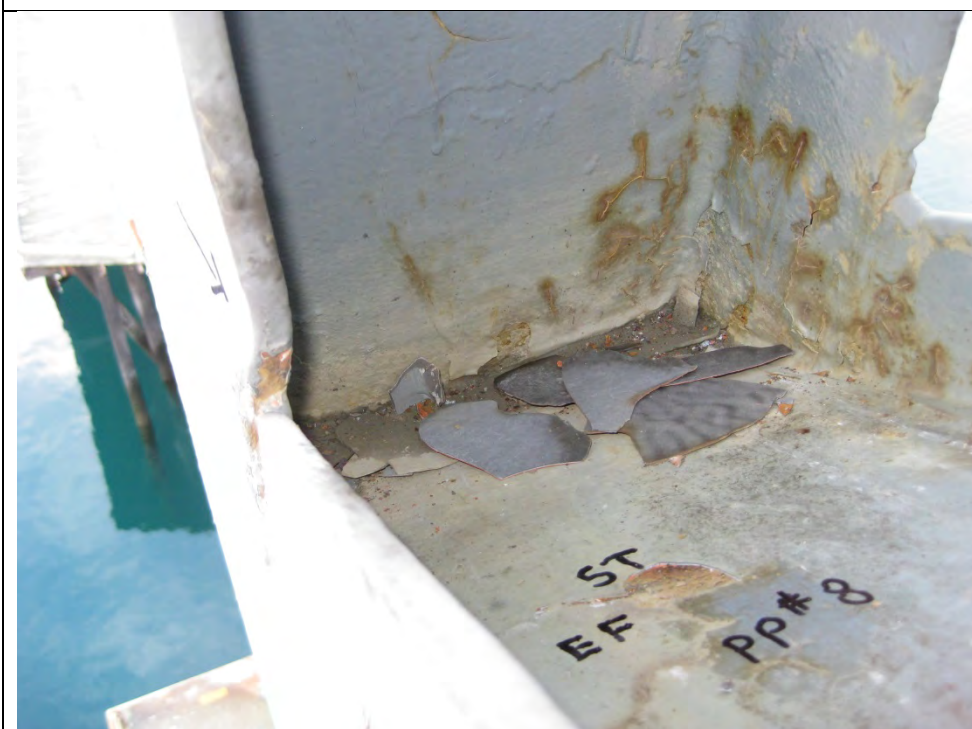
**JG-111313-12 SKAGWAY ORE TERMINAL SHIP LOADER**  
**LOCATION: SOUTH SHIP LOADER TOWER EAST FACE AT PP# 8**

**DESCRIPTION: OUTBOARD VERTICAL TOWER FLANGE IS BENT OUT OF PLANE UP TO ¼-INCH.**

**CONDITION STATE CS4**

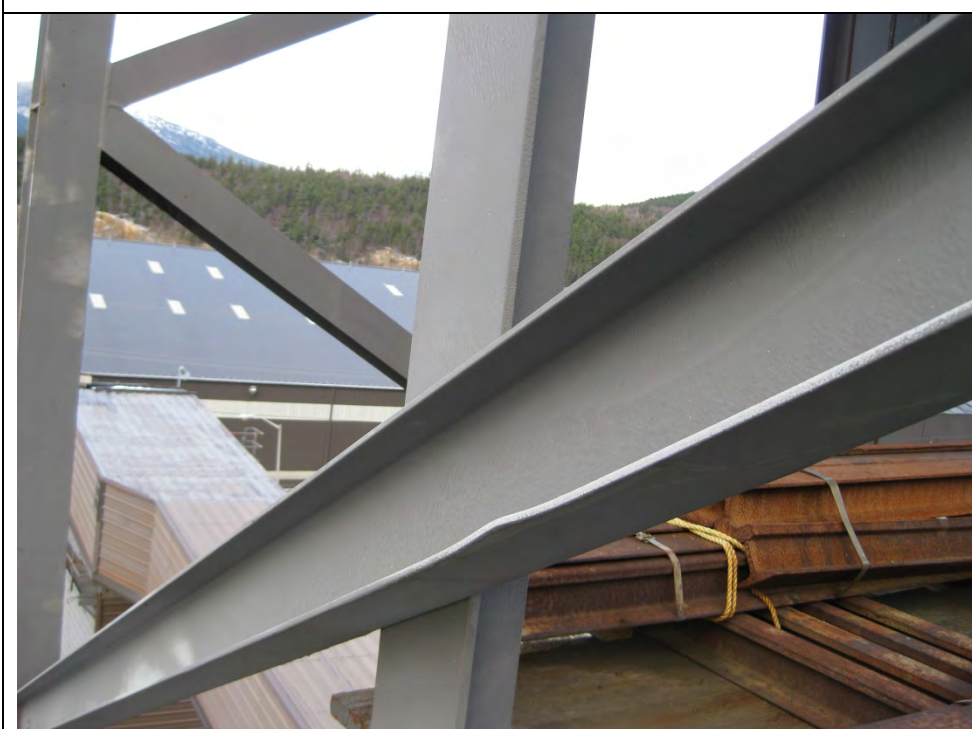
**JG-111313-11 SKAGWAY ORE TERMINAL SHIP LOADER**  
**LOCATION: SOUTH SHIP LOADER TOWER SOUTH FACE AT SE CORNER PP#9**

**DESCRIPTION: DIAGONAL BRACE BETWEEN PP#9 AND PP#? 3 FEET FROM PP#9 BOTTOM OUTBOARD FLANGE IS BENT OUT OF PLANE ½-INCH.**

**CONDITION STATE CS2**

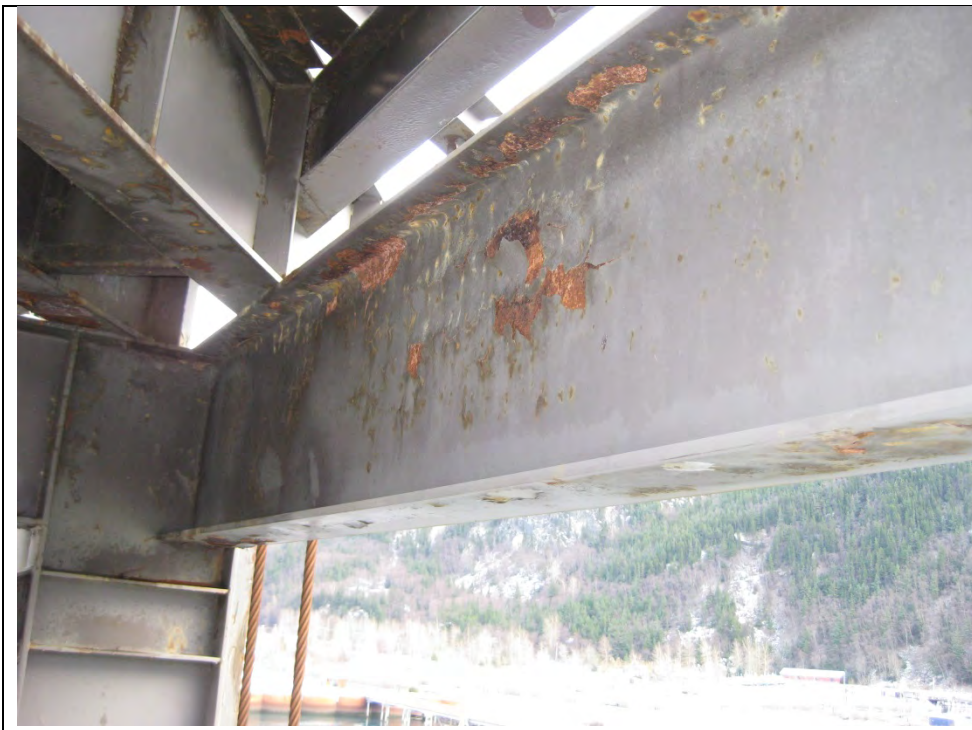
**JG-111313-10 SKAGWAY ORE TERMINAL SHIP LOADER**  
**LOCATION: SOUTH SHIP LOADER TOWEREAST FACE GIRDER BETWEEN NE AND SE TOWER LEGS**

**DESCRIPTION: MID SPSN 3'X2' AREA WITH HEAVY LAMINAR RUST FORMING BEHIND FAILED PAINT.**

**CONDITION STATE CS3**

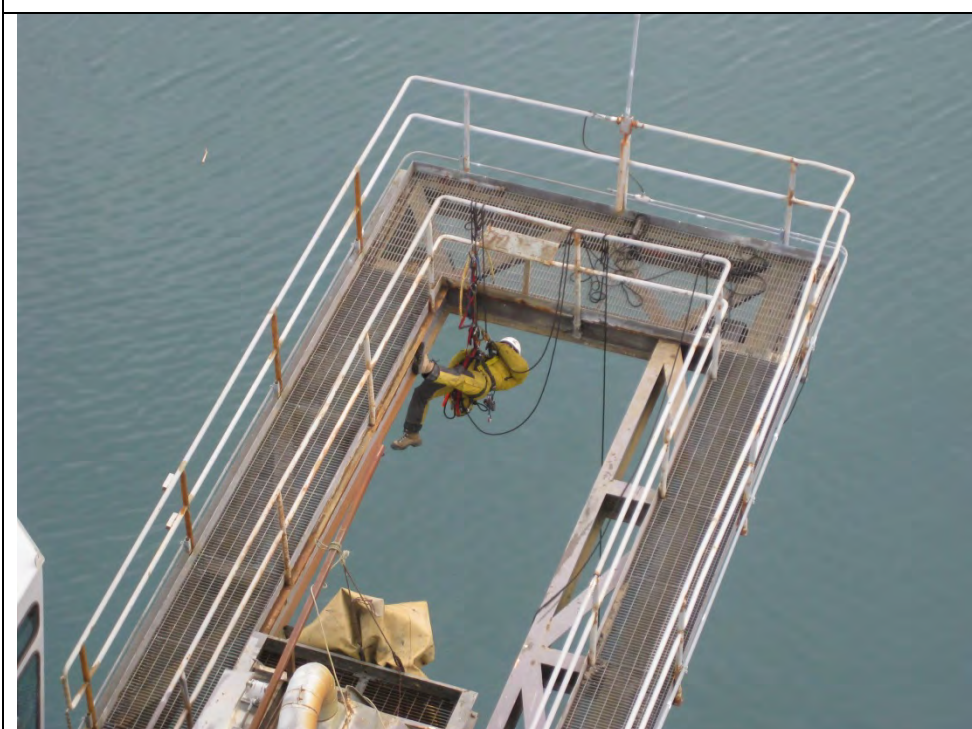
**JG-111313-08 SKAGWAY ORE TERMINAL SHIP LOADER**  
**LOCATION: SHIP LOADER BOOM VIEWED FROM ABOVE ON SOUTH TOWER**

**DESCRIPTION: BOOM STRUCTURE INSPECTION AT SHUTTLE SPOUT SLOT. NOTE RUSTED FLANGE AND WEB ON LEFT OF OPENING THAT IS CAUSED BY SHUTTLE WHEEL RUBBING.**

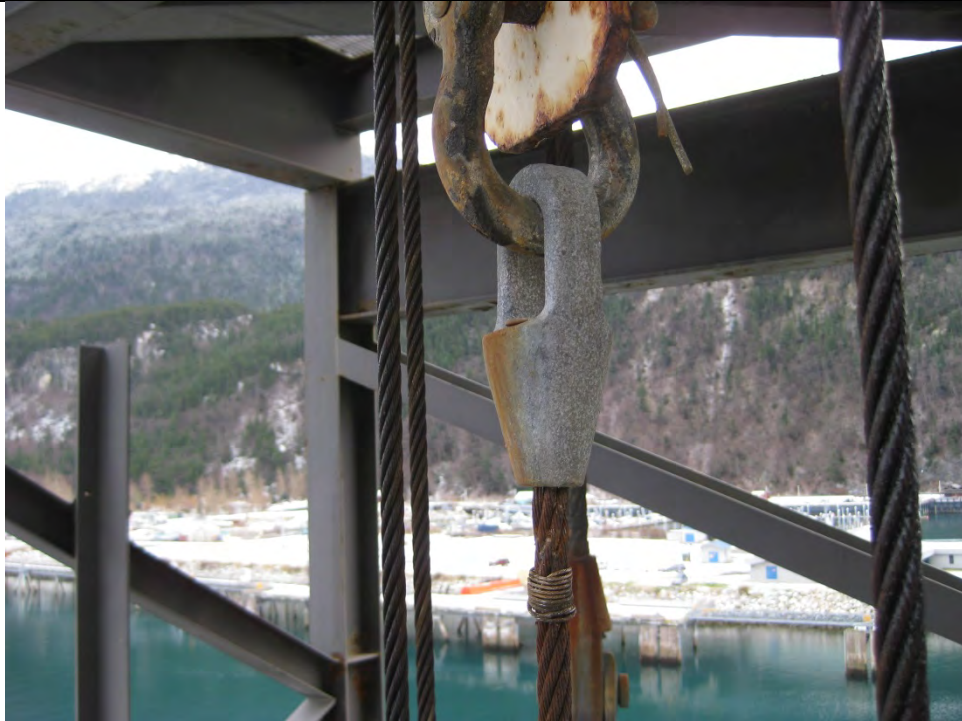
**JG-111313-07 SKAGWAY ORE TERMINAL SHIP LOADER**  
**LOCATION: SOUTH SHIP LOADER TOWER COUNTER WEIGHT LIFT CABLE CONNECTION TO PULLEY AT TOP PLATFORM**

**DESCRIPTION: HEAVY CORROSION WITH SECTION LOSS AT THIMBLE.**

**CONDITION STATE CS5**

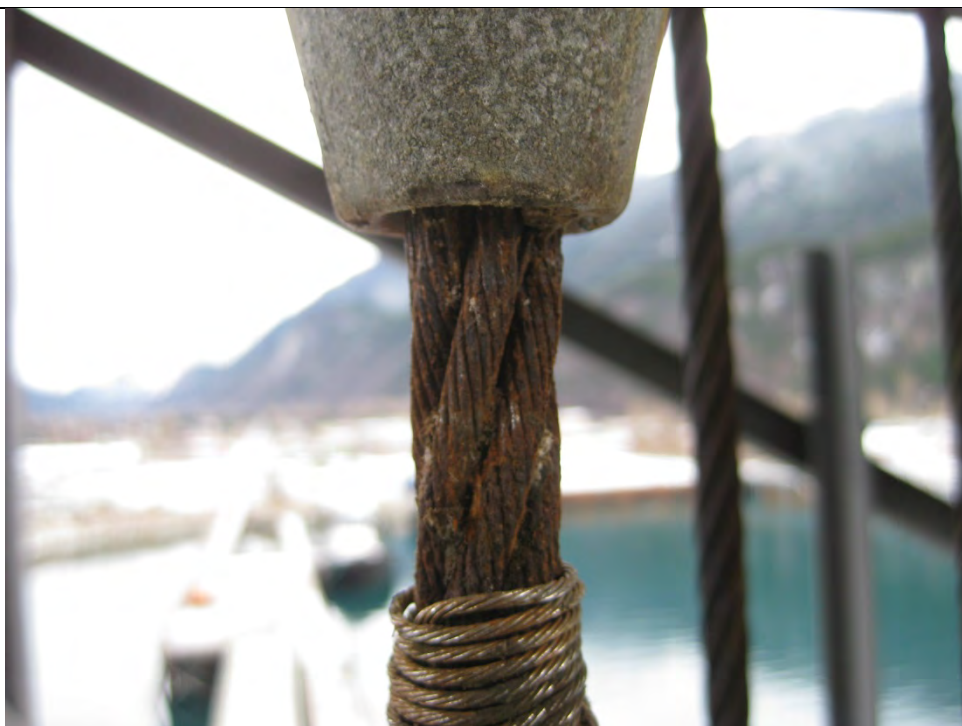
**JG-111313-06 SKAGWAY ORE TERMINAL SHIP LOADER**  
**LOCATION: SOUTH SHIP LOADER TOWER COUNTER WEIGHT LIFT CABLE CONNECTION TO PULLEY AT TOP PLATFORM**

**DESCRIPTION: HEAVY CORROSION WITH SECTION LOSS AT THIMBLE.**

**CONDITION STATE CS5**

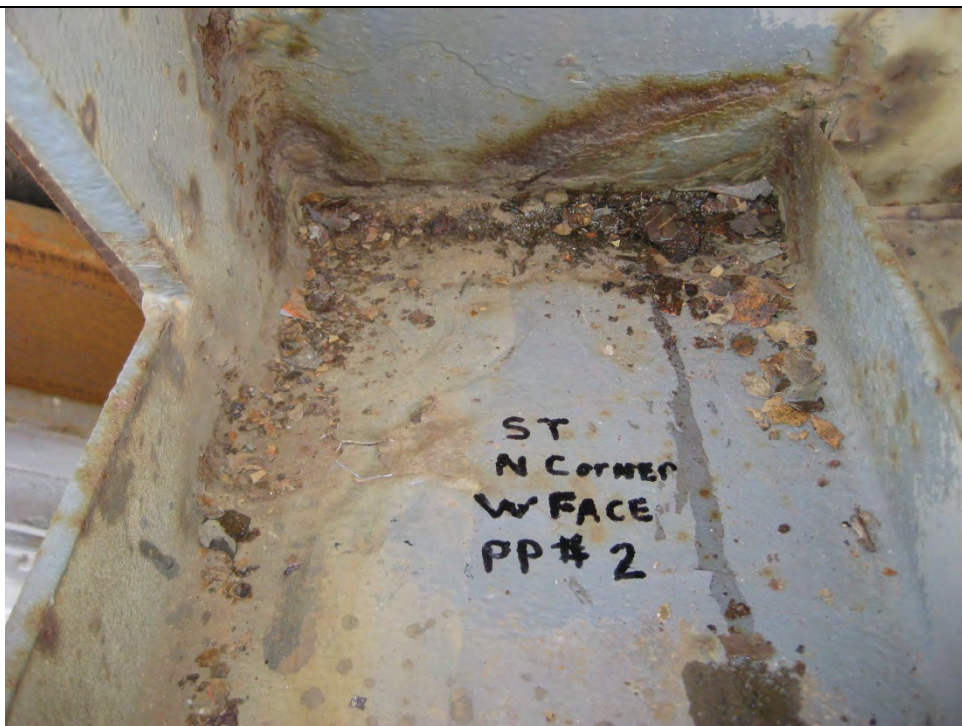
**JG-111313-05 SKAGWAY ORE TERMINAL SHIP LOADER**  
**LOCATION: SOUTH SHIP LOADER TOWER W FACE AT NW CORNER PP#2**

**DESCRIPTION: HEAVY LAMINAR RUST WITH SECTION LOSS TO INBOARD FLANGE UP TO 1/8-INCH (COMMON TO FIND CORROSION AT THESE LOCATIONS)**

**CONDITION STATE CS4/5**

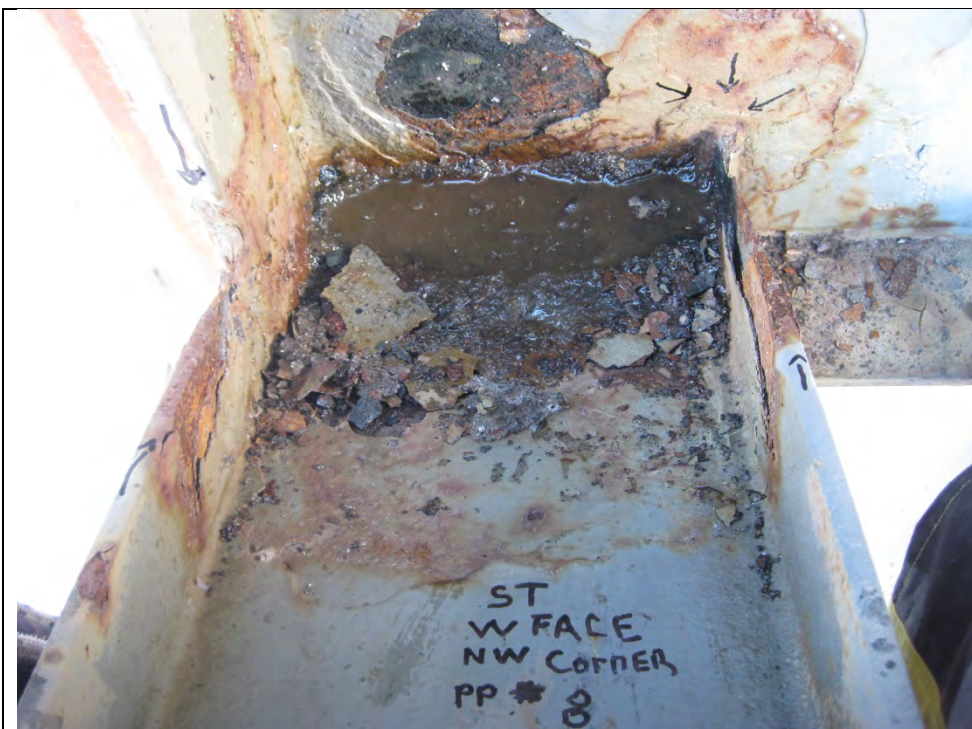
**JG-111313-04 SKAGWAY ORE TERMINAL SHIP LOADER**  
**LOCATION: SOUTH SHIP LOADER TOWER W FACE AT NW CORNER AT PP#8**

**DESCRIPTION: WATER IS POOLING ON TOP[SIDE OF DIAGONAL BRACE. SECTION LOSS TO WEN ON TOWER UP TO 1/16-INCH. 12-INCH OUT FROM TOWER FLANGESS HAVE UP TO 3/4-INCH SECTION LOSS. HEAVY CORROSION AT THIS PANEL POINT.**

**CONDITION STATE CS4/5**

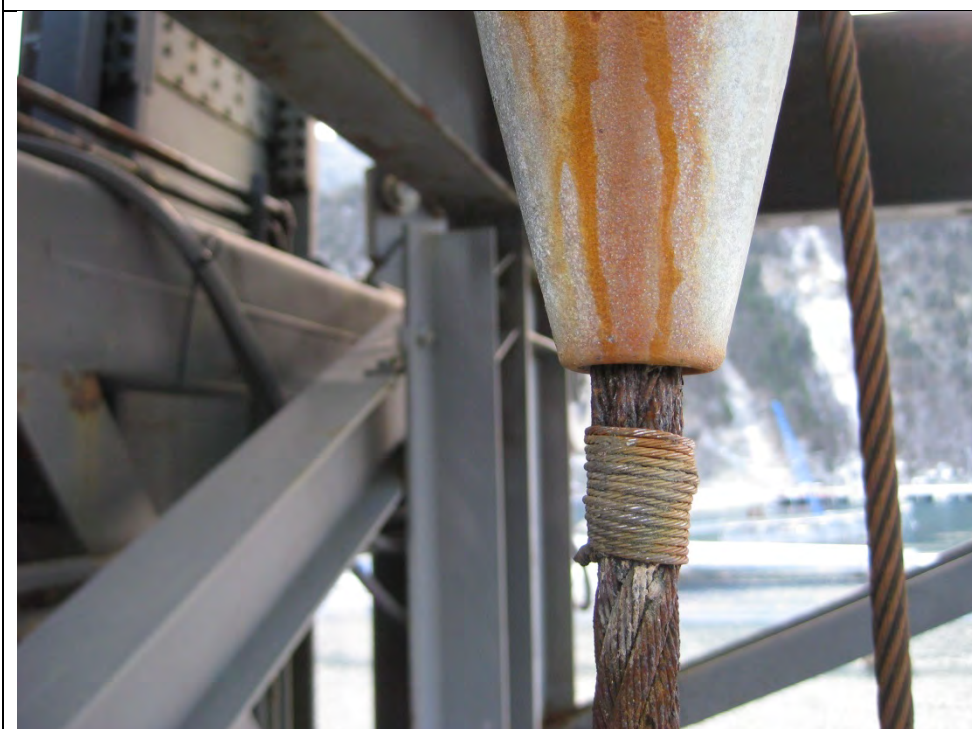
**JG-111313-03 SKAGWAY ORE TERMINAL SHIP LOADER**  
**LOCATION: SOUTH SHIP LOADER TOWER WEST FACE AT NW CORNER**

**DESCRIPTION: CABLES CONNECTED TO BOOM HOIST PLATFORM HAS HEAVY CORROSION WITH BROKEN STRANDS JUST UNDER THIMBLE SOCKET FITTING.**

**CONDITION STATE CS5**

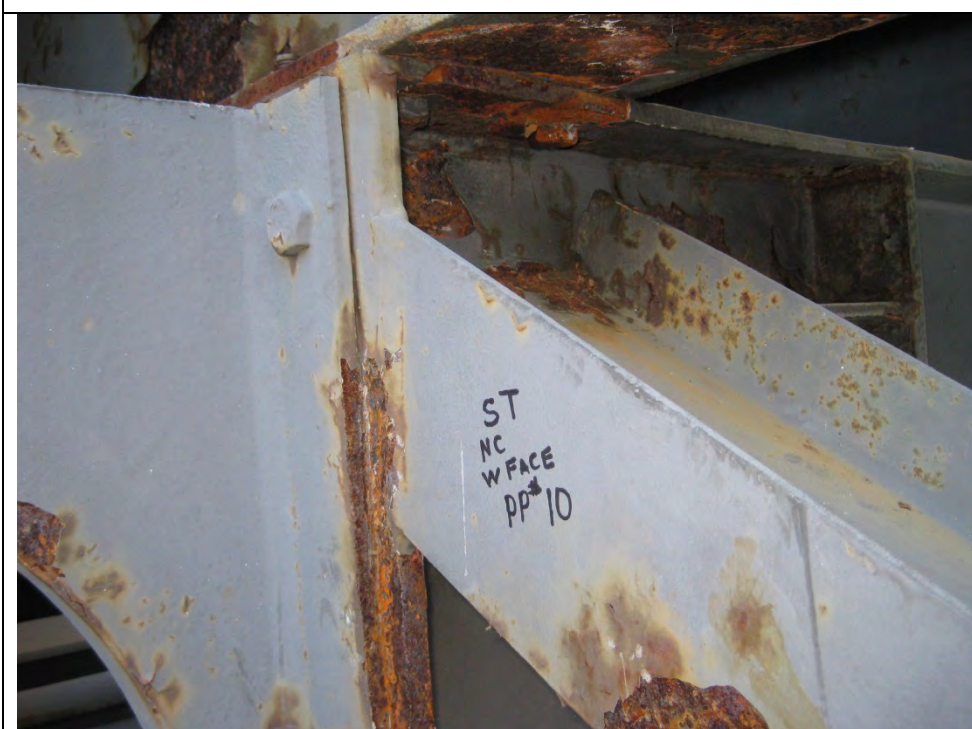
**JG-111313-02 SKAGWAY ORE TERMINAL SHIP LOADER**  
**LOCATION: SOUTH SHIP LOADER TOWER W FACE AT NW CORNER LEG PP# 10**

**DESCRIPTION: HEAVY RUST SCALE/LAMINAR RUST AT WELDS AND BOLTED CONNECTIONS 1/4-INCH OF PACK RUST FORMING BETWEEN BOLTED CONNECTIONS.**

**CONDITION STATE CS4/5**

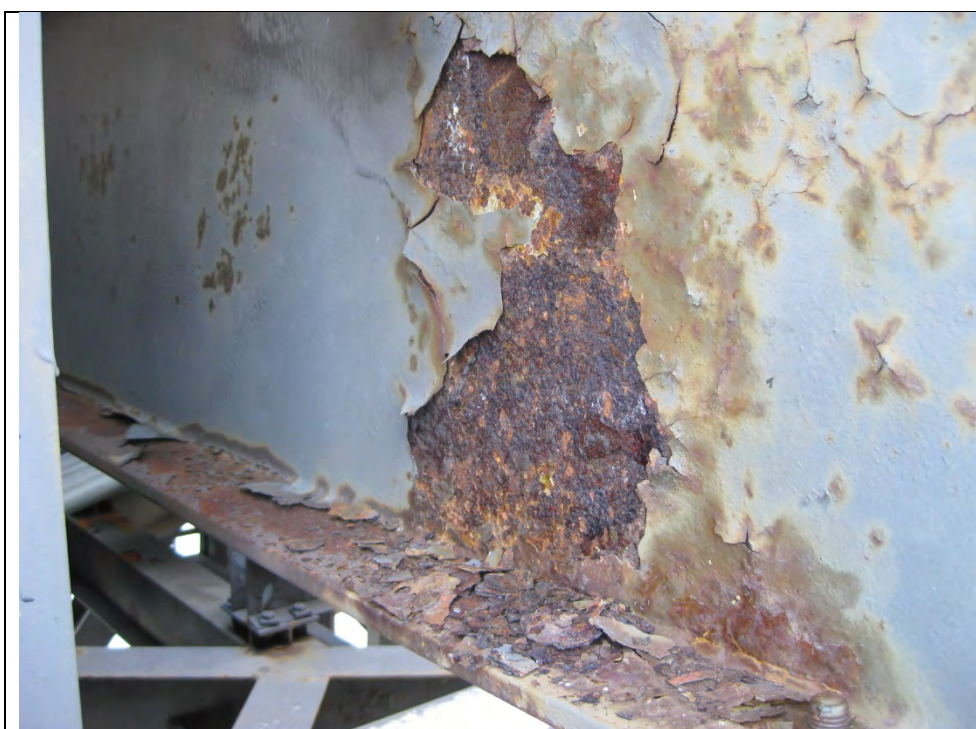
**JG-111313-01 SKAGWAY ORE TERMINAL SHIP LOADER**

**LOCATION: SOUTH SHIP LOADER TOWER W FACE AT NW CORNER LEG**

**DESCRIPTION: WEB ABOVE NW LEG HAS A 1 FOOT BY 2 FOOT AREA WITH 100% PAINT FAILURE WITH HEAVY LAMINAR RUST FORMING AND SECTION LOSS TO WEB.**

**CONDITION STATE CS4/5**
