CONDITION SURVEY
REPORT

AIDEA Building
813 W. Northern
Lights
Anchorage, AK

RSA Engineering, Inc
670 W Fireweed Lane, Ste 200
Anchorage, AK 99503

Dustin McCleskey, PE, Tim Hall, PE
RSA No. M0150

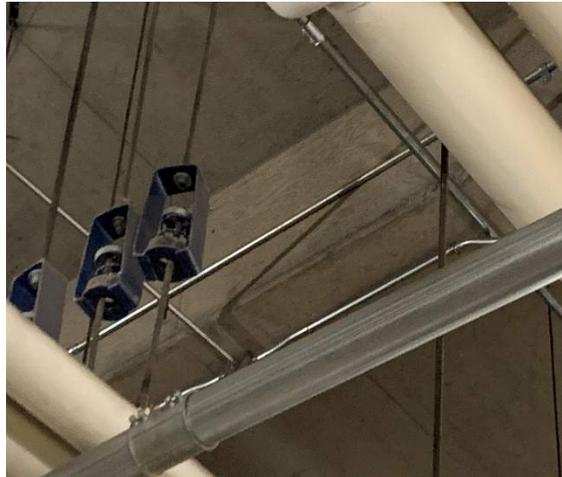
Photograph No. 1

- a. Foundation: The foundation consists of combination CMU and concrete stem walls assumed to be on strip footings.
- b. First Floor Framing: The first-floor framing, shown in Photograph No. 1, contains 16x14 concrete beams spanning 19 feet framing to concrete girders of the same size spanning 12 feet. The girders are supported by CMU/concrete walls on either end. The floor is made of a concrete slab, shown in Photograph No. 2. These girders are supported by CMU and concrete walls.

Description: Basement framing

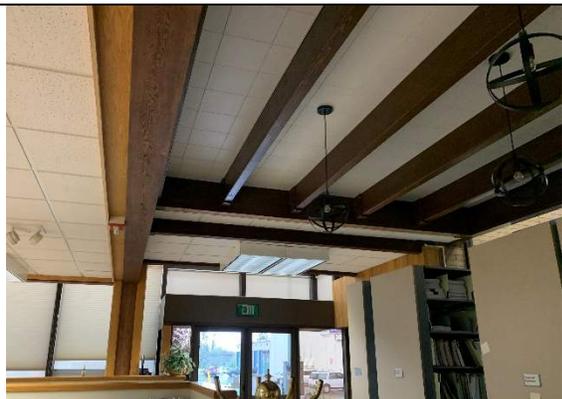
- c. Mezzanine Framing: The framing at this level, shown in Photograph No. 3 consists of 5.75x19 glue-laminated beams (GLB) normal to the girders that span 28 feet at 7 feet on center framing to 8.75x28 GLB at 26 feet on center. The GLB are supported by timber columns on each end. There are also 2x8 joists running between the beams.

Description: First floor/mezzanine framing

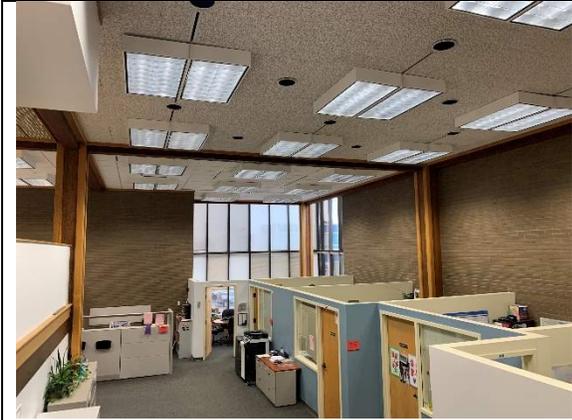
Photograph No. 4

Description: Second floor framing

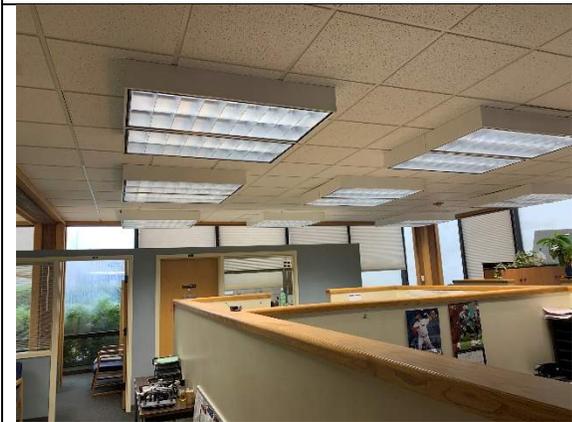
Photograph No. 5

- a. Structural roof and floor framing, where visible, appeared to be in good condition. The structural floor framing for the first and second floors were designed for approximately 70 psf live load and show no apparent signs of damage or failure. Ceiling nonstructural components, shown in Photograph No. 5, are in good condition and don't appear to need any additions/modifications made to them.

Description: Typical light fixtures and ceiling tiles
