MUNICIPALITY OF ANCHORAGE

SOILS LOG

HOLE NO. 1 19

PROJECT 26th & 27th Ave. RID Test Holes
 CONTRACTOR _____

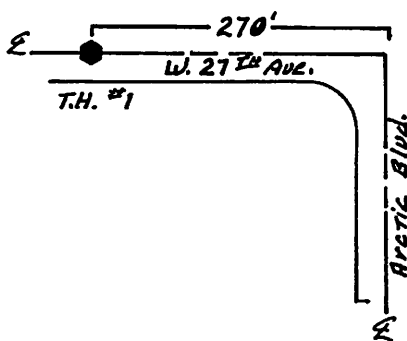
LOCATION SKETCH:

LOCATION 26TH/27TH Ave. R.I.D. / E of W. 27TH Ave.
270' West of the E of Arctic Blvd.

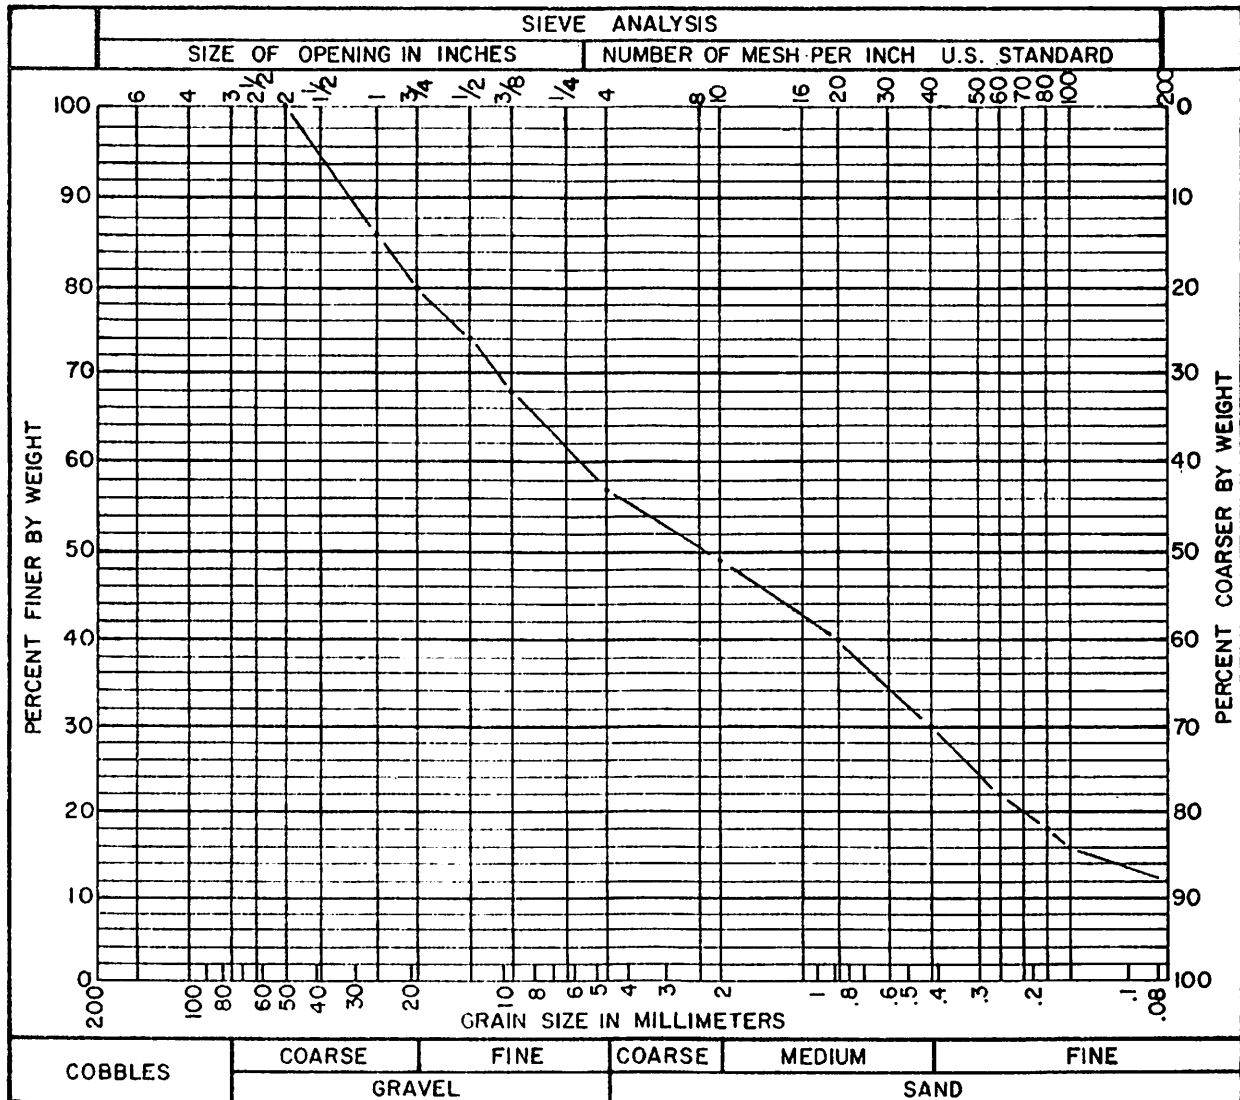
TEST NO. EX-717
 DATE Nov. 8, 1979

MATERIAL SOURCE 1-A / 0 to 0.5' below O.G.

COMMENTS SW-SM/F-2 / Gravelly sand w/ silt / 4% Moisture
43% 45% 12%

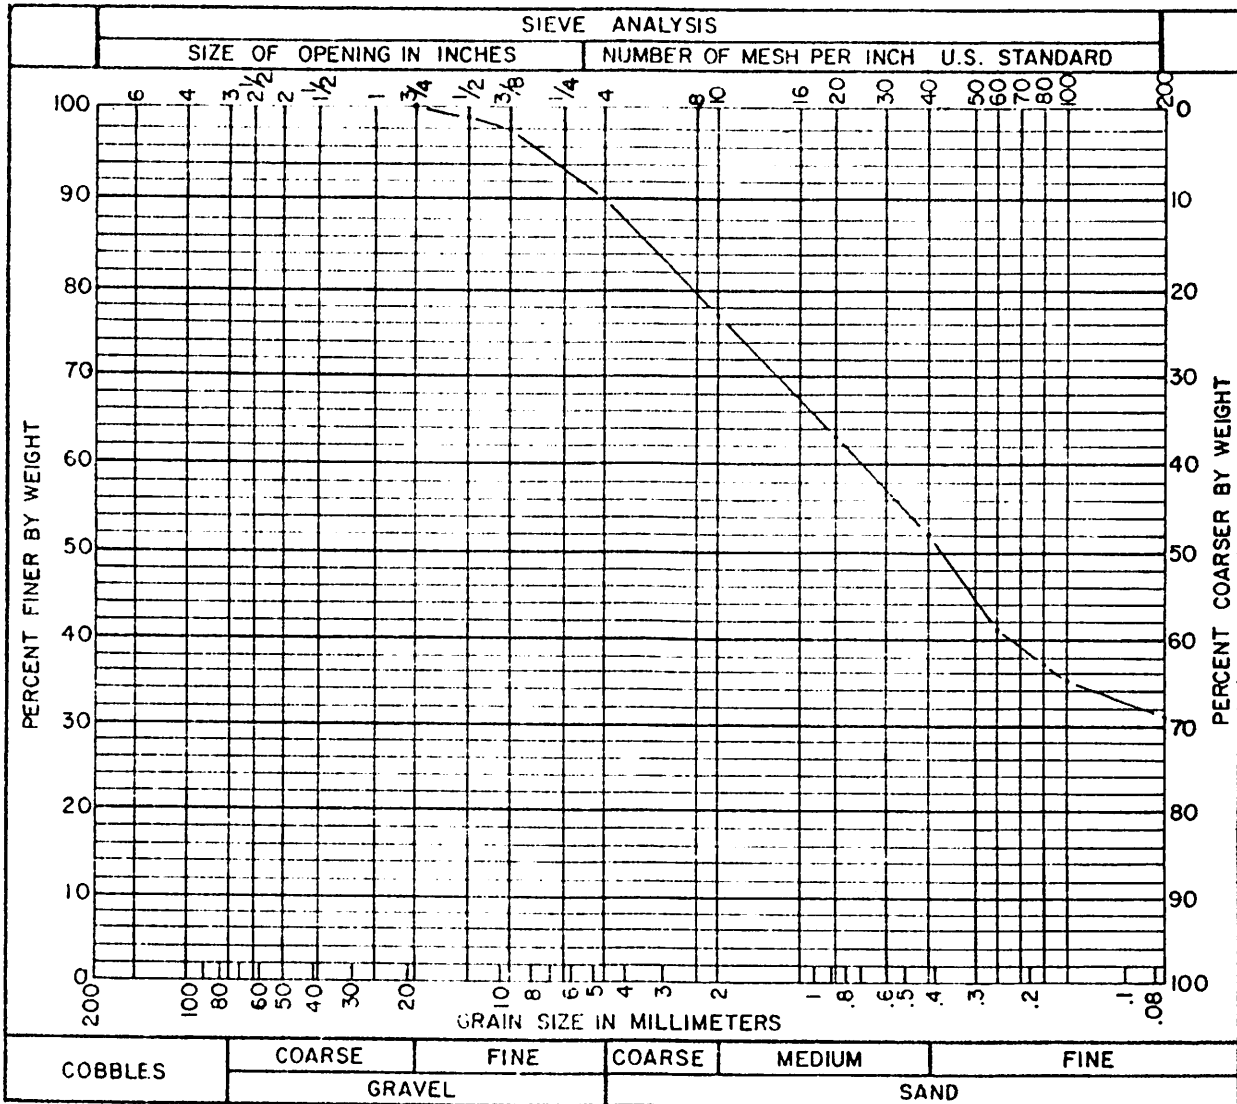
TEST NO. EX-718

MATERIAL SOURCE 1-B / 0⁵' to 1⁵' below O.G.

COMMENTS SM/F-3 / Silty Sand w/ Gravel / 14% Moisture
31% 59% 10%

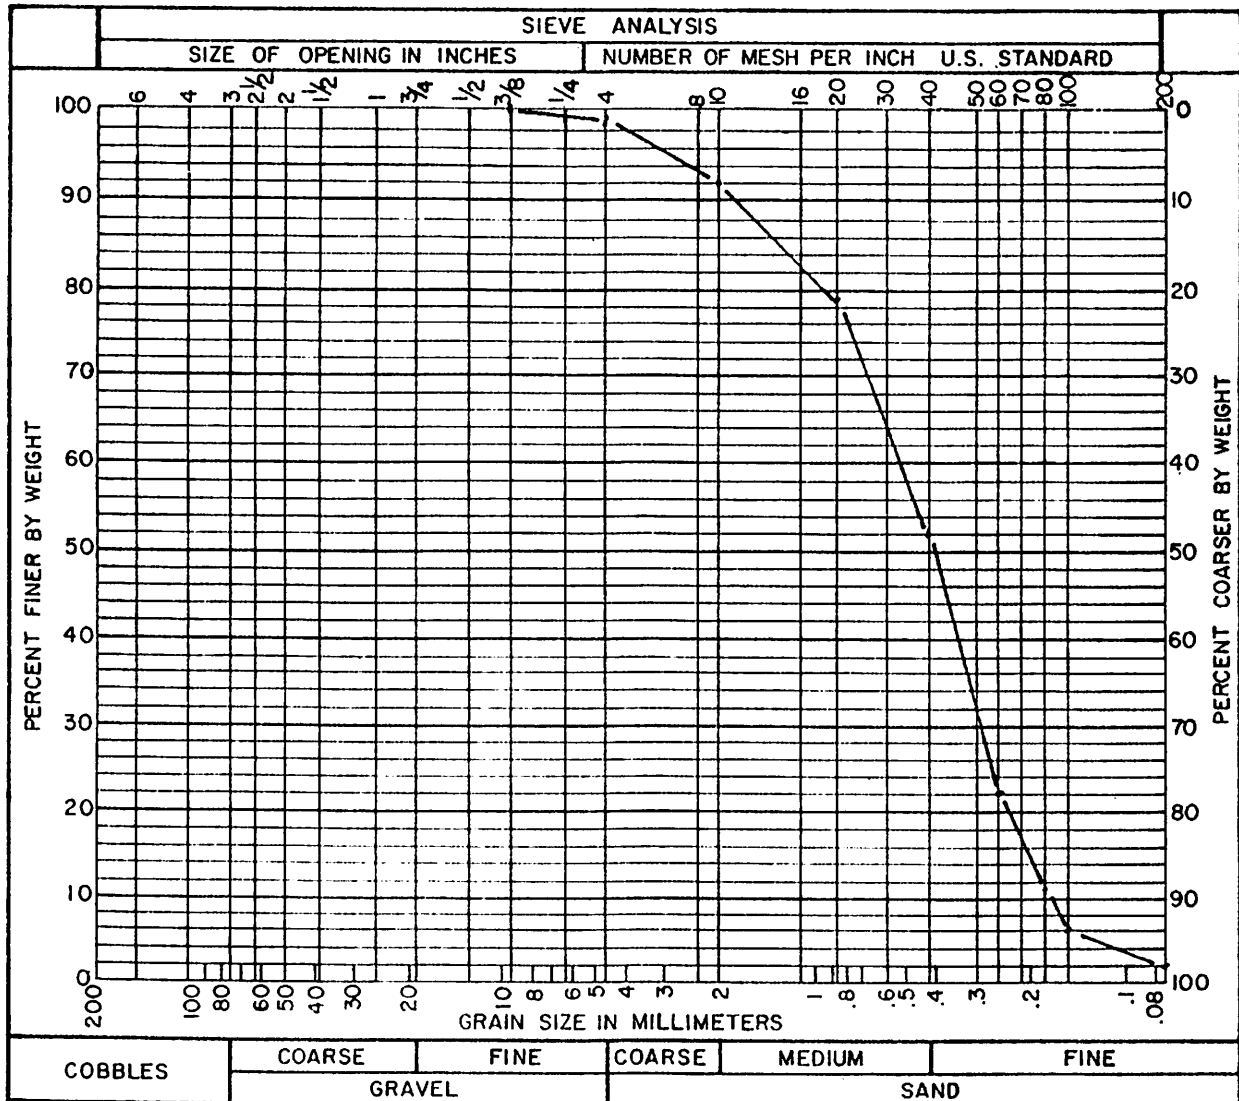
TEST NO. EX-719
 DATE Nov. 8, 1979

MATERIAL SOURCE 1-C / 15' to 45' below O.G.

COMMENTS SP/NES / SAND / 97% / 4% Moisture / 2% Silt; 1% Gravel

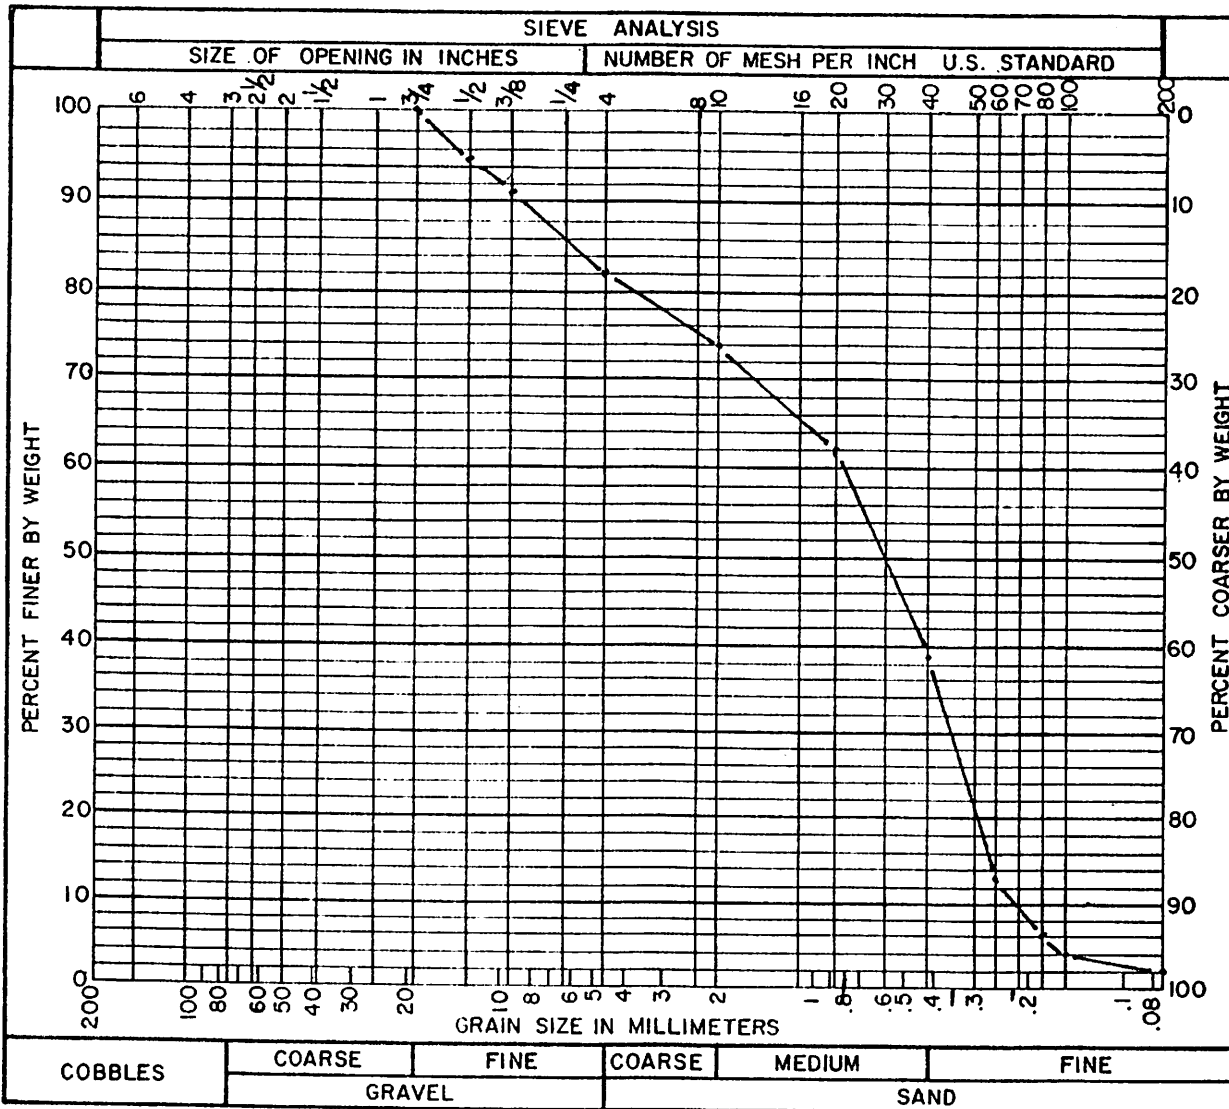
TEST NO. EX-720

MATERIAL SOURCE 1-D/4^{5'} to 6^{5'} below O.G.

COMMENTS SP/NFS / Gravel Sand / 18% Moisture / 80% Silt / 2%

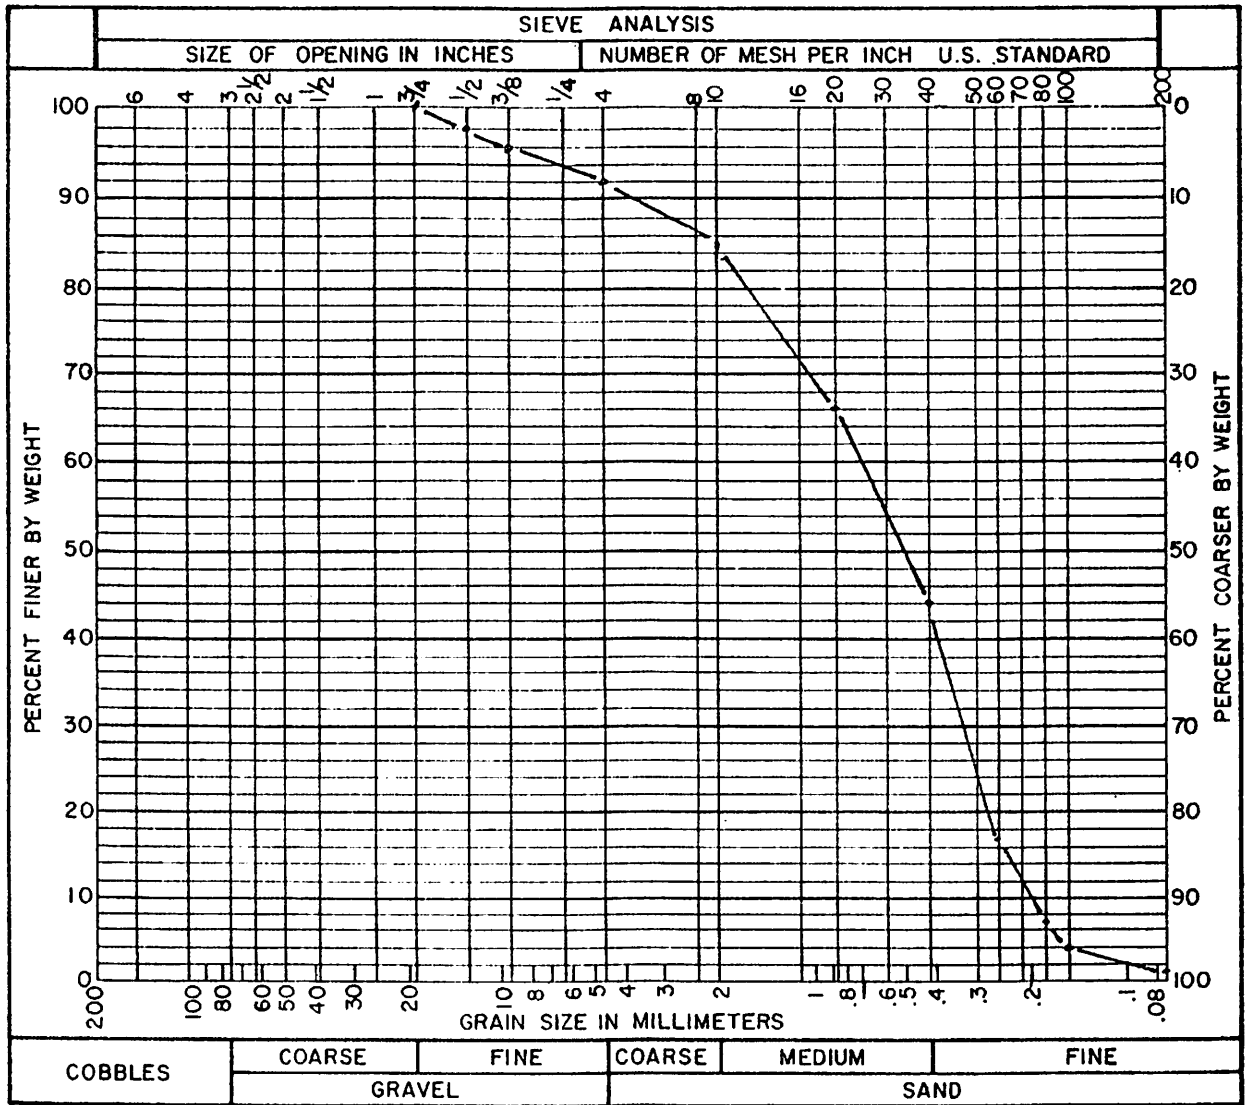
PROJECT 26th & 27th Ave RID Test Holes TEST NO. EX-721
 DATE Nov. 8, 1979
 CONTRACTOR _____
 MATERIAL SOURCE 1-E/6⁵' to 8²' below O.G.
 LOCATION SAMPLED 27th Ave. / 270' W of Arctic Blvd. BY M. Krueger, D. Bolles
 COMMENTS SP/NFS / Sand w/ Gravel / 3% Moisture / 1% Silt
 REPORTED TO _____
 PLOTTED BY SA CHECKED BY BD MATERIALS SUPERVISOR J. D. Pennington

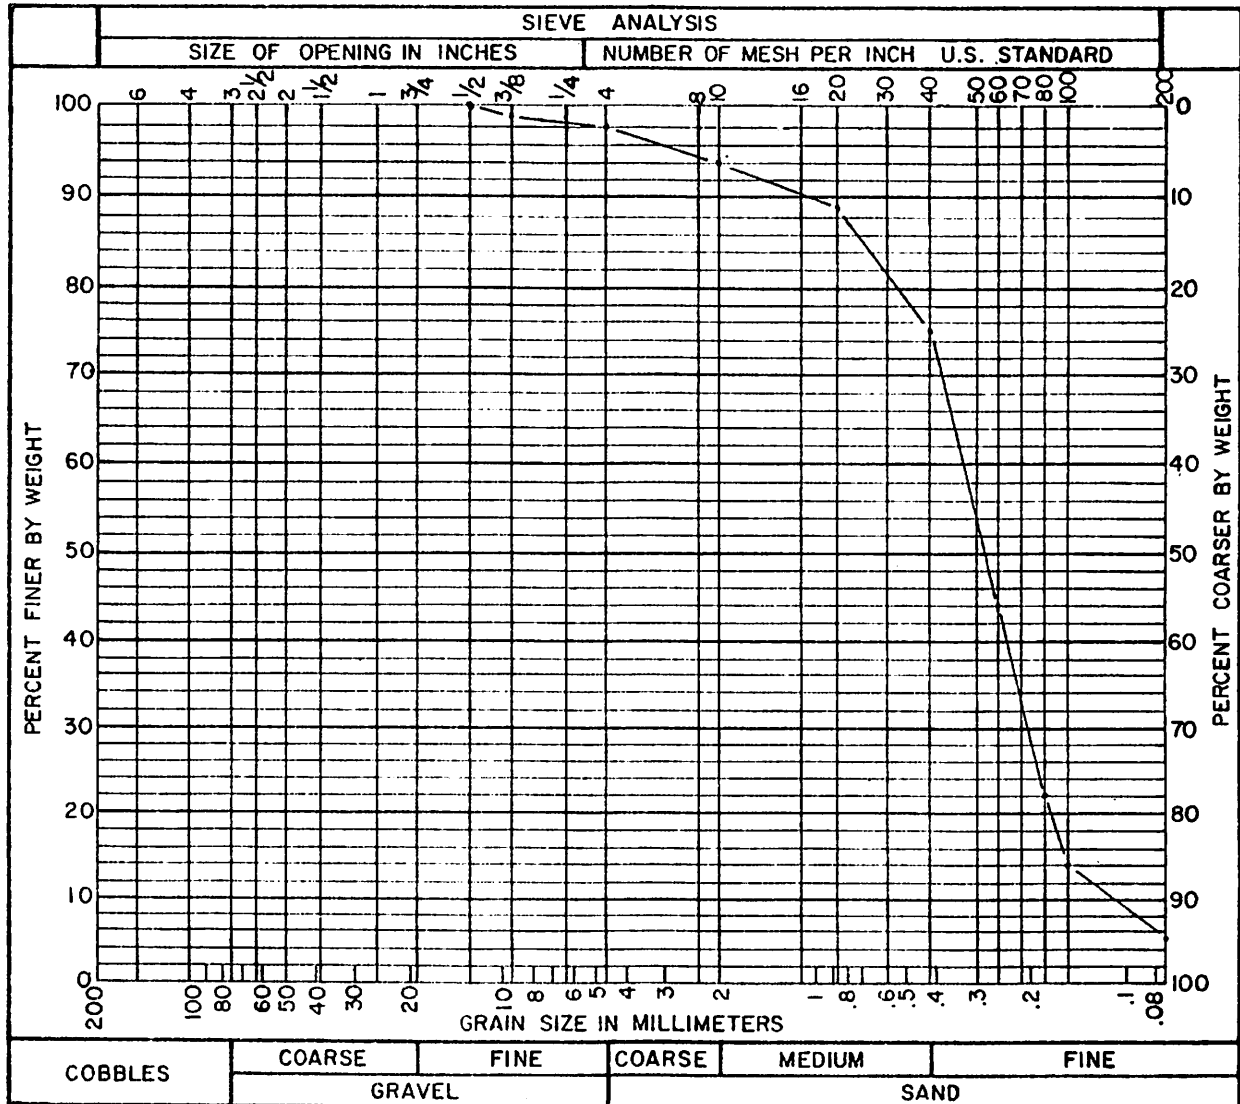
TEST NO. EX-722

MATERIAL SOURCE 1-F/8' to 9' below O.G.

COMMENTS SP-SM/NFS / Sand w/ Silt / 4% Moisture / 2% Gravel
93% 5%
