ALASKA ENERGY AUTHORITY
VILLAGE POWER SYSTEM ASSESSMENT

Community: Chignik Bay
Evaluation Date: June 10, 2012 Time Started 10:00am Completed 4:00pm
Evaluator(s): Tim Gardner

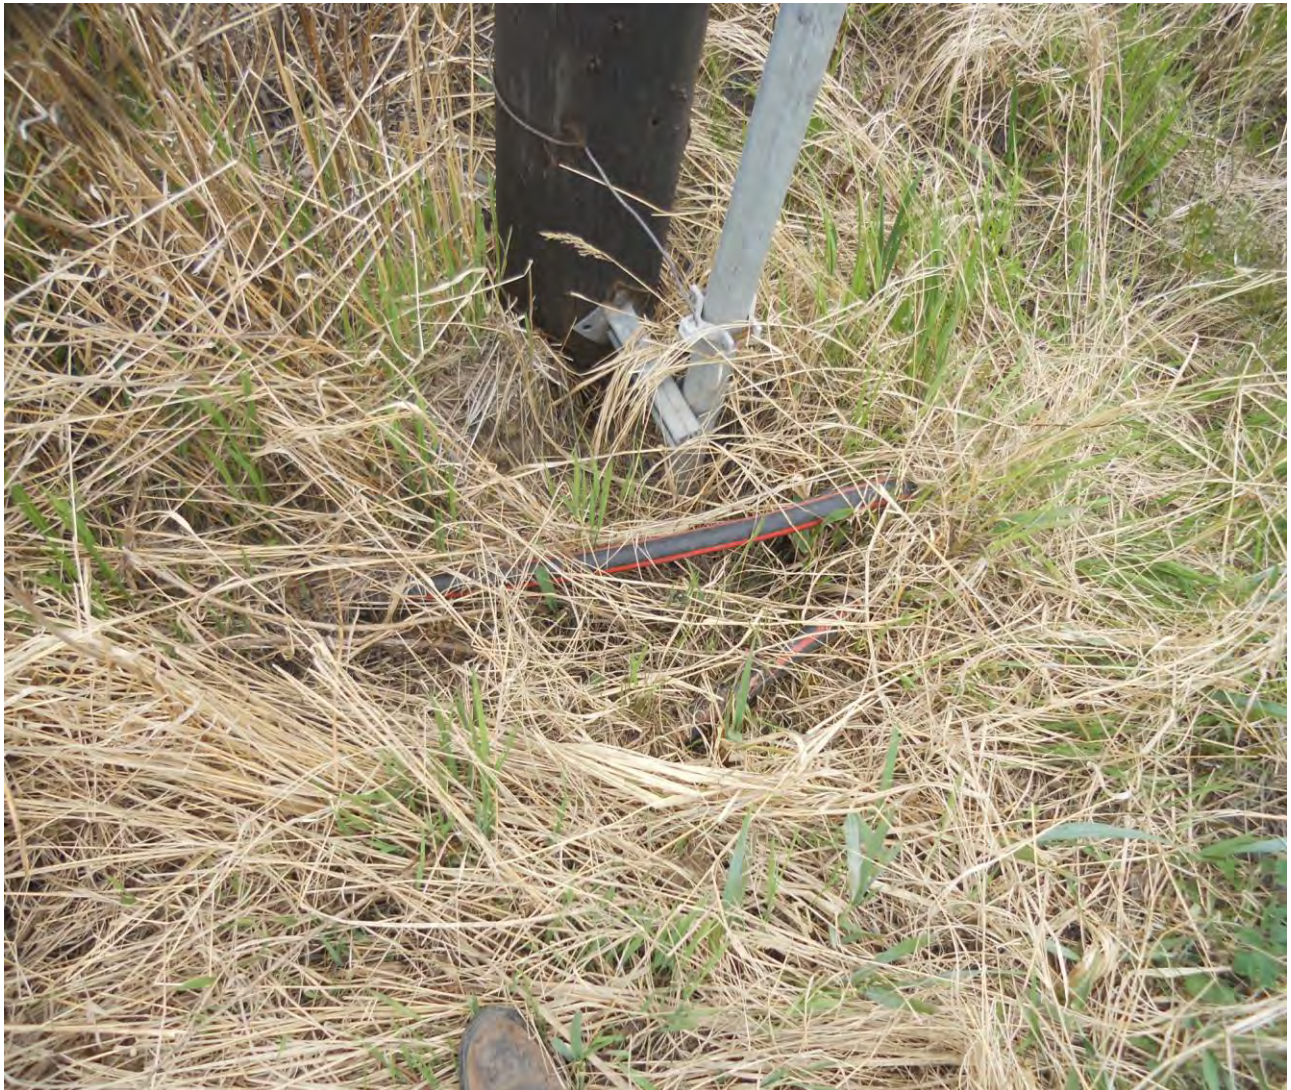
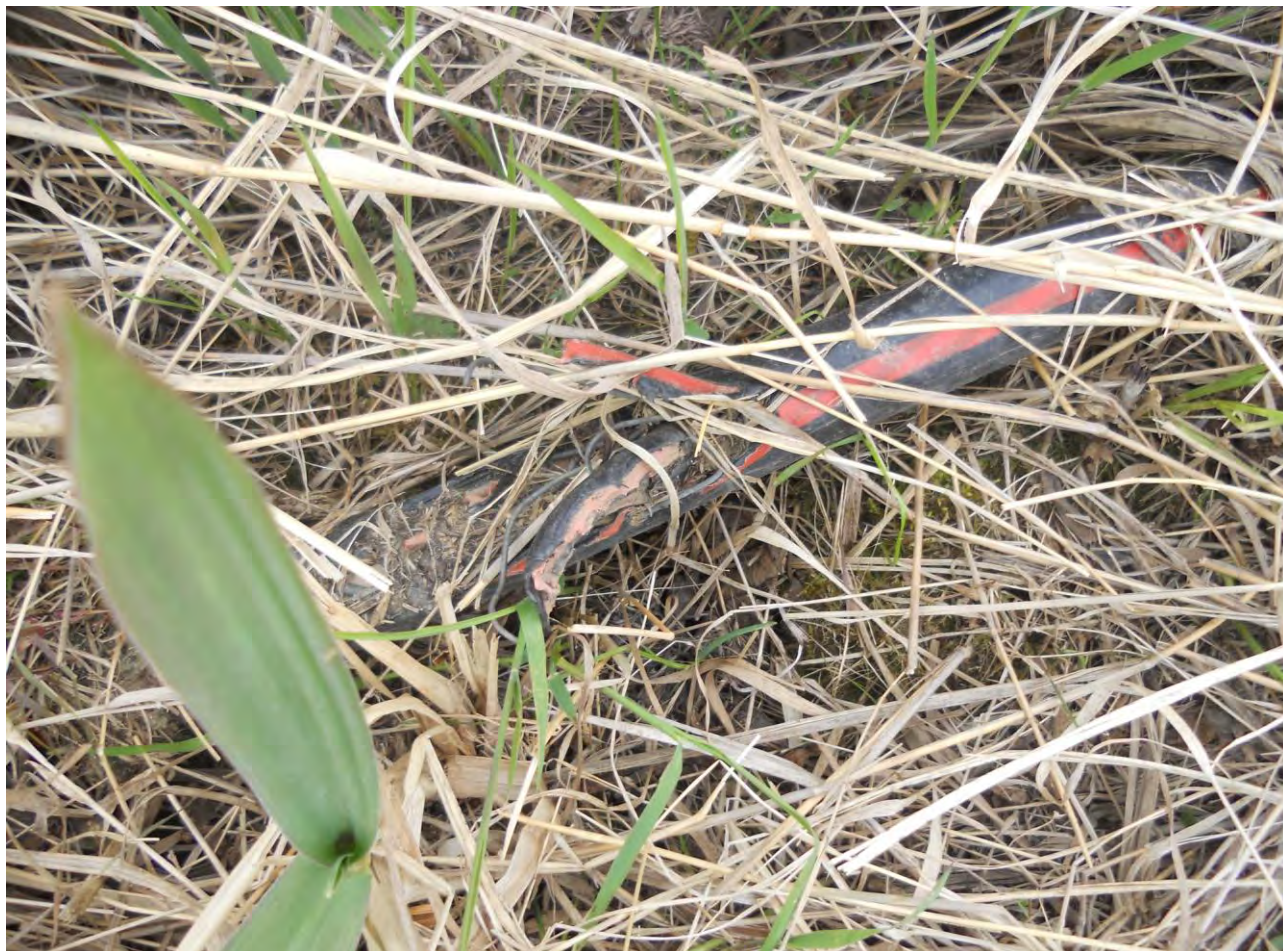
Other notes: A distribution conductor has been damaged where it has been pulled out of the ground, and the insulation nicked, possible from a road grader. We were unable to verify if the conductor was energized or not. See attached photos.
